**An Overview of Mining-Related Environmental and Human Health Issues,
Marinduque Island, Philippines: Observations from a Joint U.S. Geological
Survey – Armed Forces Institute of Pathology Reconnaissance Field Evaluation,
May 12-19, 2000**

U. S. Geological Survey Open-File Report 00-397

Executive Summary

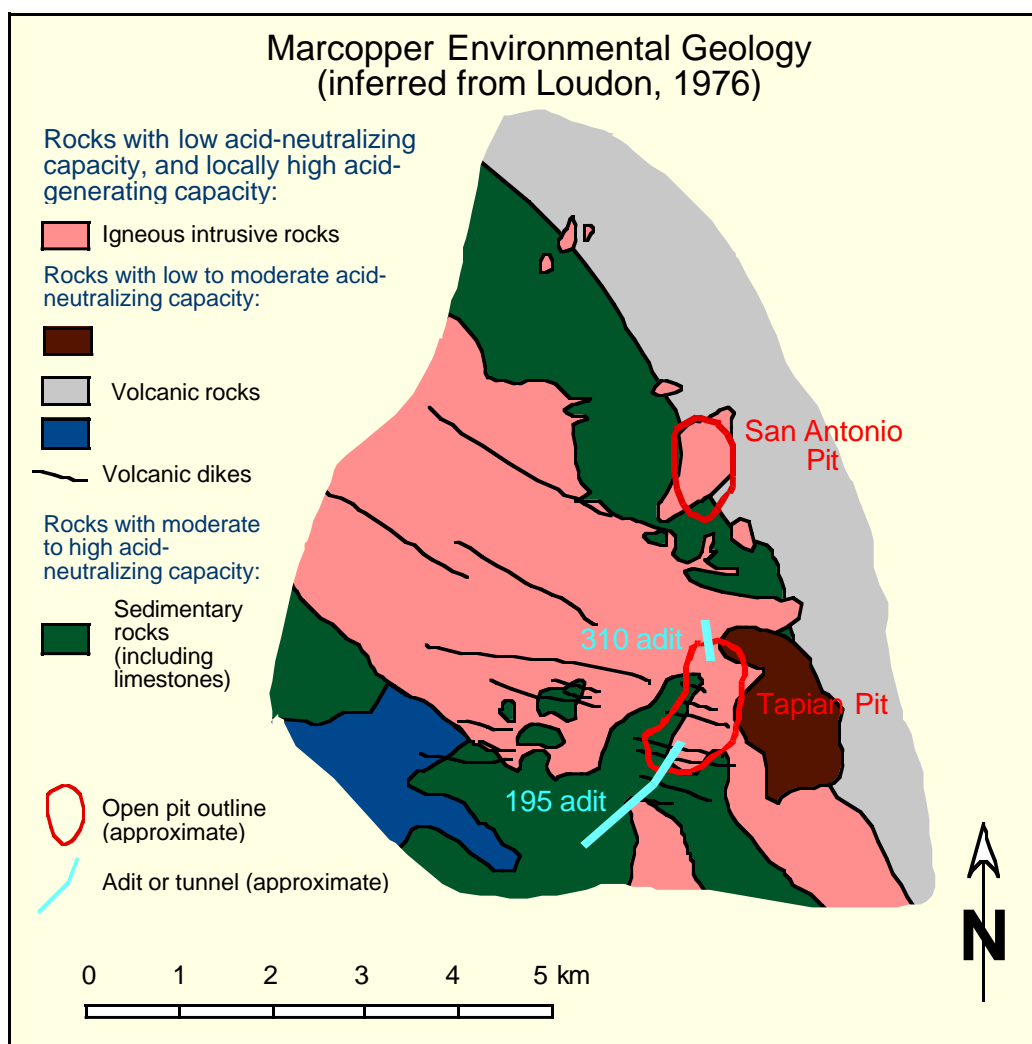
Figure 4. The rock units around Marcopper have varying abilities to react with and neutralize acid generated by oxidation of sulfide minerals in the Marcopper porphyry-Cu deposit. This figure is a geologic map from Loudon (1976) that has been modified to show the inferred environmental characteristics of the rock units around Marcopper, and the approximate locations of some adits around the Tapian pit.

Marcopper deposit, the mineralized areas in and around the Tapian and San Antonio open pits have high potential to generate acid-rock drainage via sulfide oxidation. Similarly, mill tailings from Marcopper would be expected to be acid-generating due to their relatively high sulfide content. Based on comparisons with similar deposits in the United States, we would expect the Marcopper drainage waters to contain elevated levels of copper, due to the Cu-rich nature of the ores.

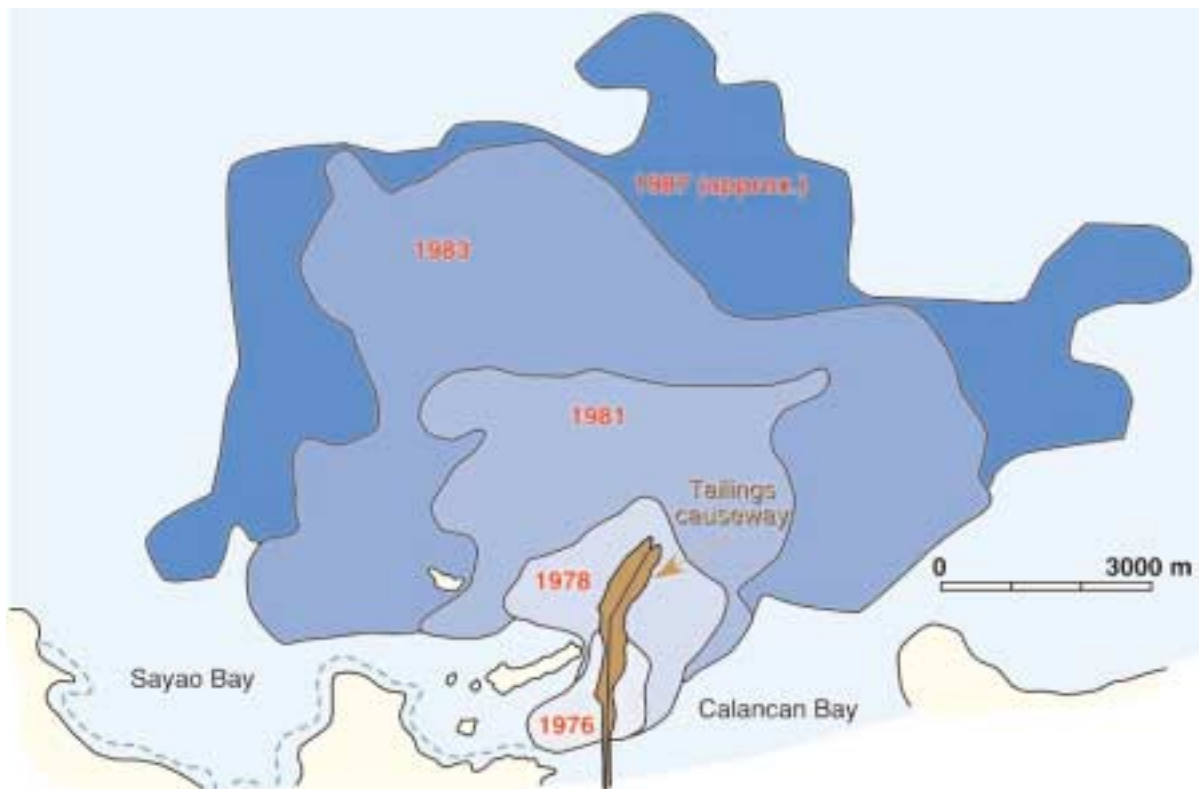
Approximately 16 years of tailings disposal in Calancan Bay resulted in the formation of a tailings causeway extending approximately 6-8 km offshore (Figs. 11, 12), and built up approximately 1-2 m above sea level. The tailings causeway itself is composed primarily of sand-sized particles, with some clay layers. Submarine tailings deposition occurred in a very large area around the causeway (Fig. 11). We did not have access on our trip to detailed bathymetric maps that

Figure 11. Map showing approximate extent of underwater tailings deposition over time in Calancan Bay. The 1987 boundary is an approximation of a gridded distribution shown in the original map. Modified from figure in Ellis et al. (1994).

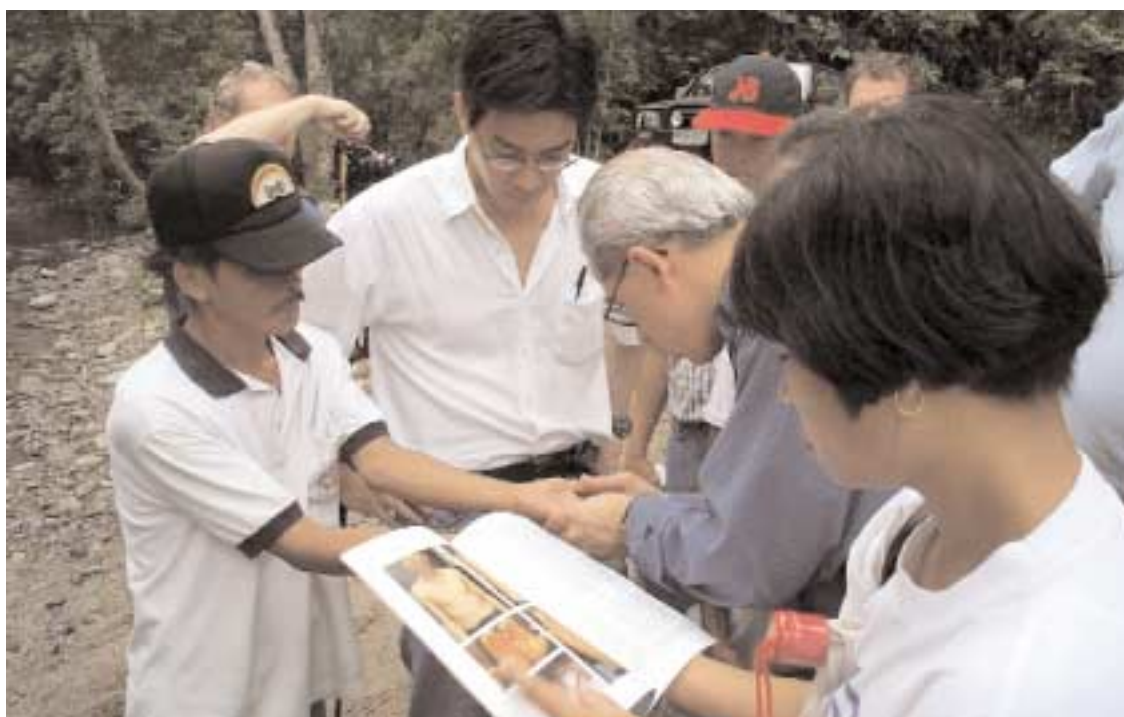
As we traveled around the island, Dr. Centeno screened a number of local residents for signs of chronic arsenic poisoning and fluorosis (Fig. 15). Only one person, an elderly gentleman from a

barangay along the Mogpog River, had symptoms (e.g., hyperpigmentation and hyperkeratotic lesions of the hands) suggesting long-term arsenic exposure. The potential source of the arsenic exposure was not readily apparent; the drinking water used by the gentleman came from a water well in the hills well above the Mogpog River, and so is seemingly unlikely to have been affected by mining-related metals from Marcopper. The gentleman’s wife did not show symptoms of arsenic poisoning.

Figure 15. Dr. José Centeno (wearing the blue shirt in the center of the photo) examined a number of local residents we met on our travels around the island for the presence of skin lesions indicative of arsenic poisoning. The gentleman being examined, who lives along the Mogpog River near where we collected the pH 4.5 water sample of the Mogpog River water (Table 1), showed no signs of arsenic poisoning. The AFIP publication being examined in the foreground (AFIP, 2000) shows pictures of the skin lesions symptomatic of arsenic poisoning. The potential human health effects of other metals was not assessed on our short trip, but needs to be done.

This preliminary assessment underscores the need for a more detailed human health assessment in the barangays and countryside that have been most affected by mining on Marinduque. If metals-related health problems are found, understanding the source of these problems, whether due to natural exposures or from human activities such as mining, will be crucial.

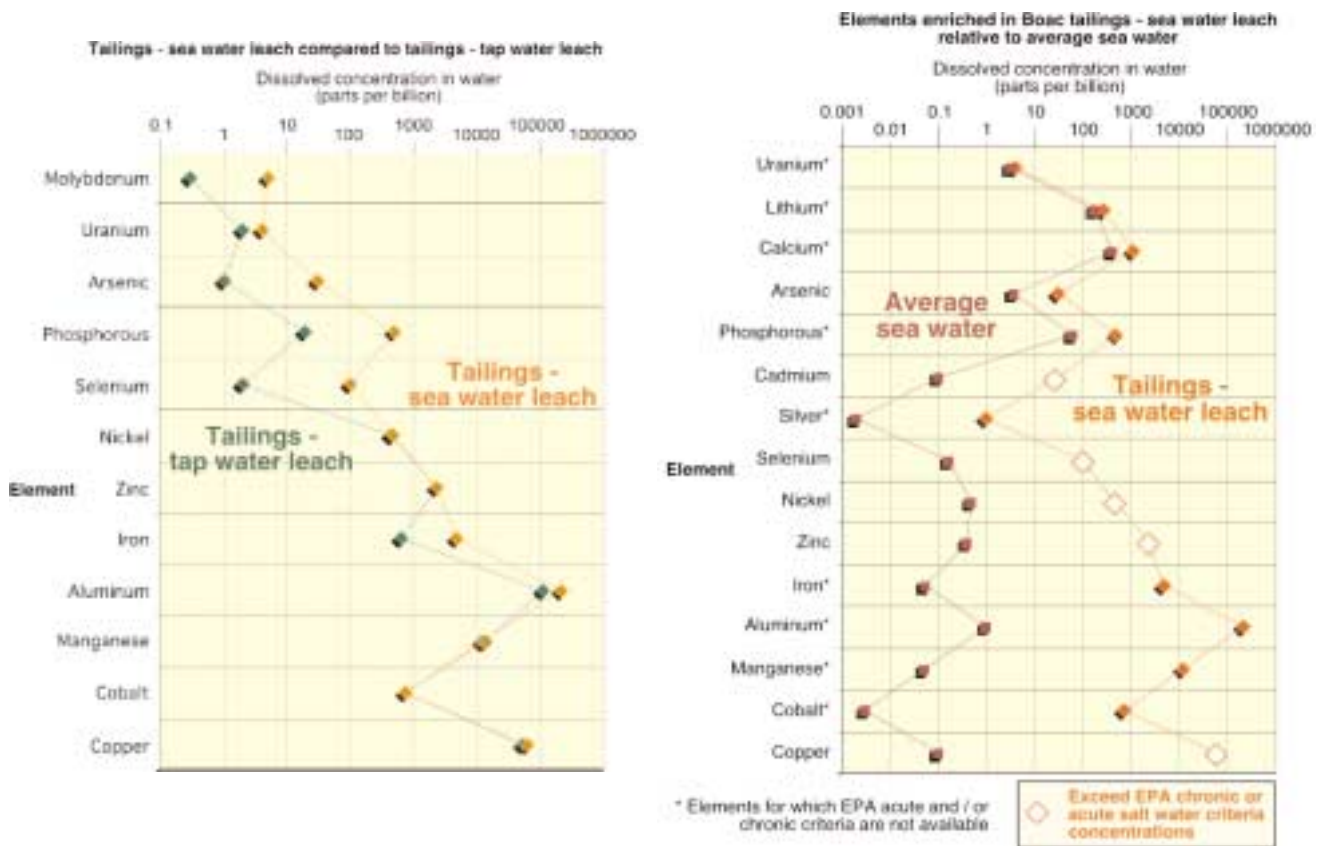
Potential metal mobility from the Boac tailings in sea water: It is possible to place some constraints on potential metal mobility from the tailings into sea water. We performed another leach test on the same Boac River tailings discussed previously, only with sea water (collected from near the Boac River mouth) as the leach agent rather than tap water. As with the tap water leach, the sea water leach was done using a water:tailings ratio of 5:1, and using a split of the same tailings sample used in the tap water leach. The analytical results of the sea water-tailings leach were somewhat surprising in that the sea water leachate developed an even lower pH (3.08 versus 3.72) than the tap water leachate, and leached even greater quantities of many metals than the tap water leach (Table 1, Fig. 16). When compared to average sea water (Fig. 16), the sea water leach is exceptionally enriched in a wide variety of dissolved metals, including aluminum, iron, manganese, copper, zinc, cobalt, and nickel.

When compared to the U.S. EPA Recommended Water Quality Criteria for sea water (U.S. EPA, 1998a), the sea water-tailings leach has several elements, for example copper, whose dissolved concentrations greatly exceed the EPA recommended maximum acute and chronic concentrations in sea water (Table 3).

The results of this simple experiment suggest that there is a substantial potential for an acid- and metal-rich plume of sea water to develop at and around the discharge point of the tailings disposal system. Key issues that must therefore be addressed are:

Figure 16. Graphs comparing dissolved heavy metal concentrations in the Boac tailings sea water leach to those of the tailings-tap water leach discussed earlier in the report (**left**), and average sea water (**right**).
