**METALLURGICAL
EVALUATION OF
DOT-E7042-3000
CYLINDER D-99604**

U.S. Department of Transportation
400 Seventh Street S.W.
Washington D.C. 20590

Timothy R. Smith, Ph.D., P.E.
310 Montgomery Street
Alexandria, VA 22314

08/27/98

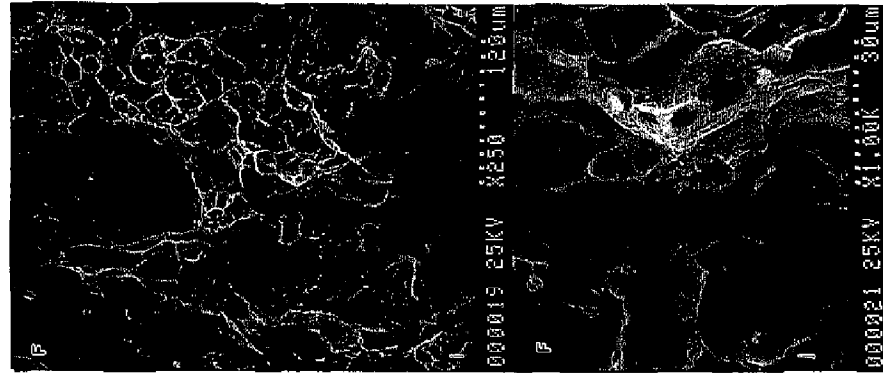
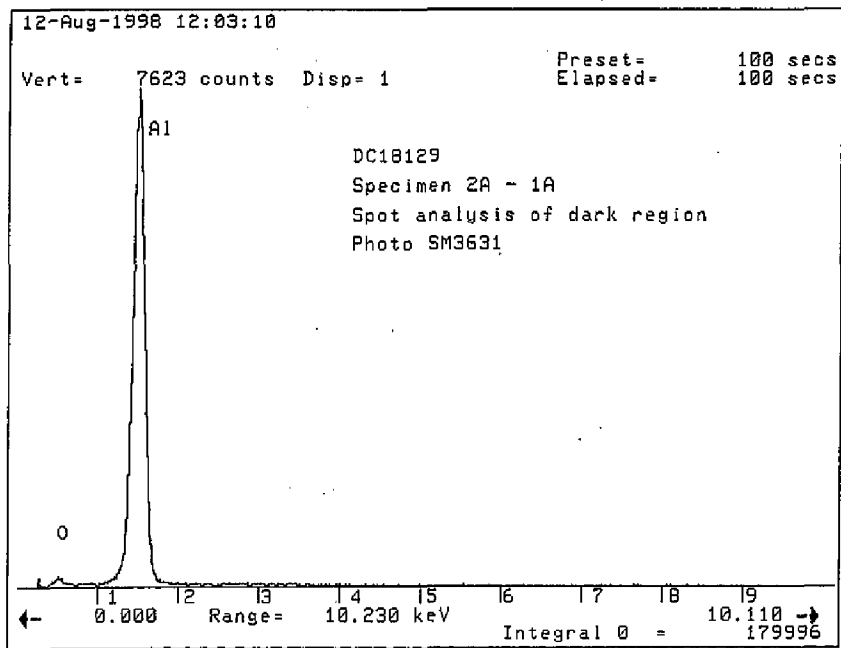
Fractography of the wafer also shows several beach marks (see Figure 3) in the flat-faced region, indicating progressive crack growth. Figure 12 shows a series of SEM fractographs taken from this fracture surface. Regions A-F are all flat-faced.

Region A (Figure 12a) was from near the inside of the tank, close to the threads at the inlet hole. Region B was close to Region A and contained a surface scale (Figure 12b) that obscured the fractographic details. Higher magnification views of Region C are shown in Figure 12c-d. This region contains predominantly intergranular fracture, with very fine-scale dimples on the faceted surfaces. In Regions D, E and F (Figures 12e-j), the fracture surface contains intergranular facets with very fine-scale poorly-formed dimples, but also contains progressively larger-scaled dimples at the locations further away from the inlet hole. Region G (Figure 12k-l) is in the shear-lipped region outside of the flat-faced portion of the fracture. This region shows predominantly dimpled rupture.

Figure 13 shows energy dispersive spectra (EDS) taken from the fracture surface of Figure 12. Figure 12a shows the spectrum for the region "A" which appears to be a coating of some sort. The spectrum shows Al and a small O peak, indicating that the coating is Al-based, perhaps formed by anodizing of the cylinder interior. Figure 13b shows the spectrum from the deposits found in Region "B", Figure 12b. The Cl, Si and O peaks indicate corrosion product or contaminants.

The shape and location of the beach marks on the fracture surface segments studied in detail (Figures 12 and 14) suggests that the cracks propagated sub-critically (i.e., slowly) for the majority of the flat-faced region. This continued up to the extent defined by the last beach mark on each side of the inlet hole. The morphology of the beach marking is asymmetric suggesting that the crack origins were not the same on each side. The fracture on the right side of Figure 3 (Section 2A-1A) propagated from an origin at the inside surface at the inlet hole and below the threads. The presence of the darkened region, similar in color to the inside of the cylinder, on the fracture surface shows that the origin of the crack was a fold in the inside cylinder wall. The fracture on the left side of Figure 3 (Section 2A-1B) appear to have originated in the lower half of the threads at the inlet hole. This region is the site of localized pitting corrosion damage (such as seen in Figures 7, 8 and 9). Apart from the initial origin, the cracks that developed on both sides of the inlet hole show very similar characteristics and appear to have grown by the same mechanism.

- Figure 12. Fractography of section 2A-1A. Overall optical micrograph view shows the regions examined in the SEM. Photo ID: DC18129-TRS-1-6/25/98.
- (a) Region A showing the coating. 500X. Photo ID: DC18129-PAL-1-6/25/98.
 - (b) Region B showing deposits on the fracture surface. 500X. Photo ID: DC18129-PAL-3-6/25/98.
 - (c) Region C. 250X. Photo ID: DC18129-PAL-4-6/25/98.
 - (d) Region C. 1000X. Photo ID: DC18129-PAL-6-6/25/98.
 - (e) Region D. 250X. Photo ID: DC18129-PAL-8-6/25/98.
 - (f) Region D. 1000X. Photo ID: DC18129-PAL-11-6/25/98.
 - (g) Region E. 250X. Photo ID: DC18129-PAL-15-6/25/98.
 - (h) Region E. 1000X. Photo ID: DC18129-PAL-17-6/25/98.
 - (i) Region F. 250X. Photo ID: DC18129-PAL-19-6/25/98.
 - (j) Region F. 1000X. Photo ID: DC18129-PAL-21-6/25/98.
 - (k) Region G. 250X. Photo ID: DC18129-PAL-23-6/25/98.
 - (l) Region G. 1000X. Photo ID: DC18129-PAL-25-6/25/98.

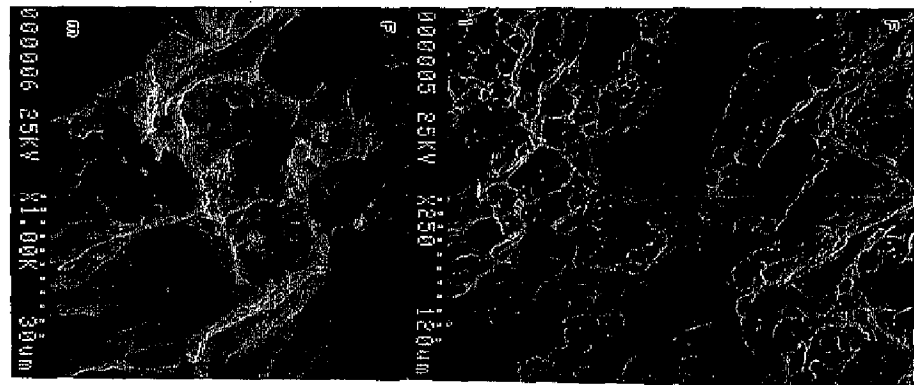
Section 2A-1B, containing the flat-faced fracture surface shown on the left in Figure 3, was also examined optically and in the SEM. As with Section 2A-1A, the flat-faced region of the fracture surface shows little macroscopic ductility and just outside of this region, transitions to an inclined shear-type of fracture. Figure 14 shows the results of the fractographic examination of this section. Figure 14a is an optical micrograph showing beach marking, described earlier. A series of SEM fractographs were taken at locations A-F on the fracture surface and are shown in Figure 14b-m. Regions A-E all show a predominantly intergranular fracture, with very fine-scale poorly formed dimples on the faceted surfaces. The fracture surface is all flat-faced in these regions and shows progressively larger-scaled dimples away from the inlet hole. Region F shows primarily ductile dimpled rupture and some intergranular faceting, with microdimpling on these facets.

- Figure 14. Fractography of section 2A-1B. Photo ID: DC18129-TRS-1-6/25/98.
- (a) Overall optical micrograph view shows the regions examined in the SEM. Scale is in 0.1 inch increments. Photo ID: DC18129-TRS-2-8/4/98.
 - (b) Region A. 250X.. Photo ID: DC18129-PAL-3-7/29/98
 - (c) Region A. 1000X. Photo ID: DC18129-PAL-4-7/29/98.
 - (d) Region B. 250X. Photo ID: DC18129-PAL-9-7/29/98.
 - (e) Region B. 1000X. Photo ID: DC18129-PAL-10-7/29/98.
 - (f) Region C. 250X. Photo ID: DC18129-PAL-5-7/29/98.
 - (g) Region C. 1000X. Photo ID: DC18129-PAL-6-7/29/98.
 - (h) Region D. 250X. Photo ID: DC18129-PAL-1-8/5/98.
 - (i) Region D. 1000X. Photo ID: DC18129-PAL-2-8/5/98.
 - (j) Region E. 250X. Photo ID: DC18129-PAL-3-8/5/98.
 - (k) Region E. 1000X. Photo ID: DC18129-PAL-4-8/5/98.
 - (l) Region F. 250X. Photo ID: DC18129-PAL-5-8/5/98.
 - (m) Region F. 1000X. Photo ID: DC18129-PAL-6-8/5/98.
