# 4. How and Why the Blackout Began

This chapter explains the major events—electrical, computer, and human—that occurred as the blackout evolved on August 14, 2003, and identifies the causes of the initiation of the blackout. It also lists initial findings concerning violations of NERC reliability standards. It presents facts collected by the investigation team and does not offer speculative or unconfirmed information or hypotheses. Some of the information presented here, such as the timing of specific electrical events, updates the Sequence of Events<sup>1</sup> released earlier by the Task Force.

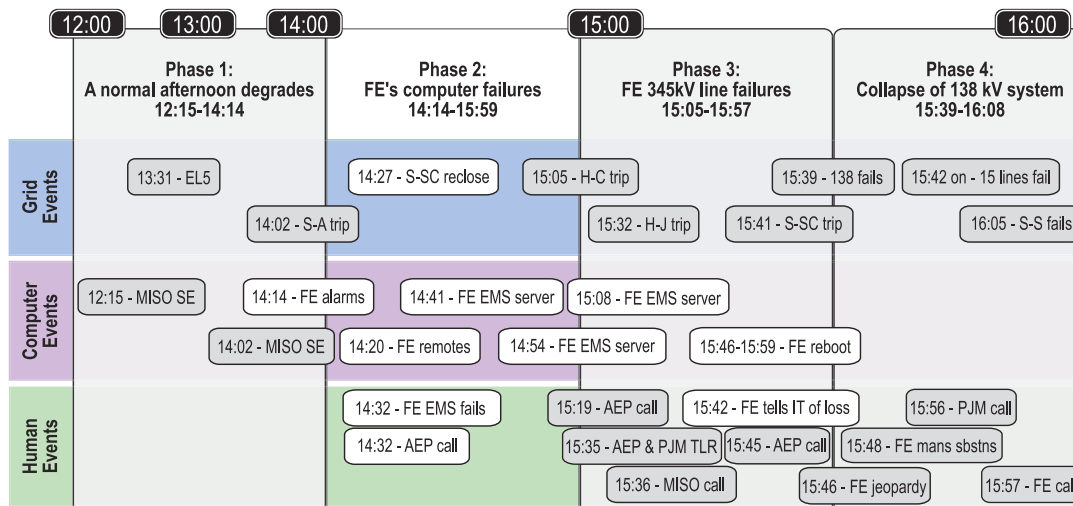
Figure 4.4. Timeline Phase 2

- 2A) 14:14 EDT: FE alarm and logging software failed. Neither FE's control room operators nor FE's IT EMS support personnel were aware of the alarm failure.
- 2B) 14:20 EDT: Several FE remote location consoles failed. FE Information Technology (IT) engineer was computer auto-paged.
- 2C) 14:27:16 EDT: Star-South Canton 345-kV transmission line tripped and successfully reclosed.
- 2D) 14:32 EDT: AEP called FE control room about AEP indication of Star-South Canton 345-kV line trip and reclosure. FE had no alarm or log of this line trip.
- 2E) 14:41 EDT: The primary FE control system server hosting the alarm function failed. Its applications and functions were passed over to a backup computer. FE's IT engineer was auto-paged.

2F) 14:54 EDT: The FE back-up computer failed and all functions that were running on it stopped. FE’s IT engineer was auto-paged.
