SUBJECT: First Five-Year Review Report  
Piper Aircraft Superfund Site  
Vero Beach, Indian River County, Florida

**First Five-Year Review Report for  
PIPER AIRCRAFT NPL SITE  
The New Piper Aircraft, Inc.  
Vero Beach, Indian River County, Florida**

**December 2003**

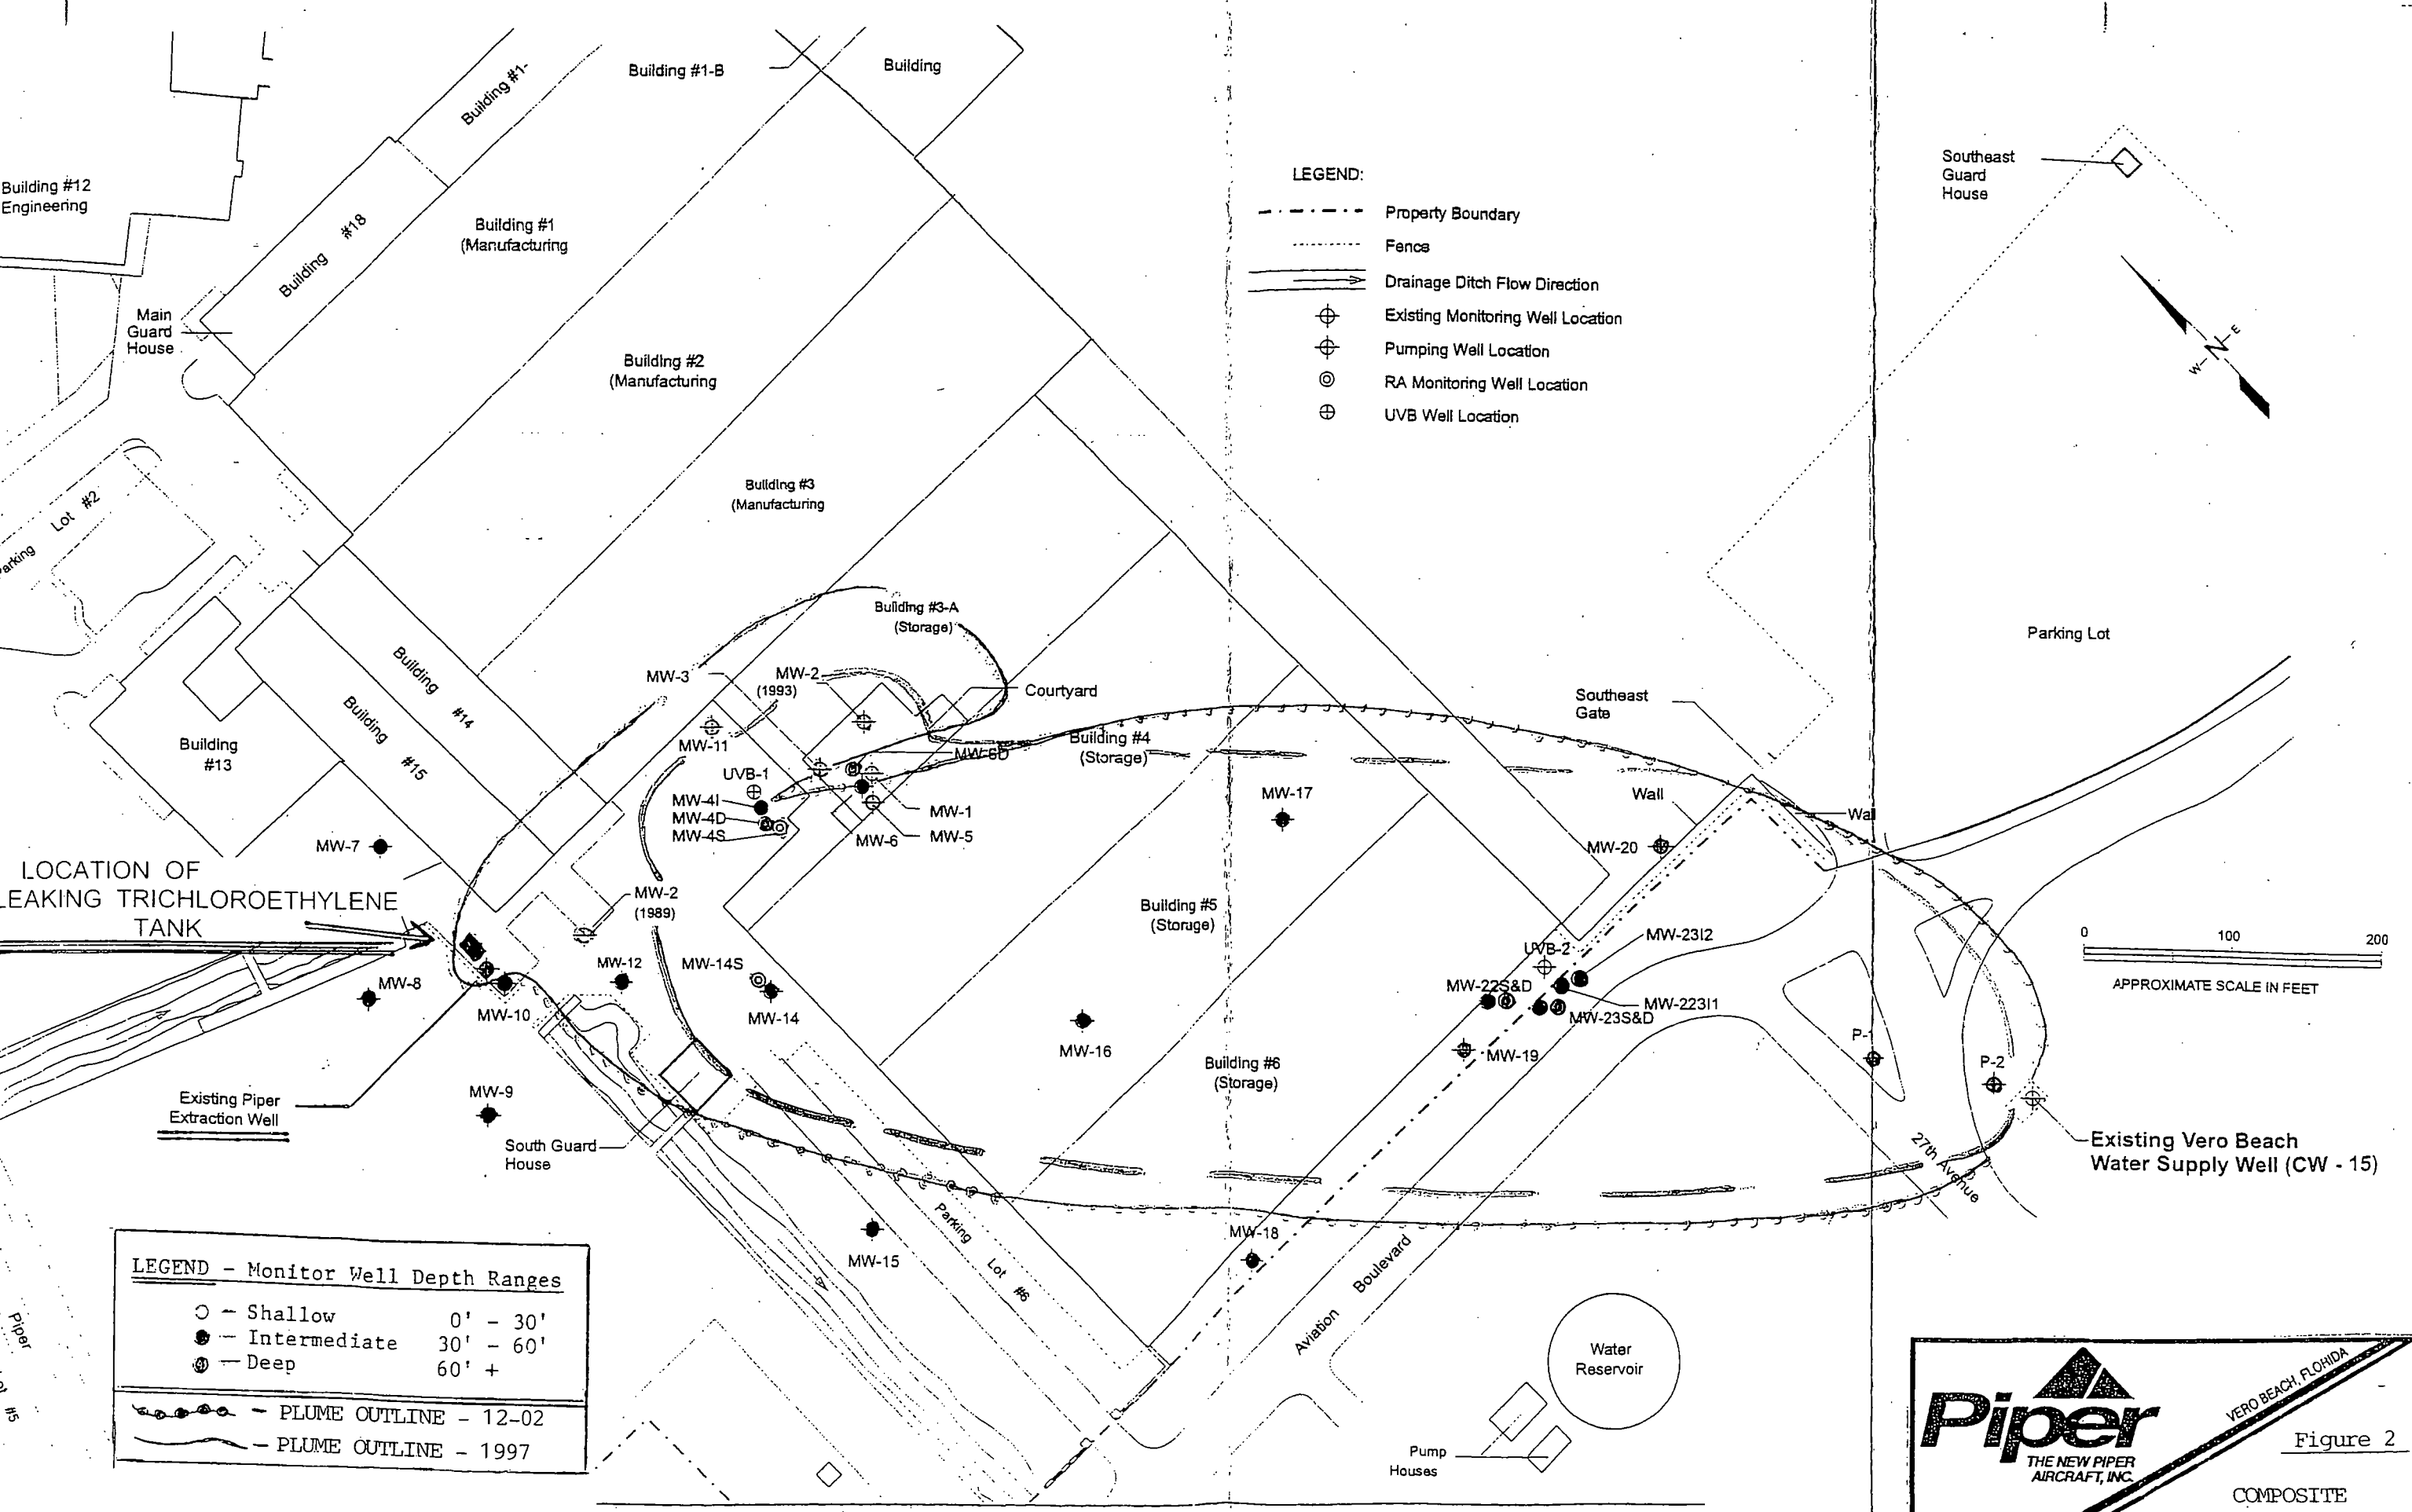
Figure 2

- 3.2 Mid-plume monitoring wells appear to be poorly placed to track the progress of the remedial action. MW-16 is best located to monitor the progress of the remedial action, but data from that well are too variable over the period of UVB well operation to make any reasonable judgement about changes in water quality in the mid-plume area. MW-17 is another mid-plume well and data from that well suggest that the remedial action is having little or no effect on the concentration of vinyl chloride in that part of the plume (Figure 2).

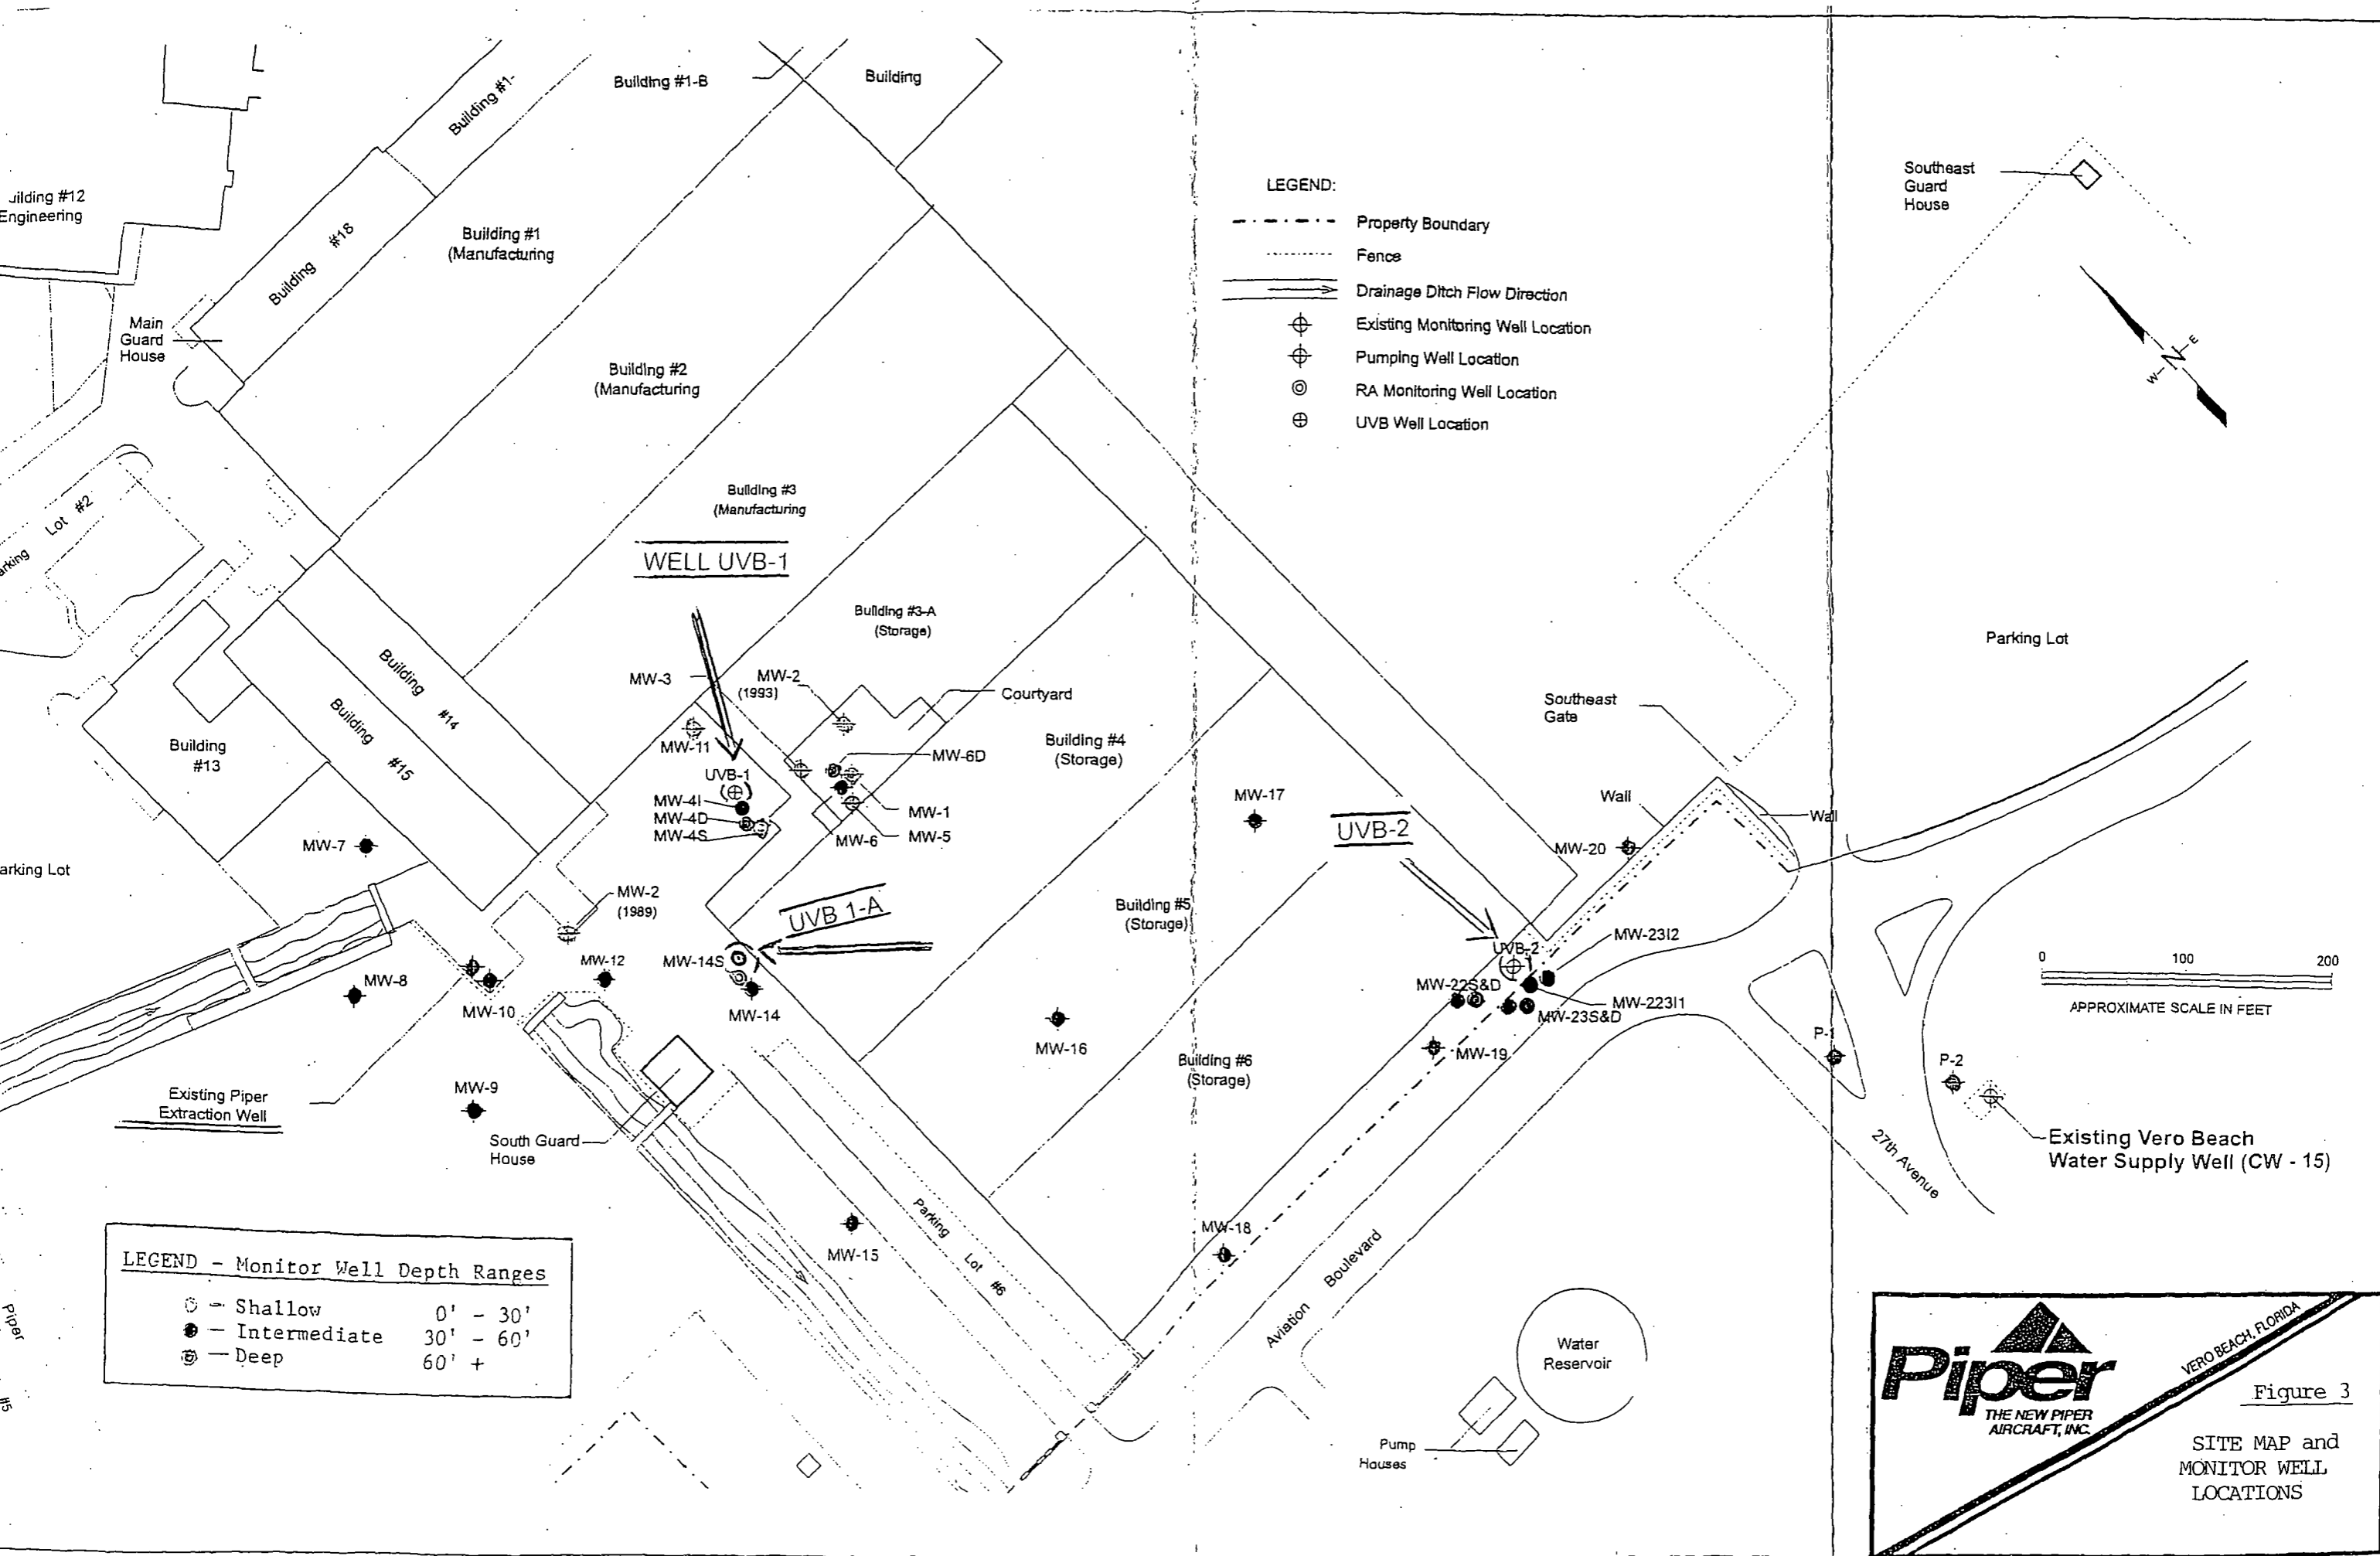
Figure 3  
SITE MAP and MONITOR WELL LOCATIONS

At MW-16, time-concentration data present an unclear picture of time concentration trends for vinyl chloride and cis 1,2-DCE. These are the two contaminants of concern that have been detected at that location in concentrations periodically exceeding their respective MCLs. **Figure 3** shows the MW-16 time-concentration data for cis 1,2-DCE and vinyl chloride. The pattern of highly variable concentrations suggests either different well sampling and purging procedures or slightly different flow patterns in the aquifer. Either condition may result in a sample representing either deeper, more contaminated ground water or shallower, less contaminated ground water (or ground water that is at times more representative of the plume centerline concentrations in this part of the plume).

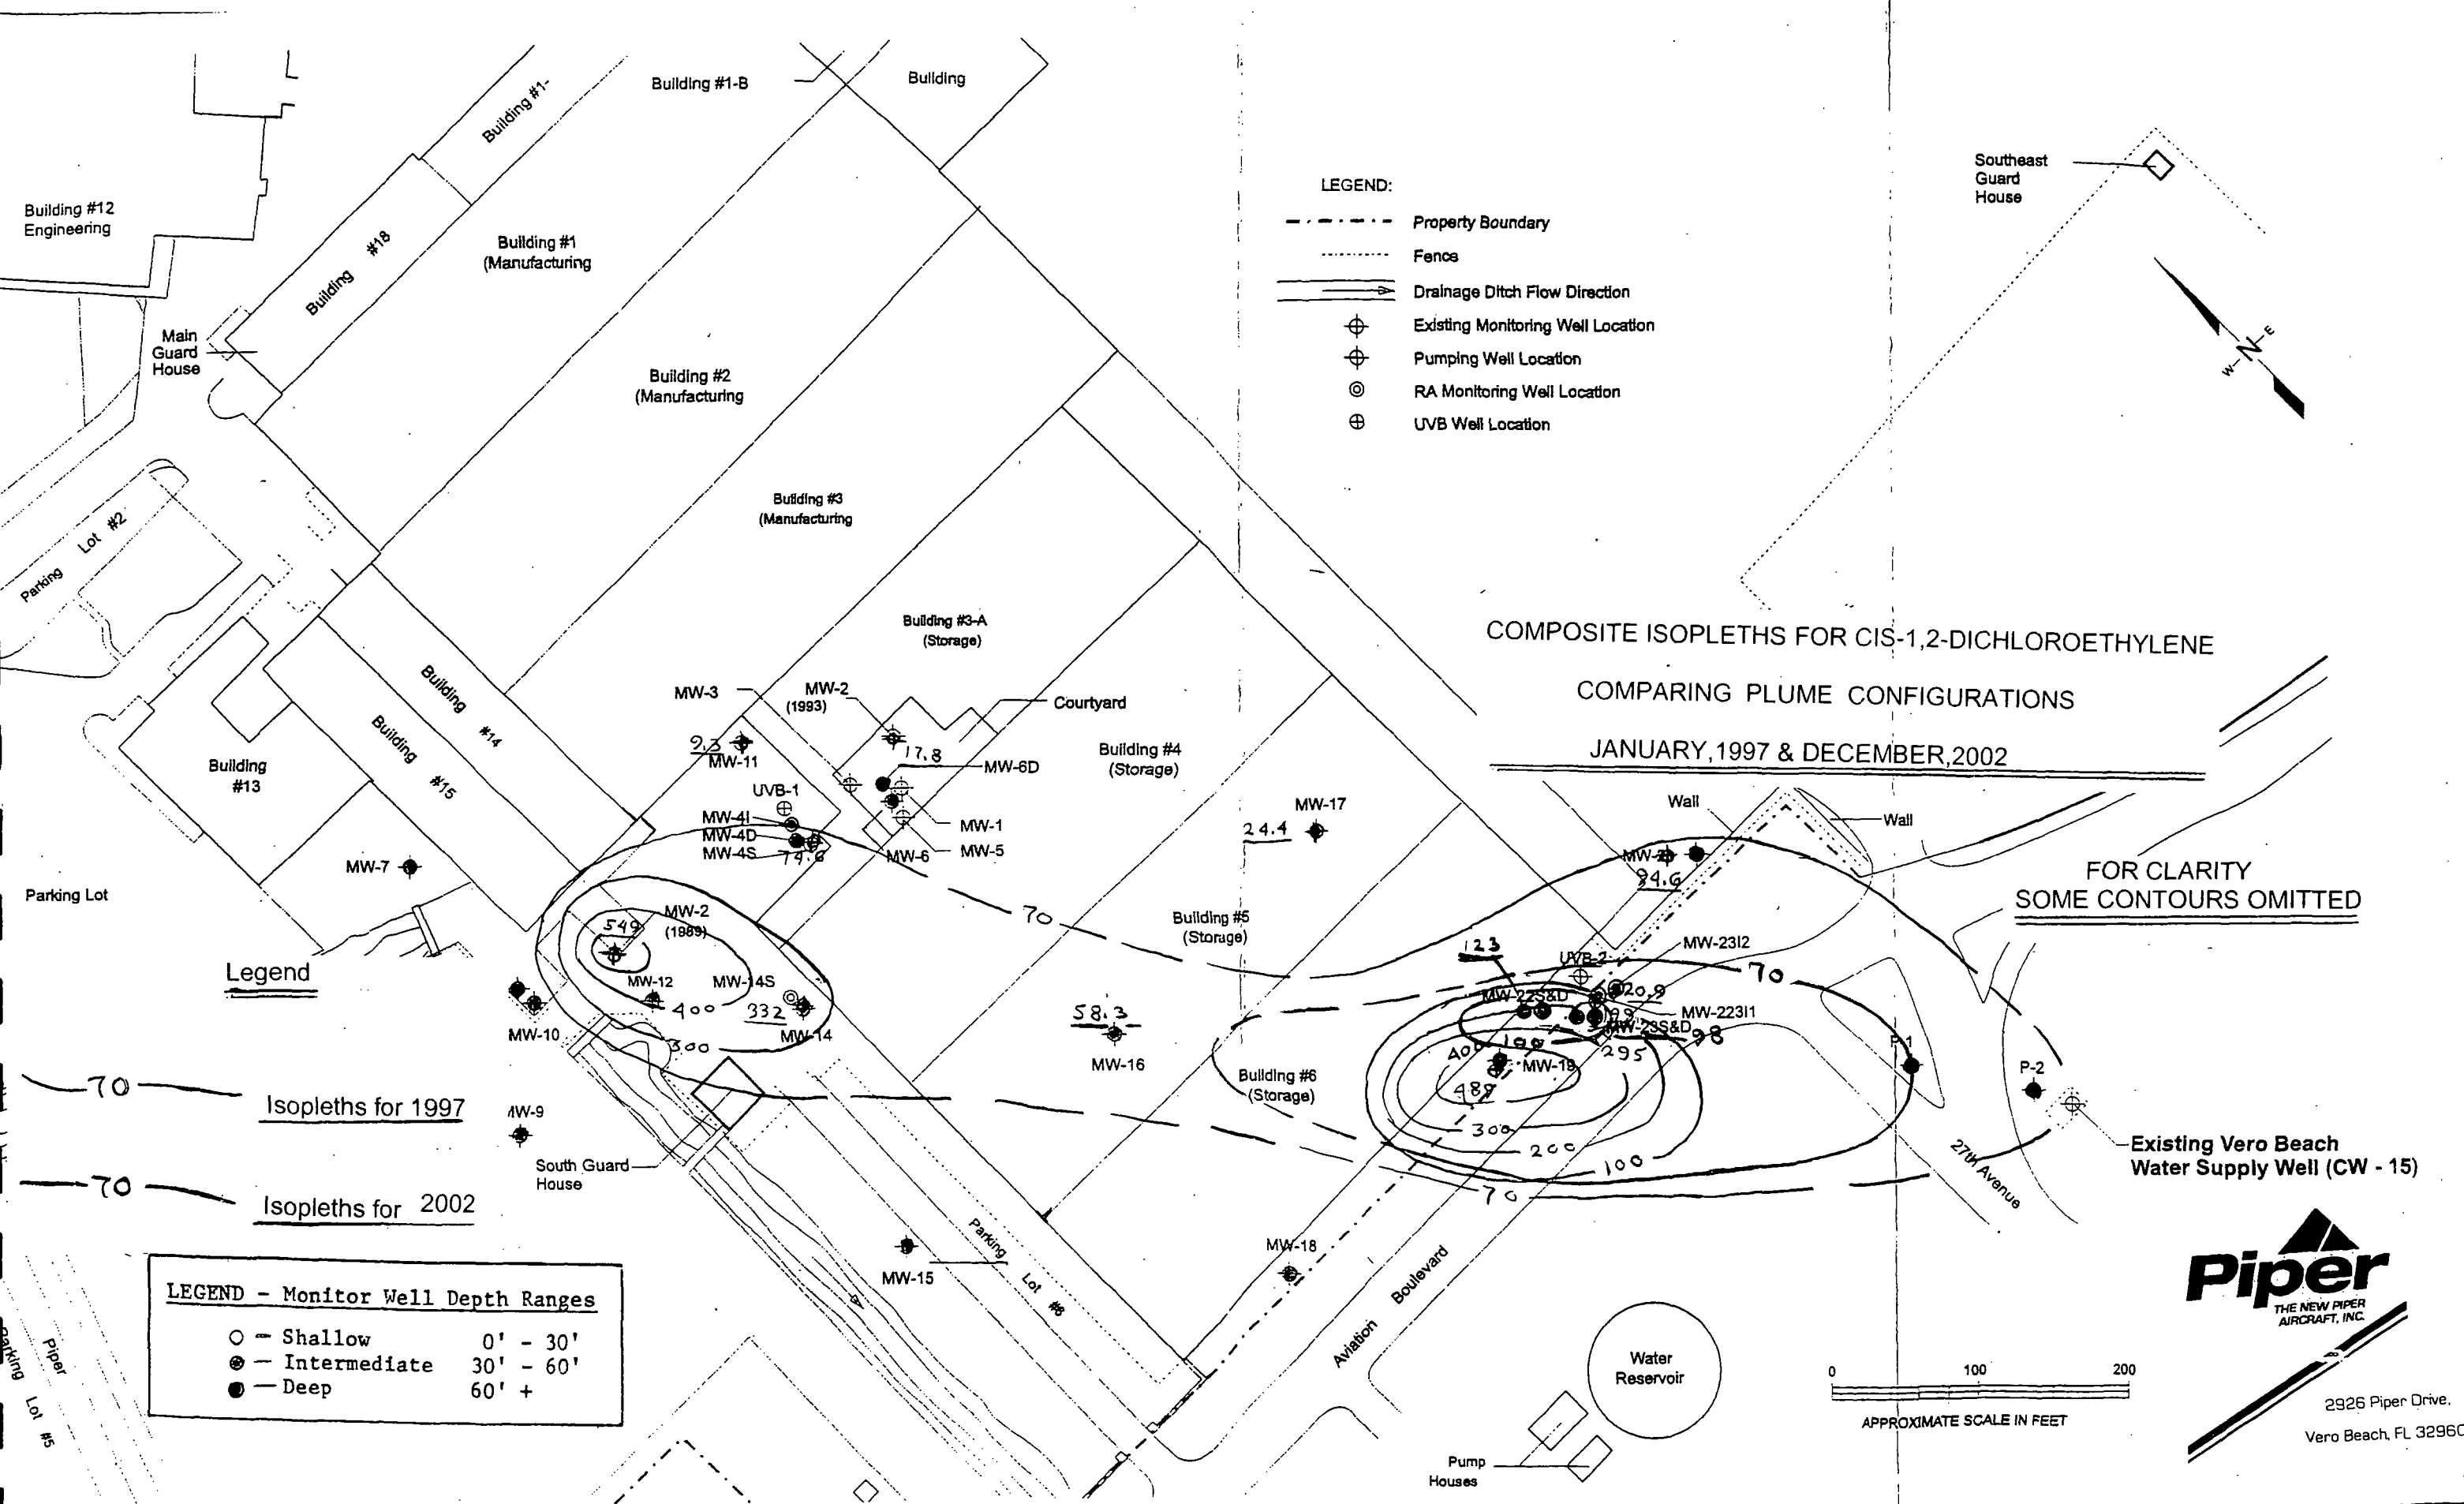
FIGURE 15

*Figure 15 isopleths show a decrease in cis,-1, 2 DCE from 1997 through 2002 in the area of MW-19. Isopleths are somewhat misleading in that they depict a smooth transition and connected occurrence of contamination. The residual contaminants probably occur in a three-dimensional random arrangement of small lenses and blobs, the placement of which is controlled by an interplay of hydrologic, geologic and phase relationship variables. Looking for a progressive downward trend in certain wells can be unproductive. The ups and downs in residual concentration shown by various wells despite a rigorous attempt to keep all sampling protocols identical are attributed to the sporadic and intermittent release of contaminants to the down gradient water flow occurring in a fairly anisotropic aquifer.*

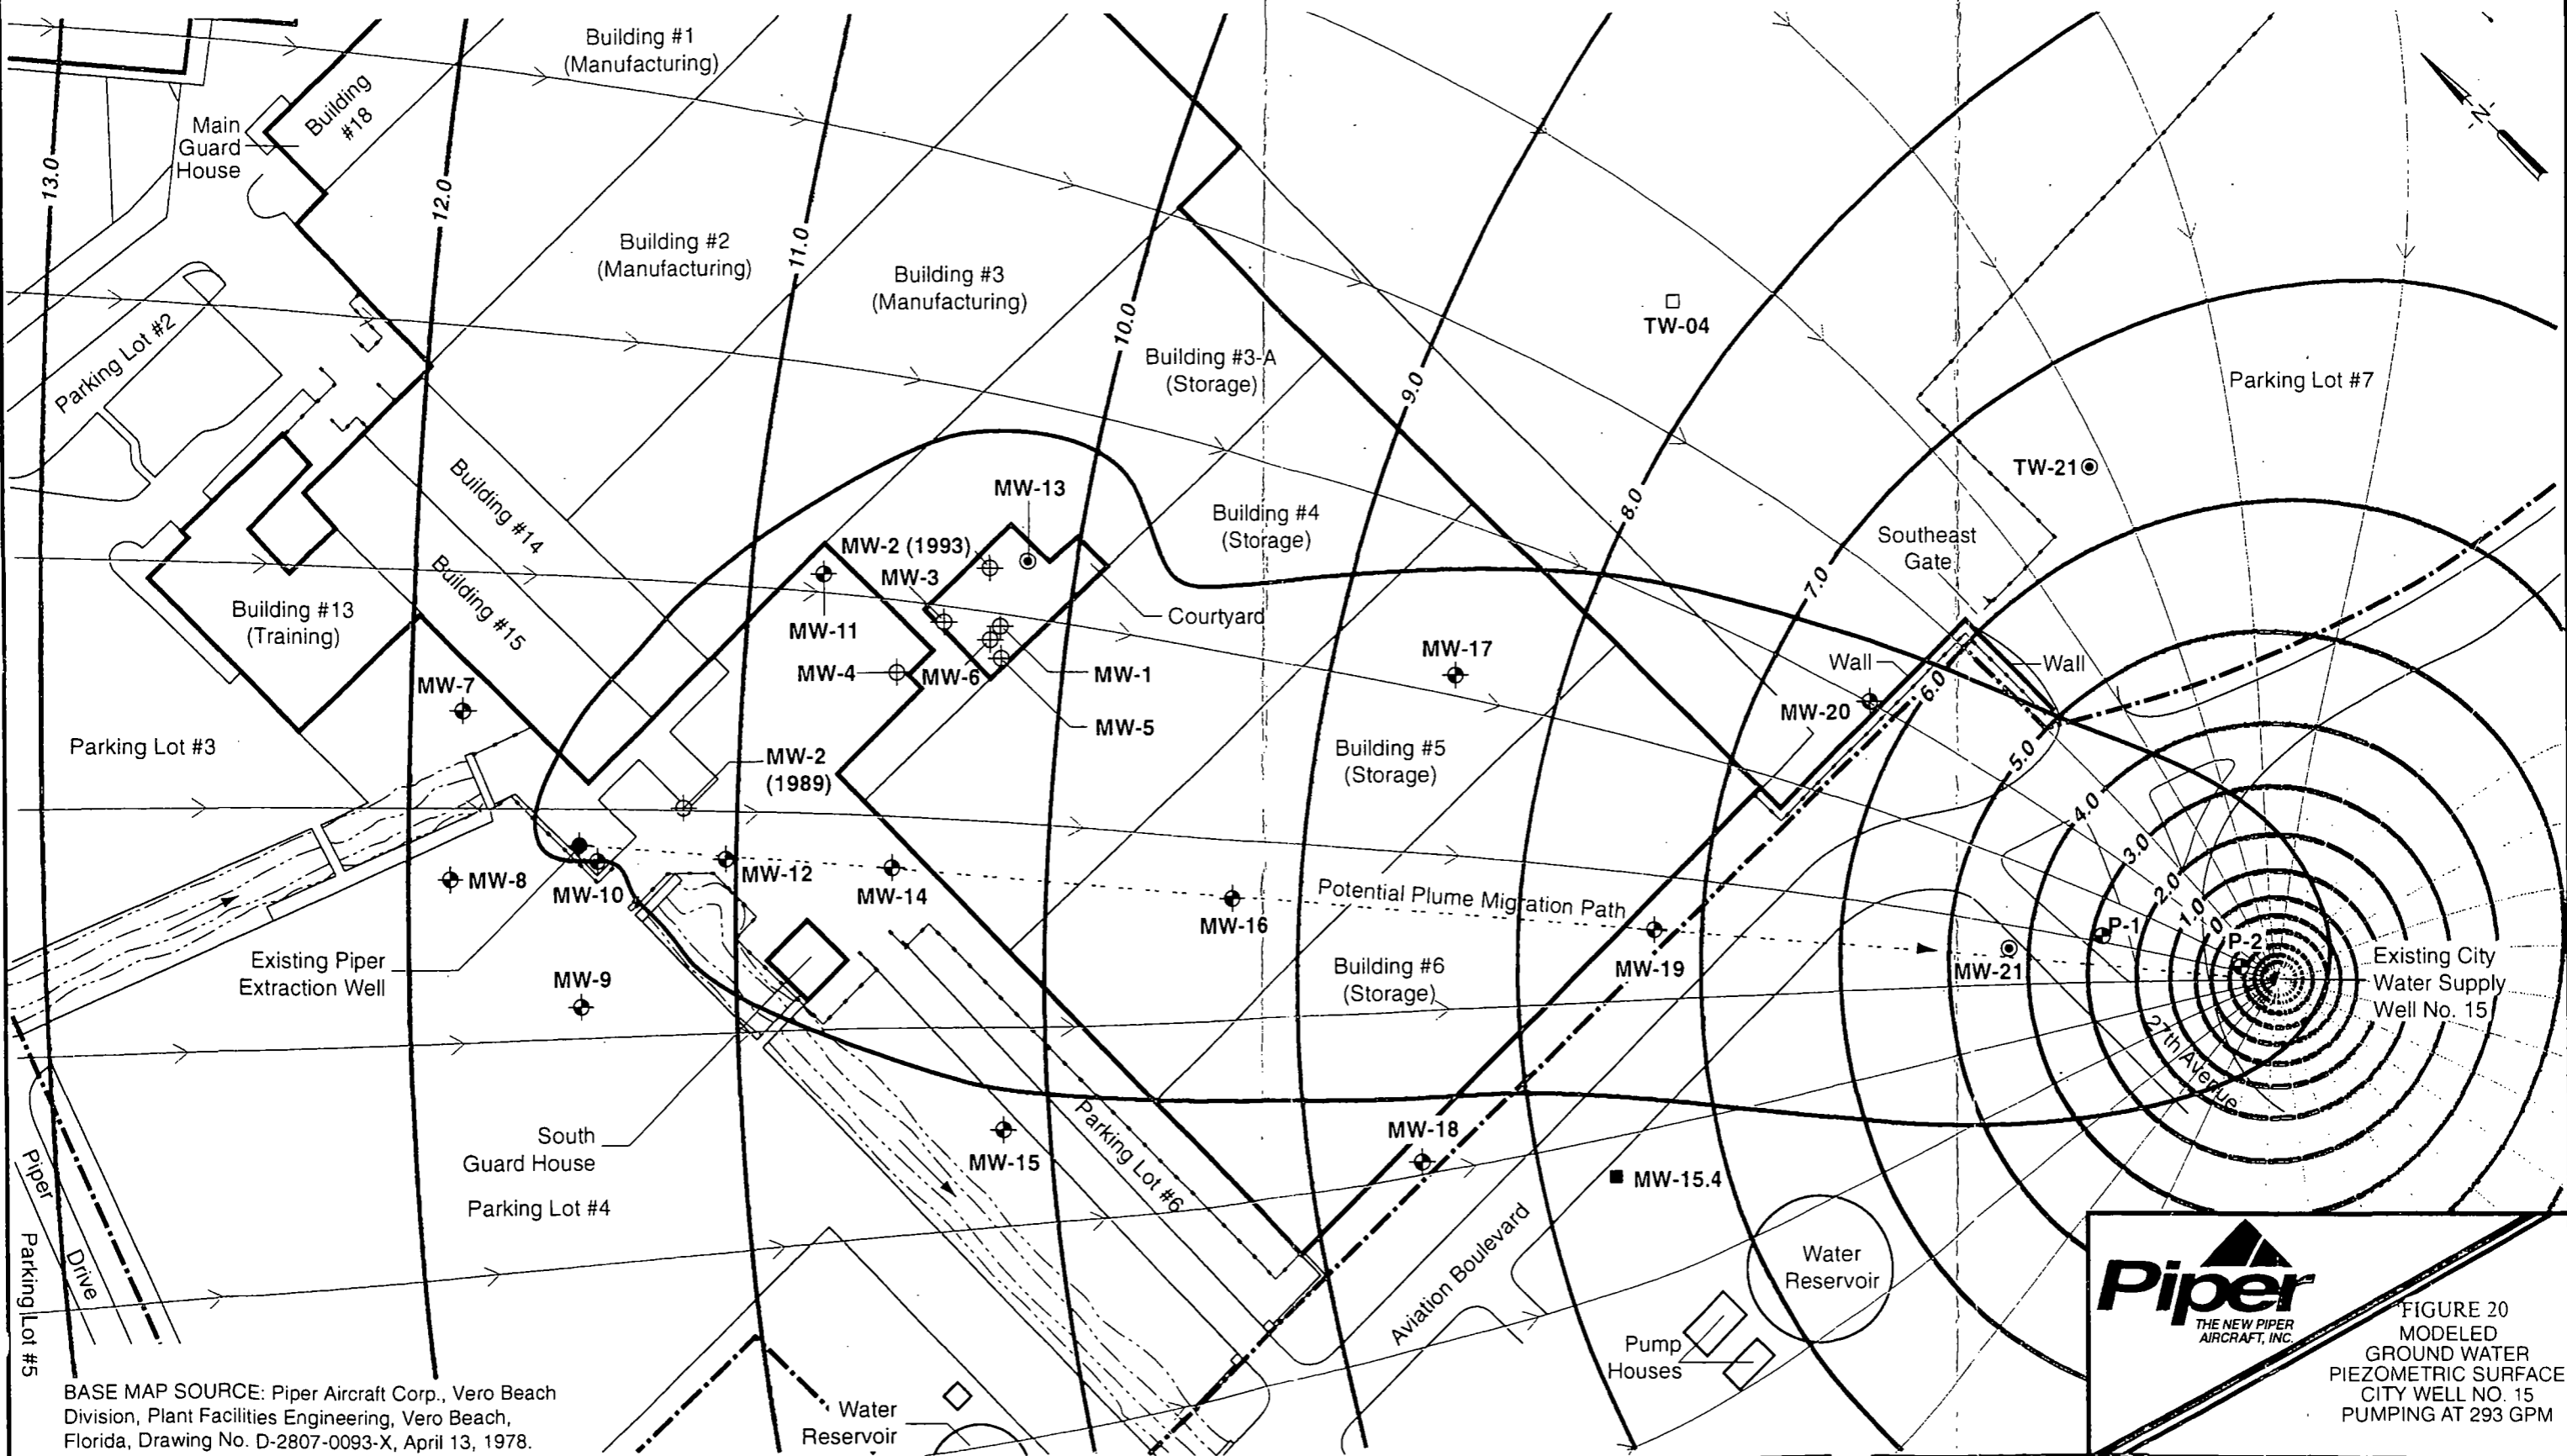
**FIGURE 20**  
 MODELED  
 GROUND WATER  
 PIEZOMETRIC SURFACE  
 CITY WELL NO. 15  
 PUMPING AT 293 GPM

*The various pumping rates over the past five years have varied from 5 to 35 GPM. The present pumping rate of 20 GPM has been maintained since April, 2003. If water level data is collected just before the well pump cycles off, a cone of influence from deep well data maps a cone of influence of approximately 50 feet in diameter. With CVB Well 15 on, the capture zone around UVB-2 is probably not much larger than observed cones of influence. Shallow and intermediate well data shows little to no disturbance of water level contours. As noted, the well processes some contaminants, but a minor portion of that which mixes with non-contaminated water within the capture zone of CVB-15, see Figure 20.*

*Figures 20 and 21 have been added to the Five Year Review Report to represent the best existing interpretation of the CVB Well 15 capture zone in the form of flow net modeling from data collected during pumping tests of CVB Well 15 with data collection from existing and former pumping test monitoring wells. These data were originally reported in Appendix K of the Supplemental Investigation And Focused Feasibility Study For Preliminary Remedial Design, March 20,1997.*

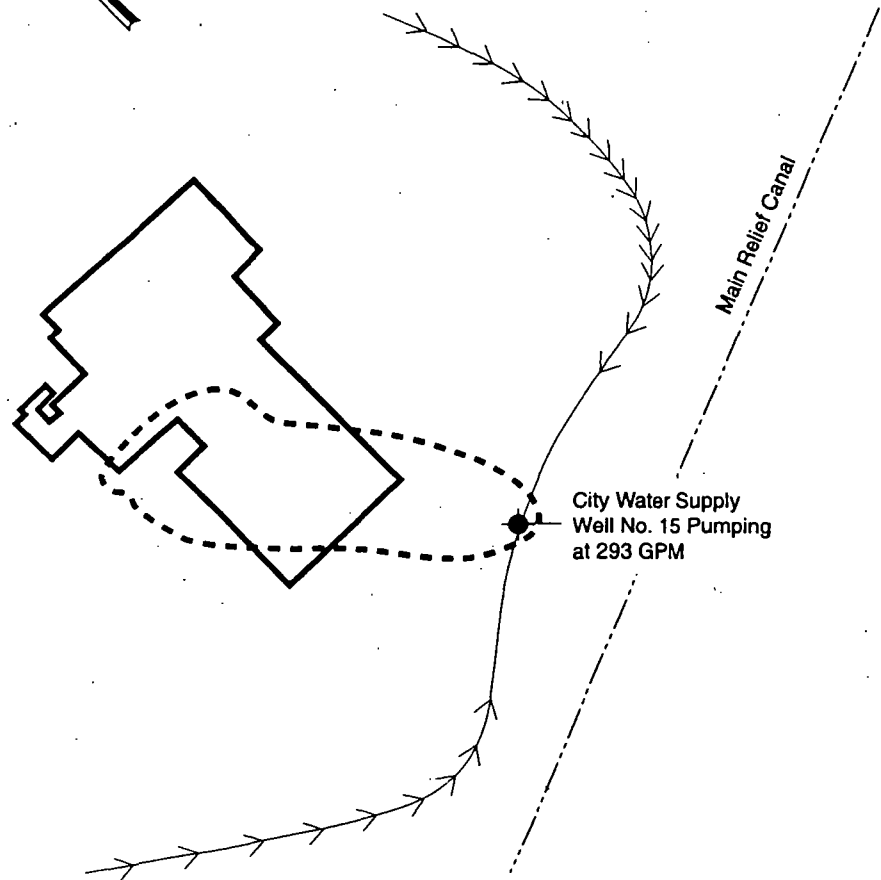
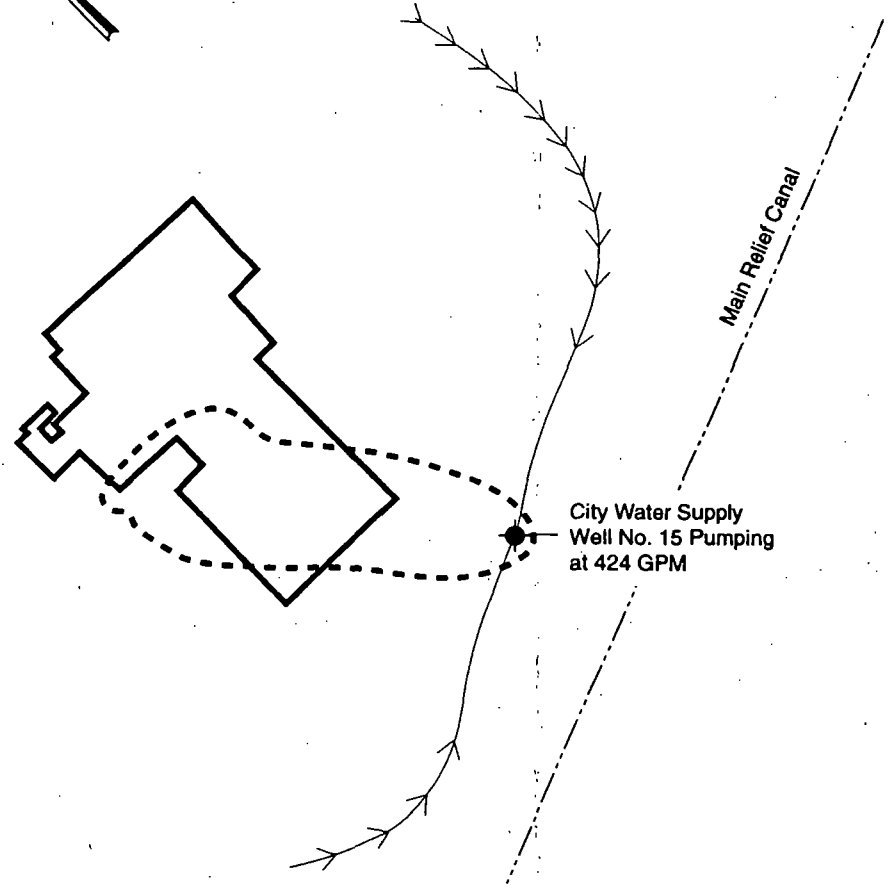
**FIGURE 21**  
MODELED GROUND WATER  
CAPTURE ZONES

*Figure 21 illustrates modeling of CVB-Well #15 capture zone based upon a large-scale comprehensive pumping test conducted in 1997 and reported in submittals at that time. It is reasonable to conclude that CVB-Well #15 acts as a complete barrier to the movement of residual Vinyl Chloride past the well to the southeast EPA groundwater quality testing in 1992 and 1993 as reported in EPA Superfund Update of January 1995, concluded that: "The canal is acting as a hydraulic barrier preventing the contaminants from migrating to the south side of the canal (e.g., no VOC's were detected south of the canal)".*
