**Lockheed**
Missiles & Space Company, Inc
Huntsville Research & Engineering Center

RESULTS OF TESTS OF THE SRB
AFT SKIRT HEAT SHIELD
CURTAIN IN THE MSFC HOT
GAS FACILITY

February 1982

Contract NAS8-32982

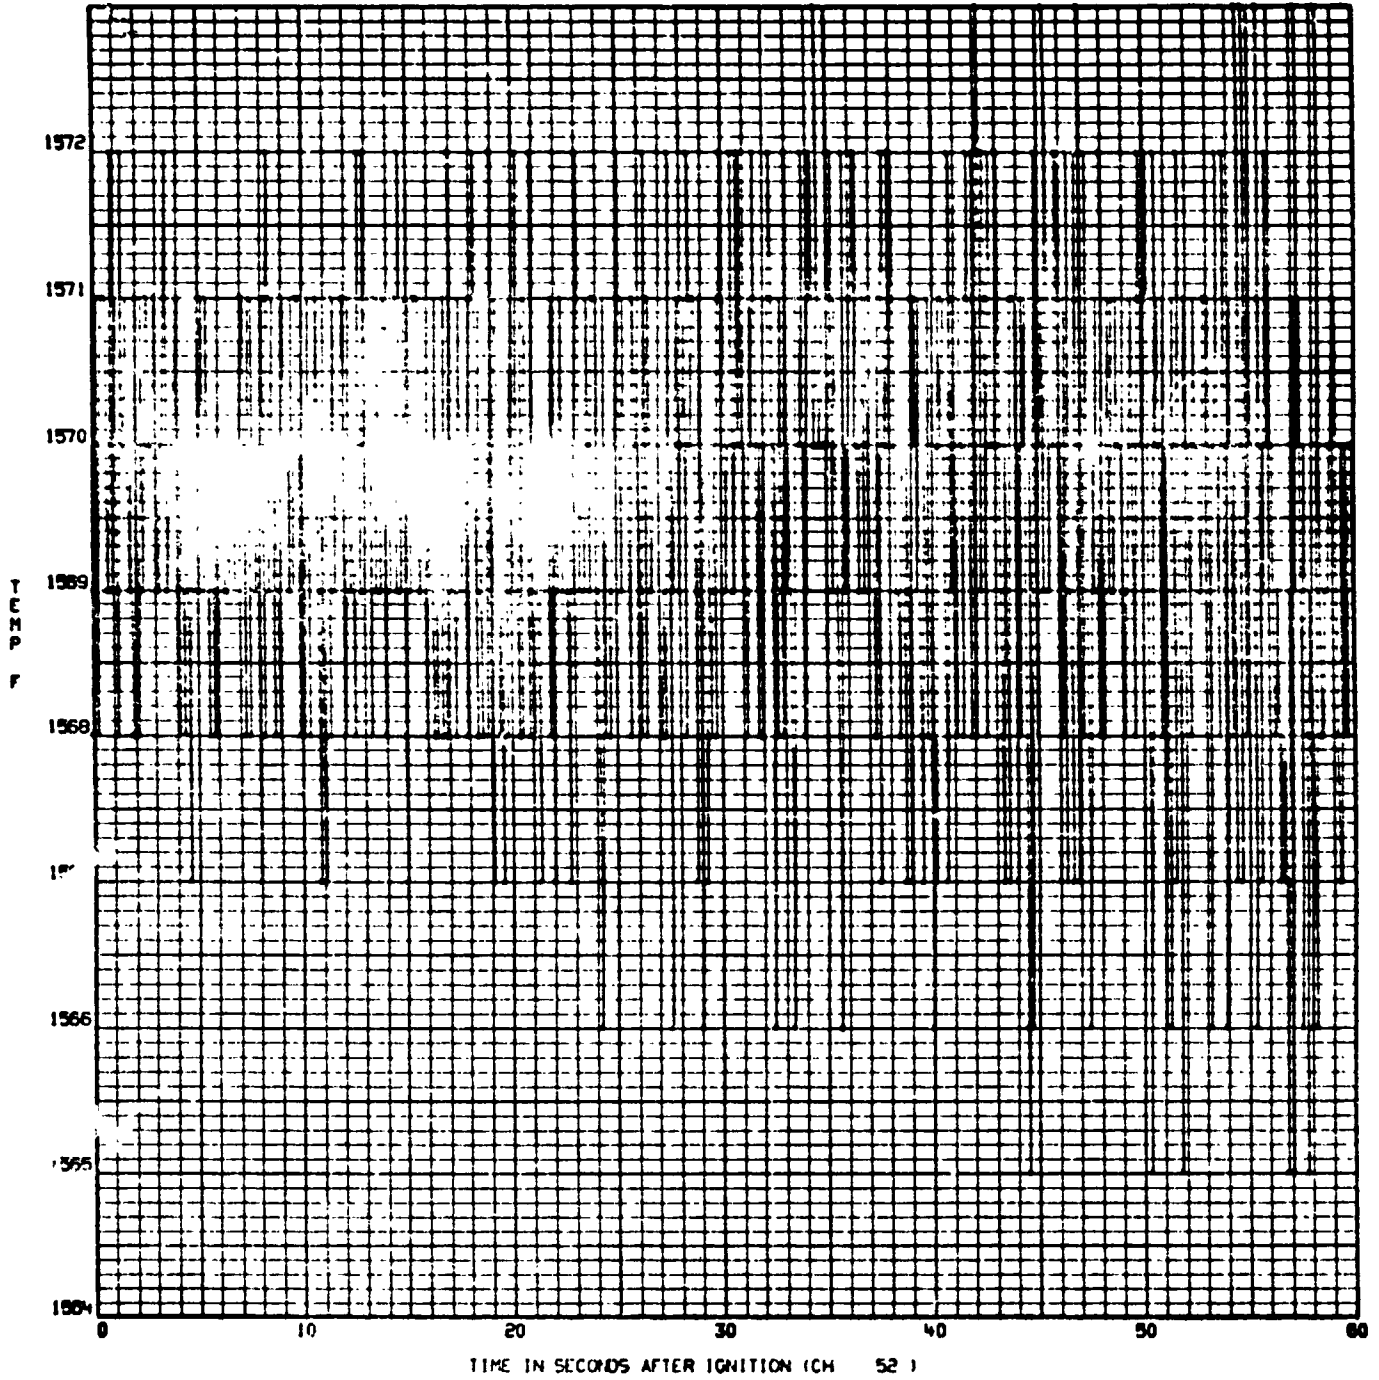
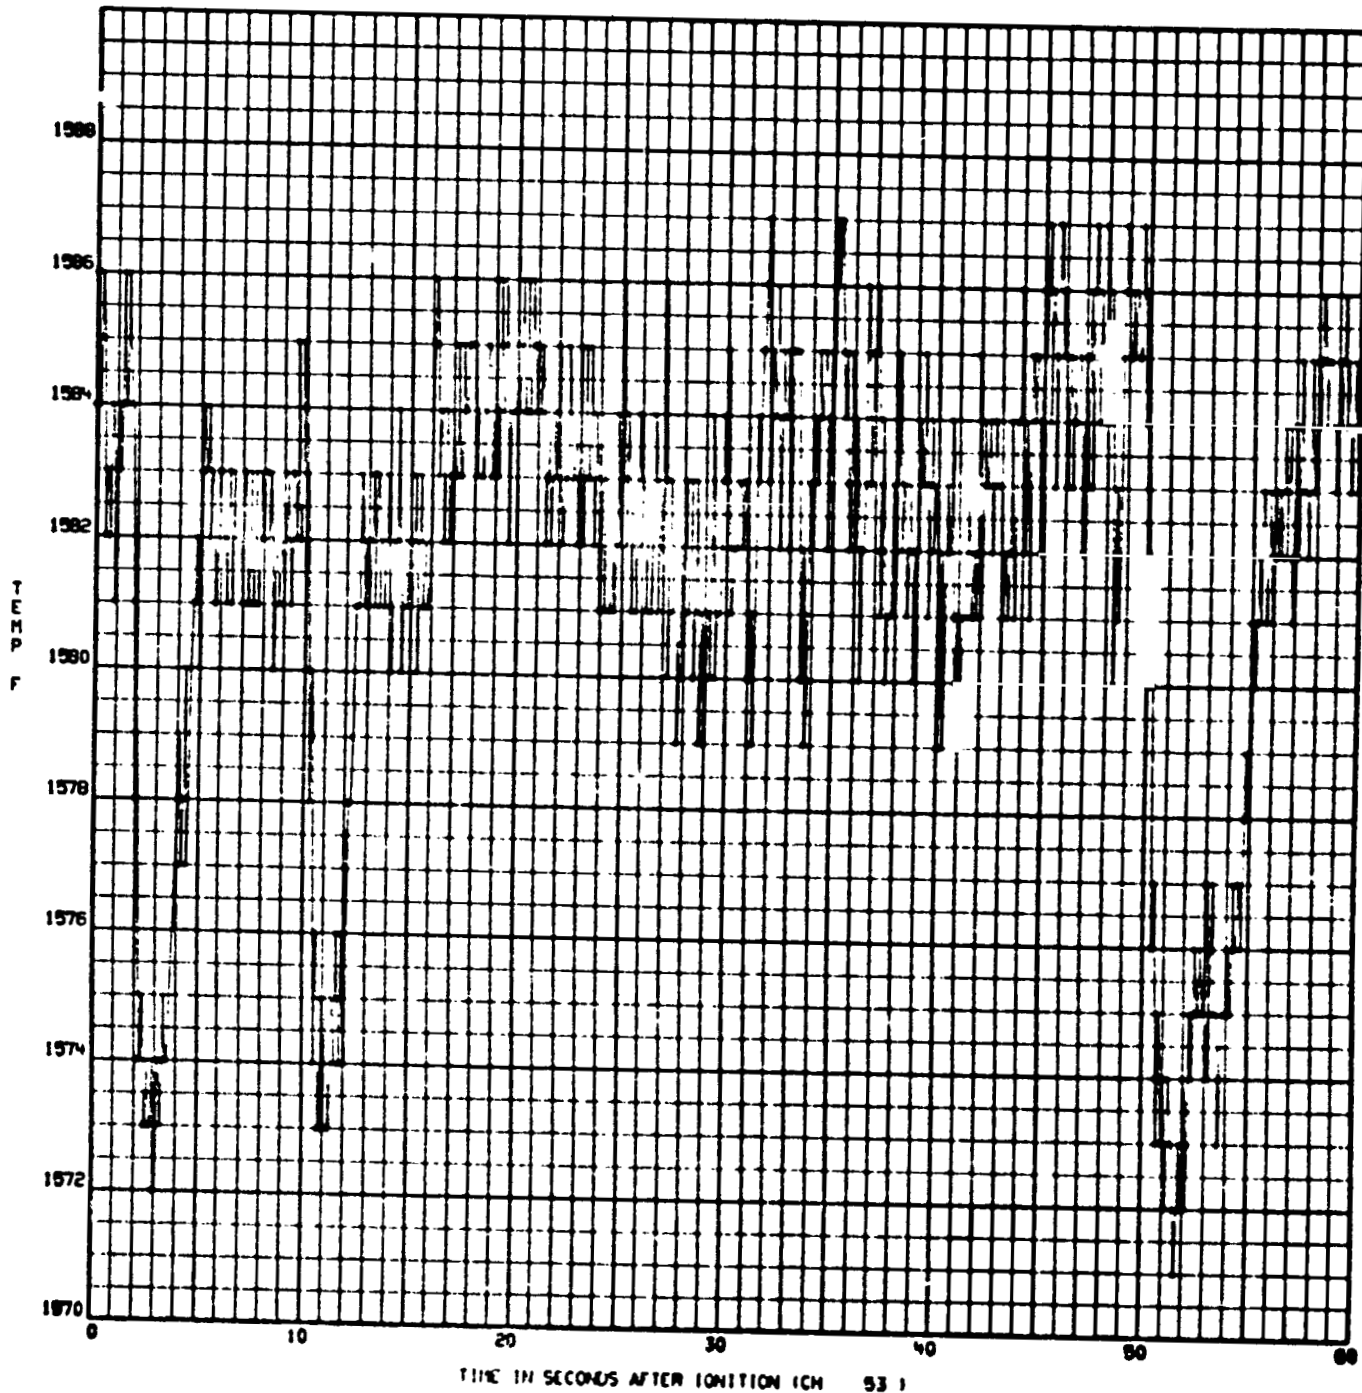
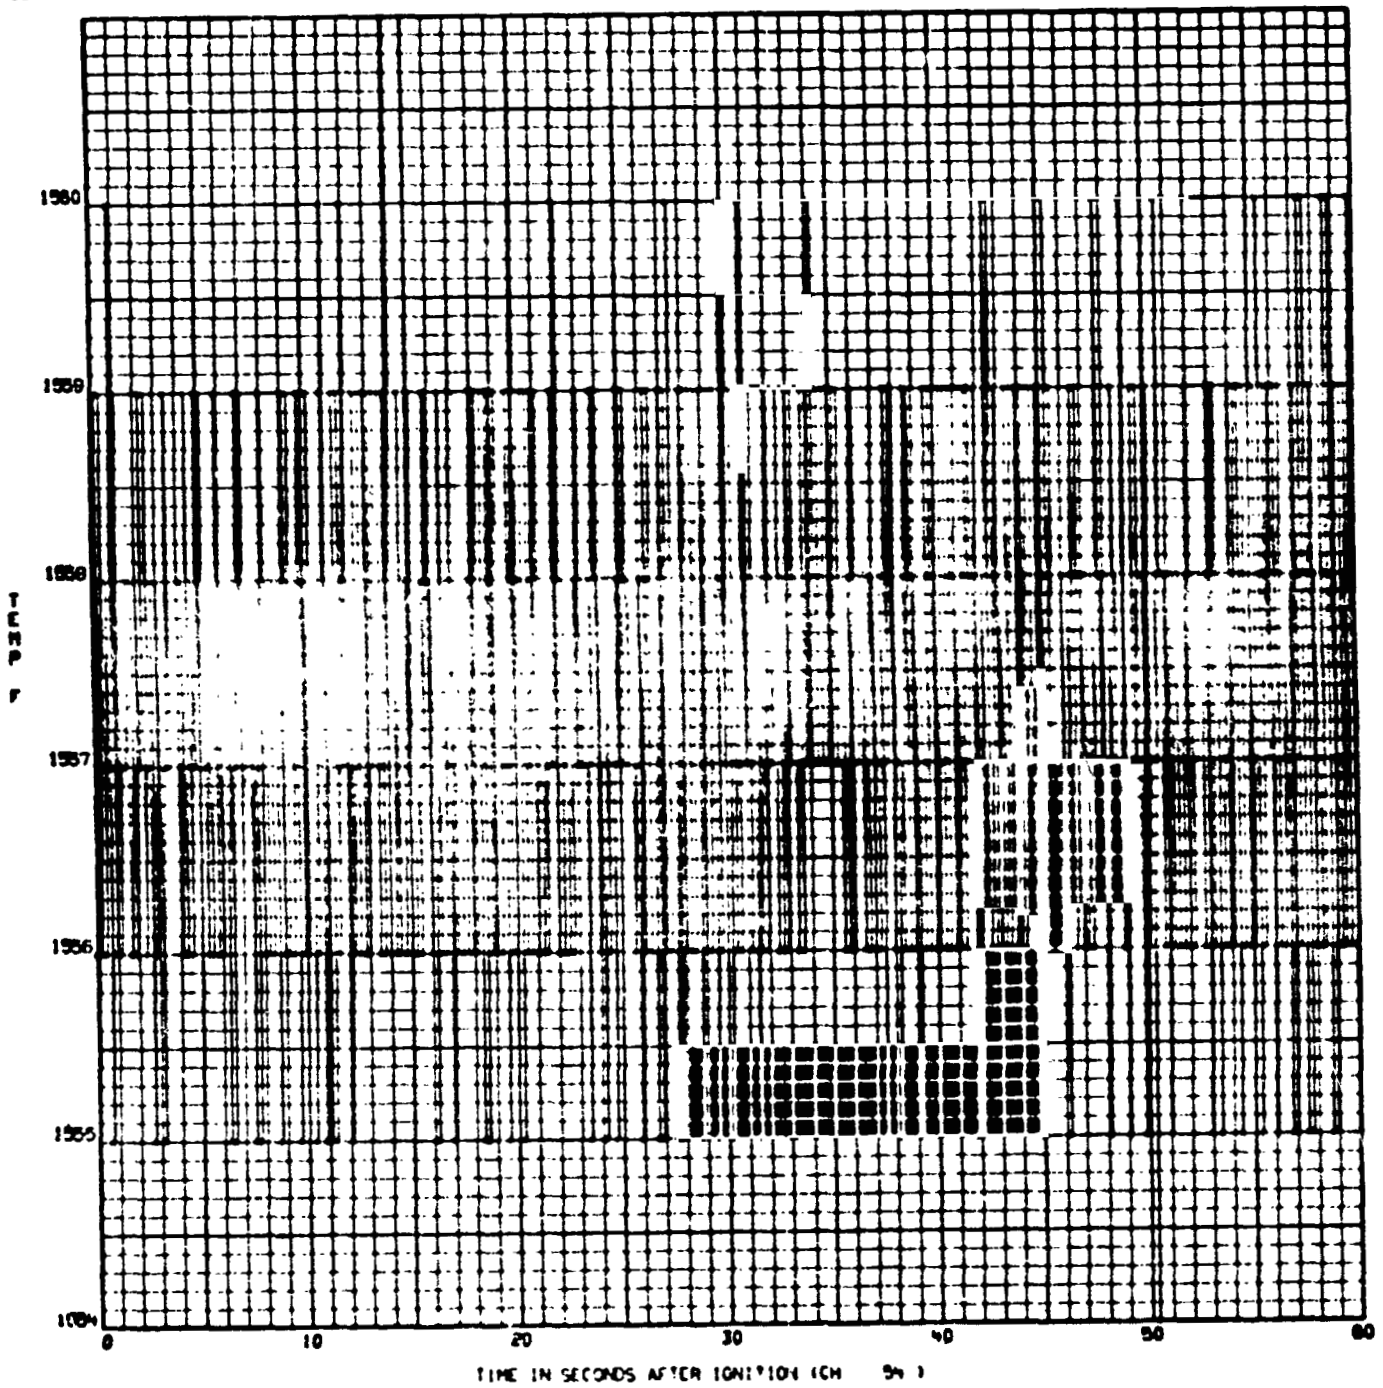
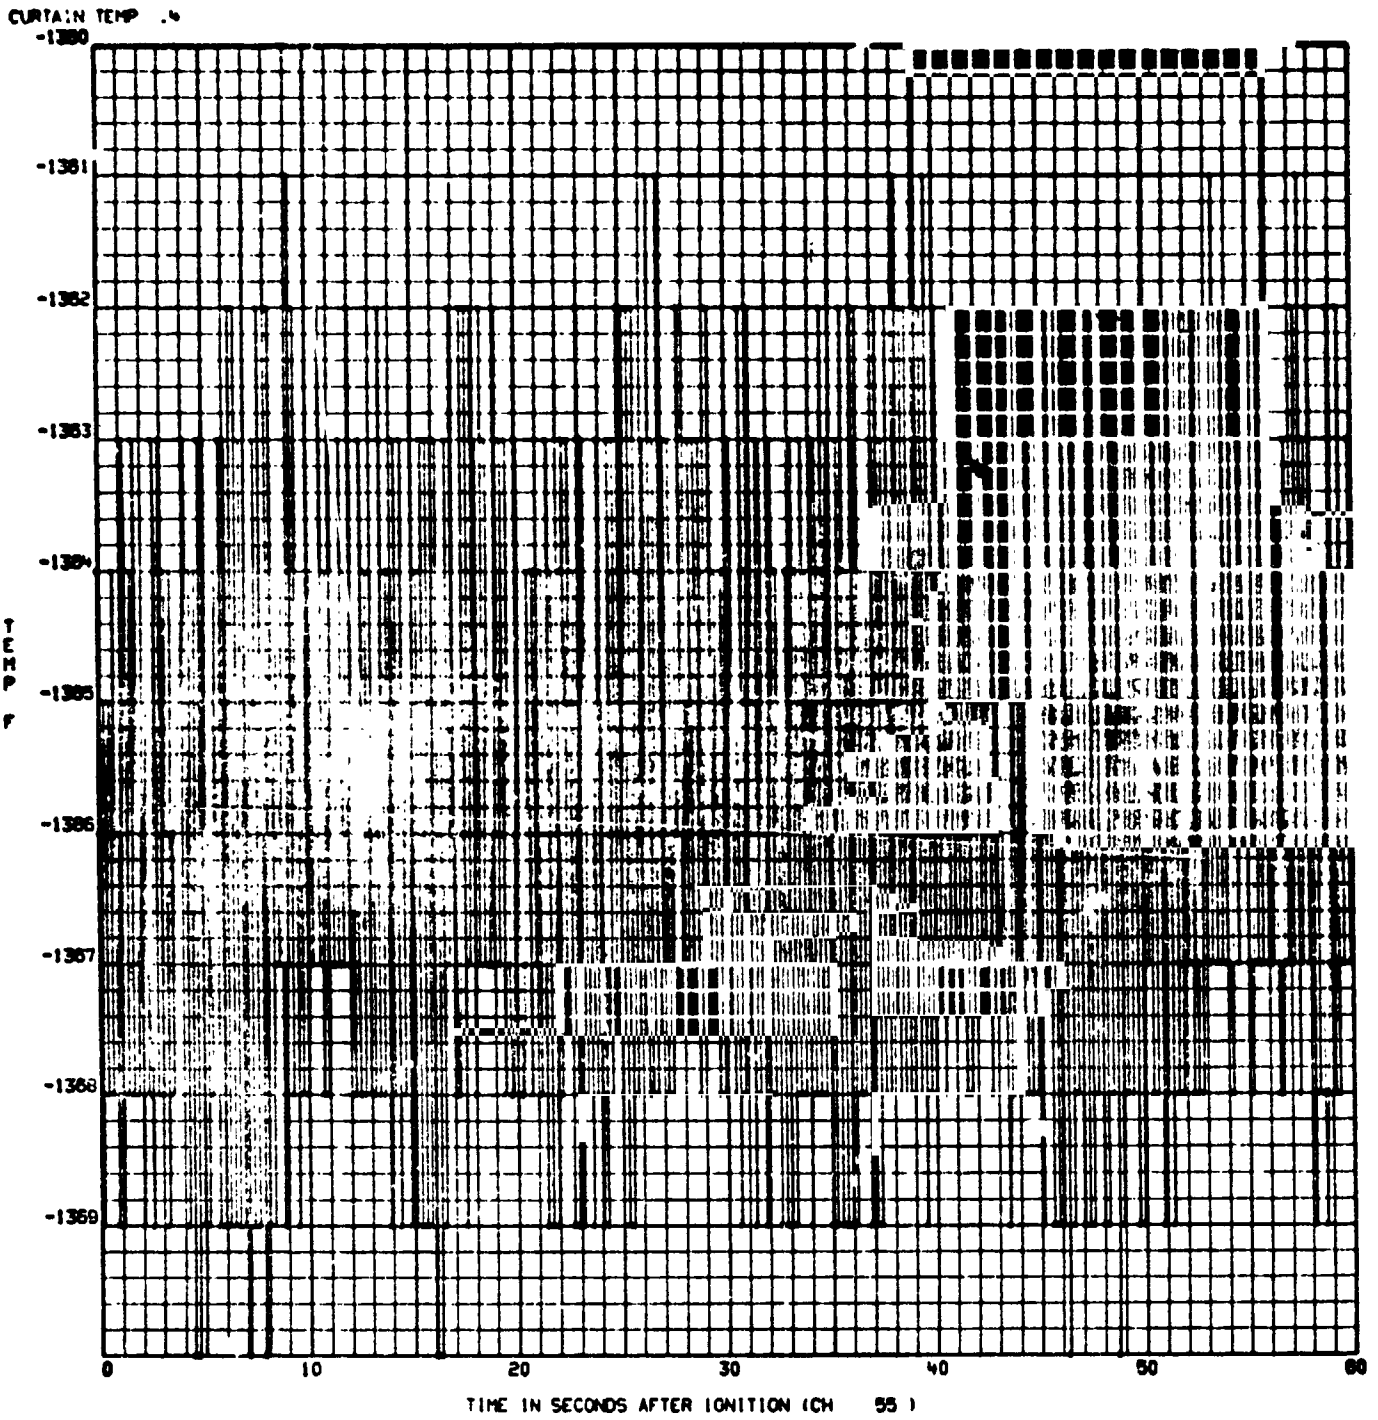
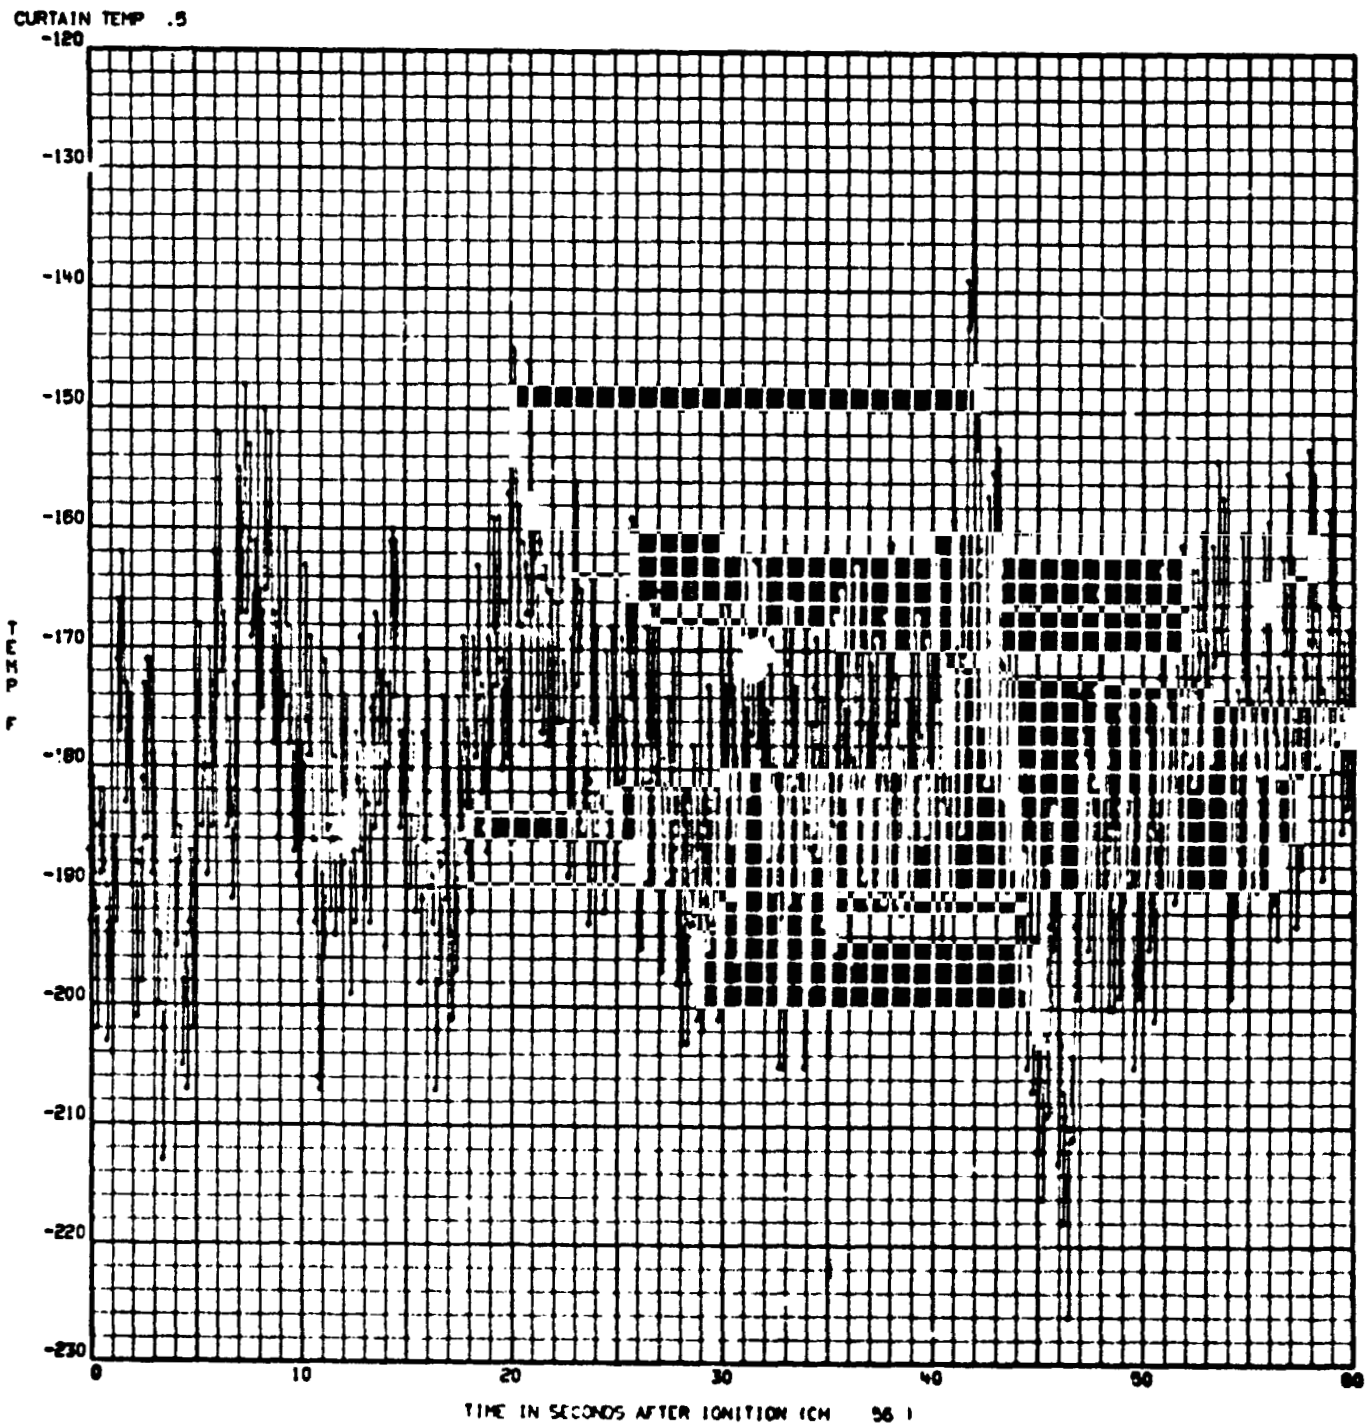
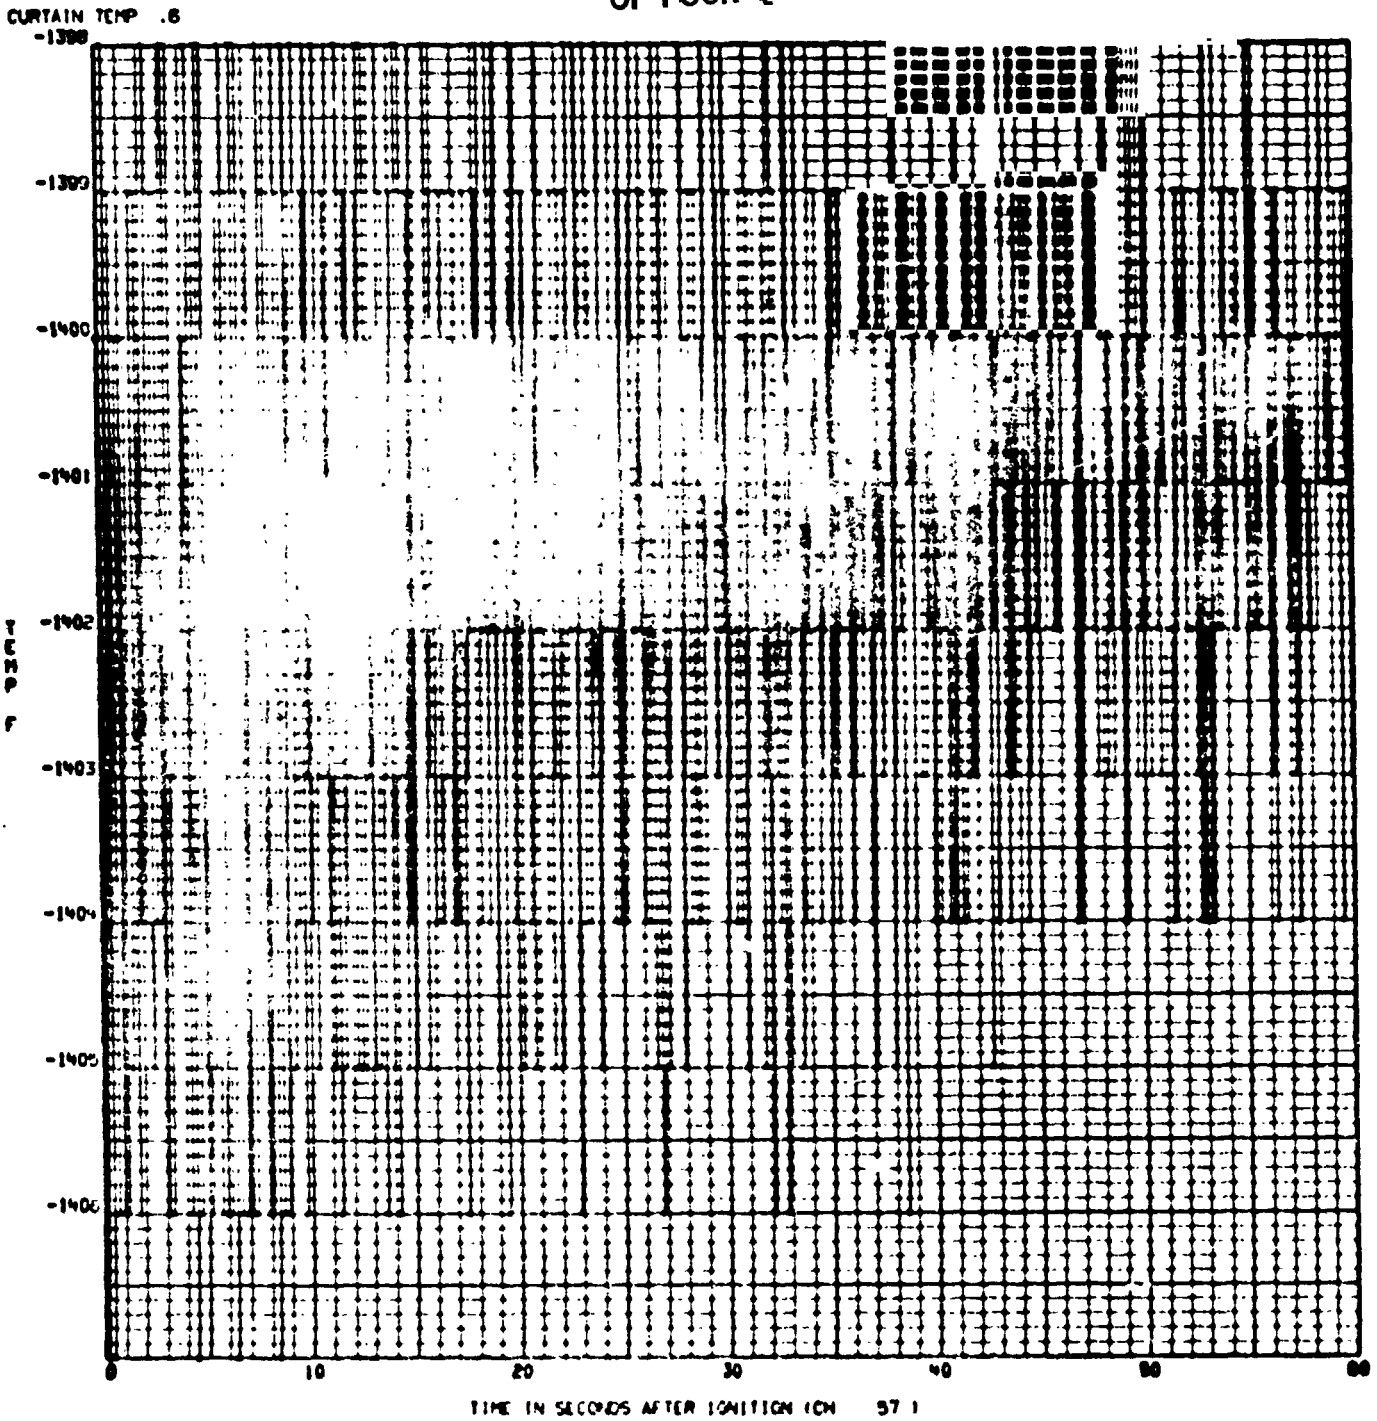
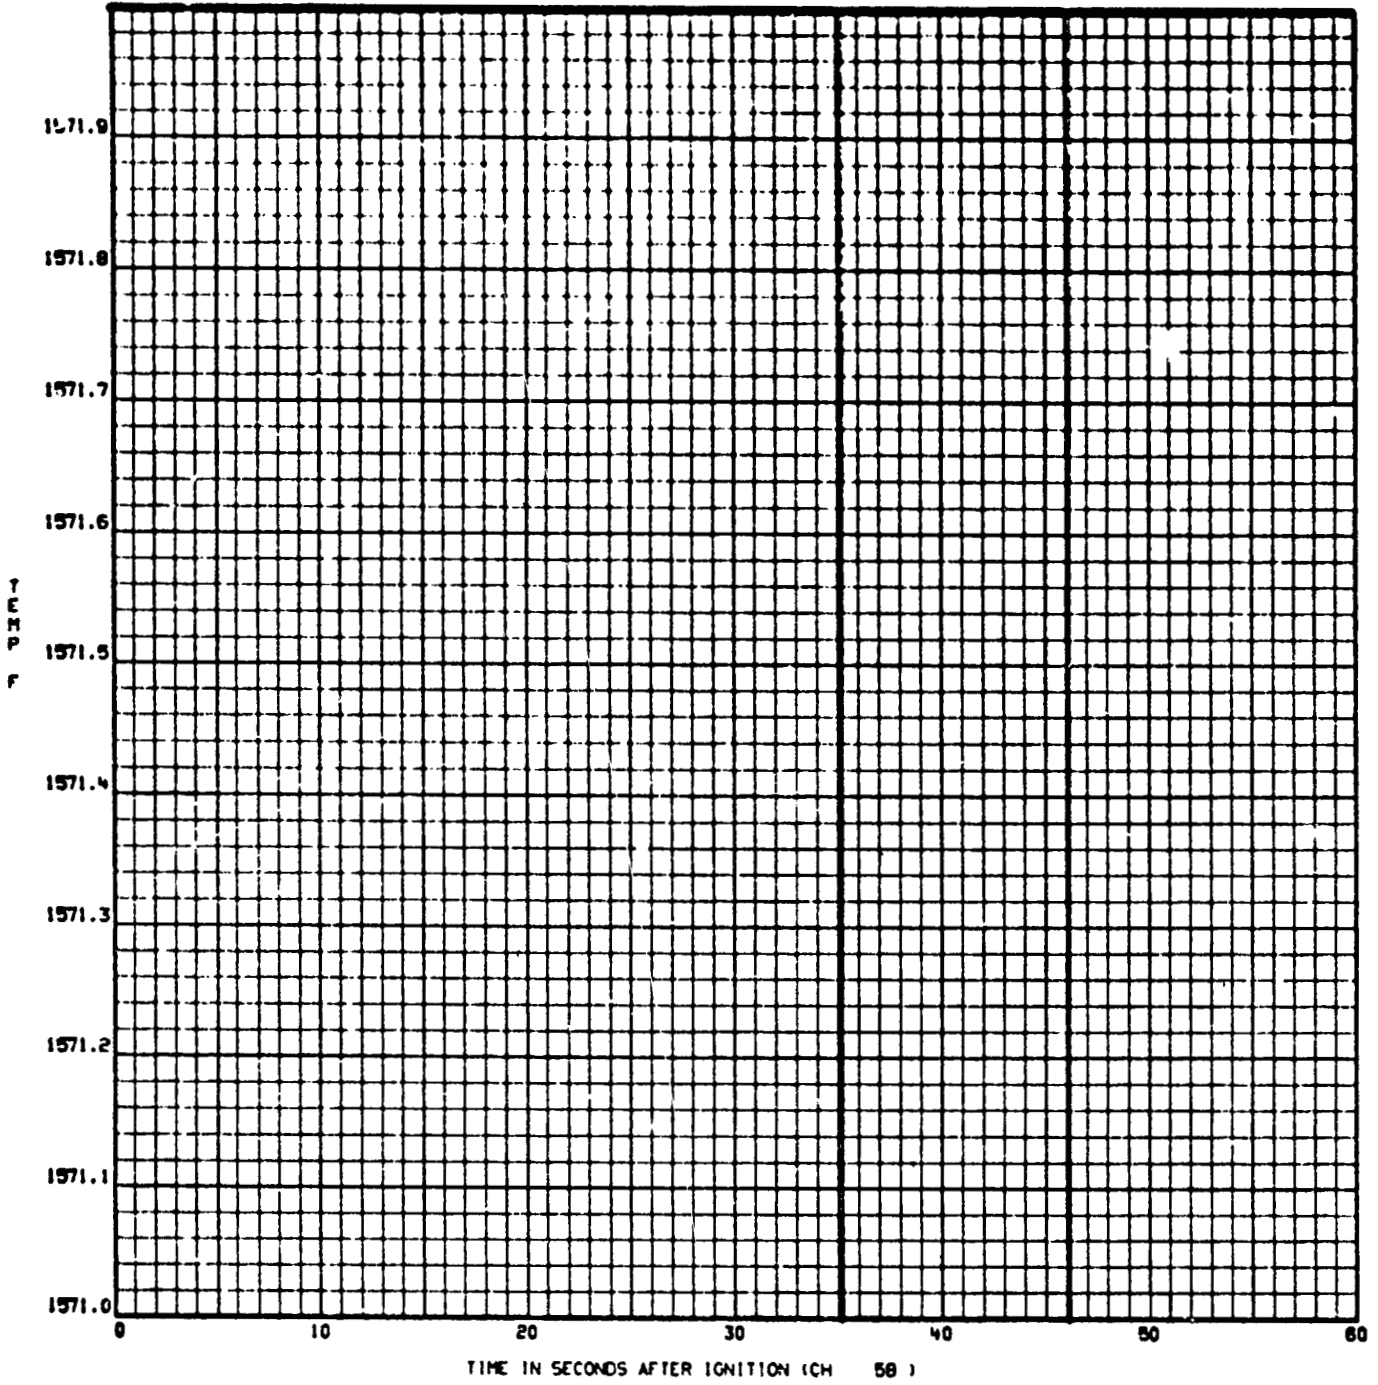
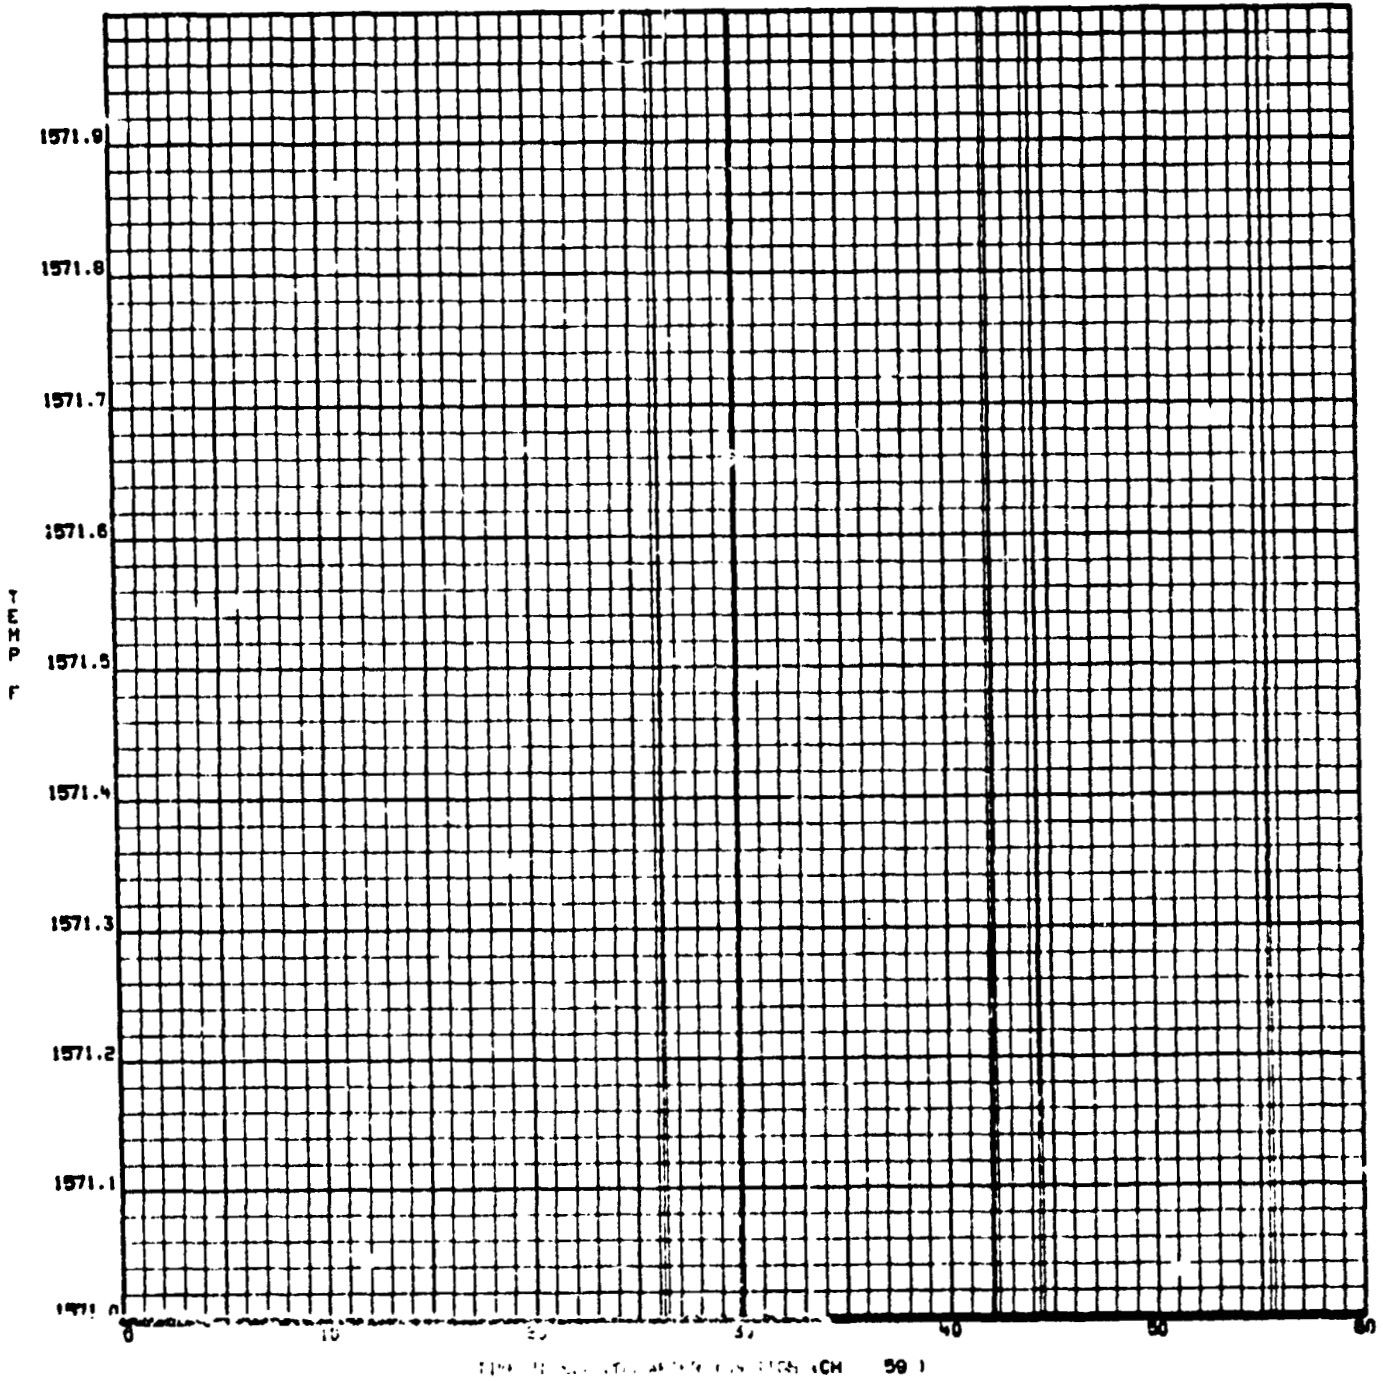
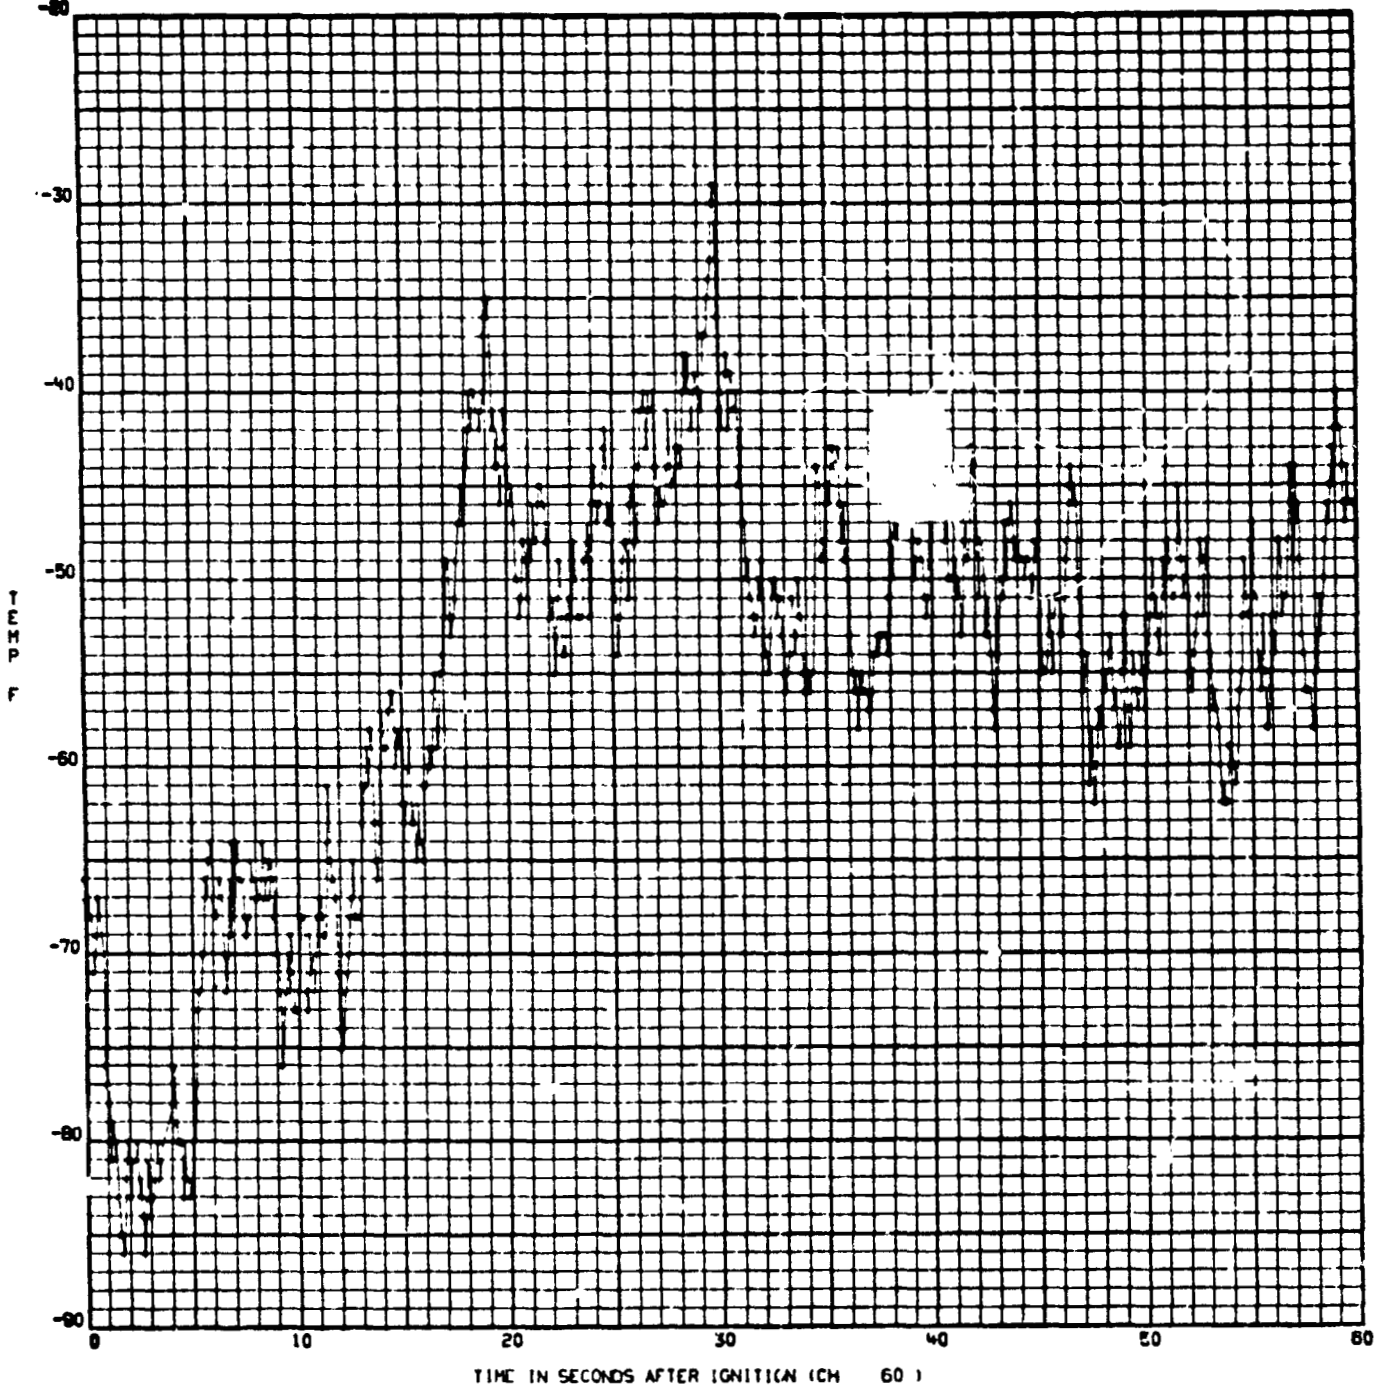
The temperature values from the first curtain hot flow test (SSC-1) are shown in Figs. 6 through 23. These results are difficult to interpret because most of the thermocouples were destroyed during the test. However, all are presented for the sake of completeness.

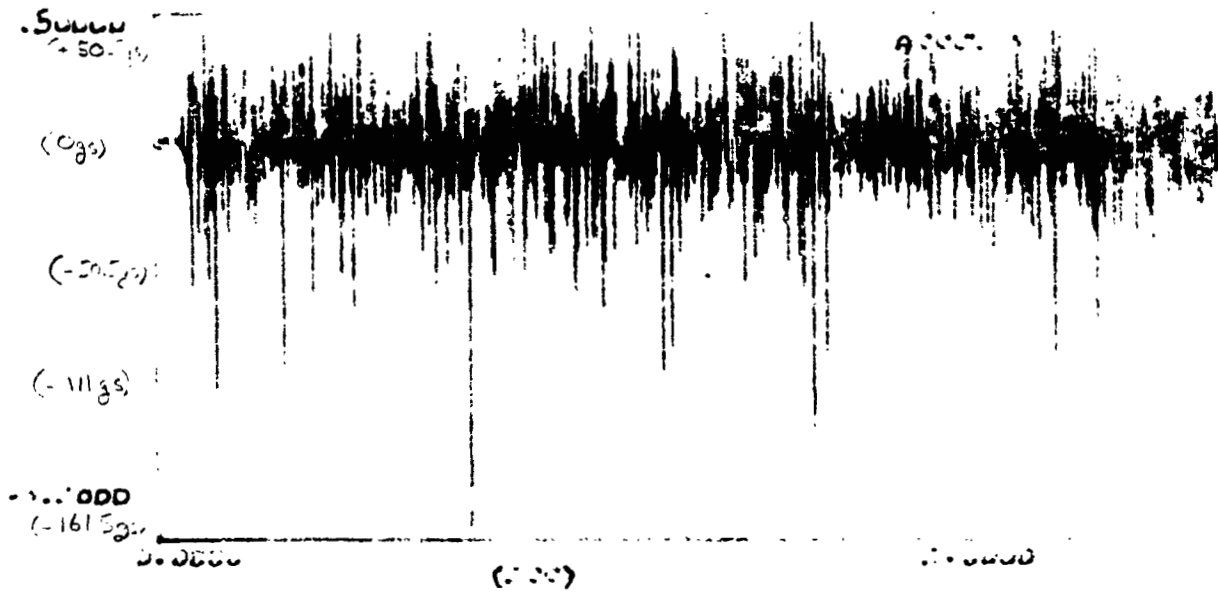
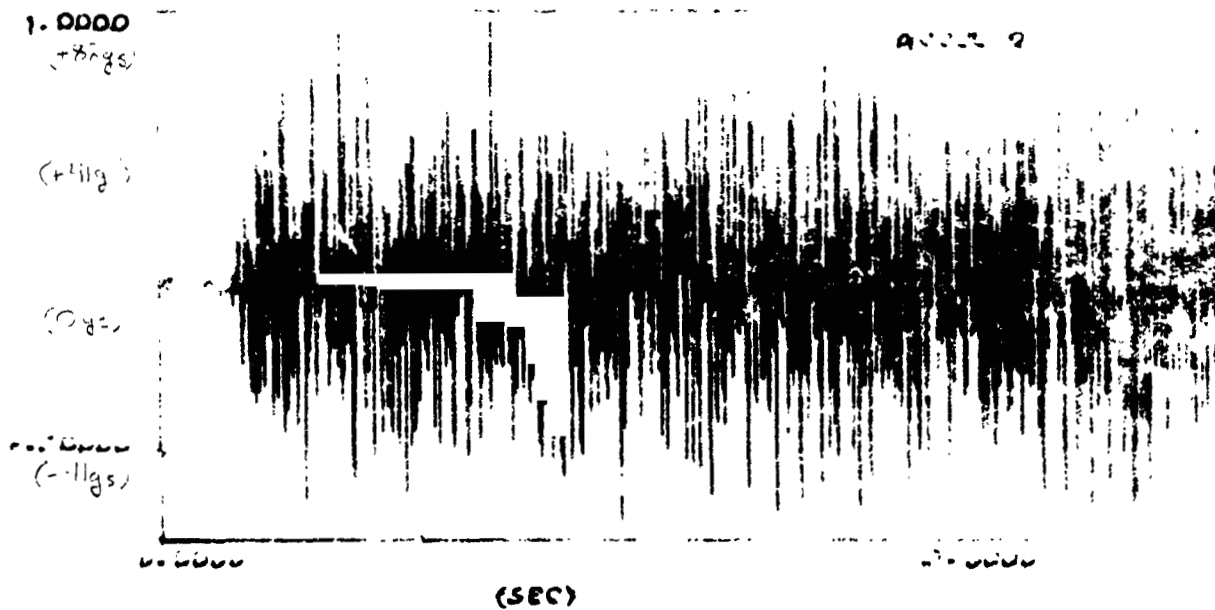
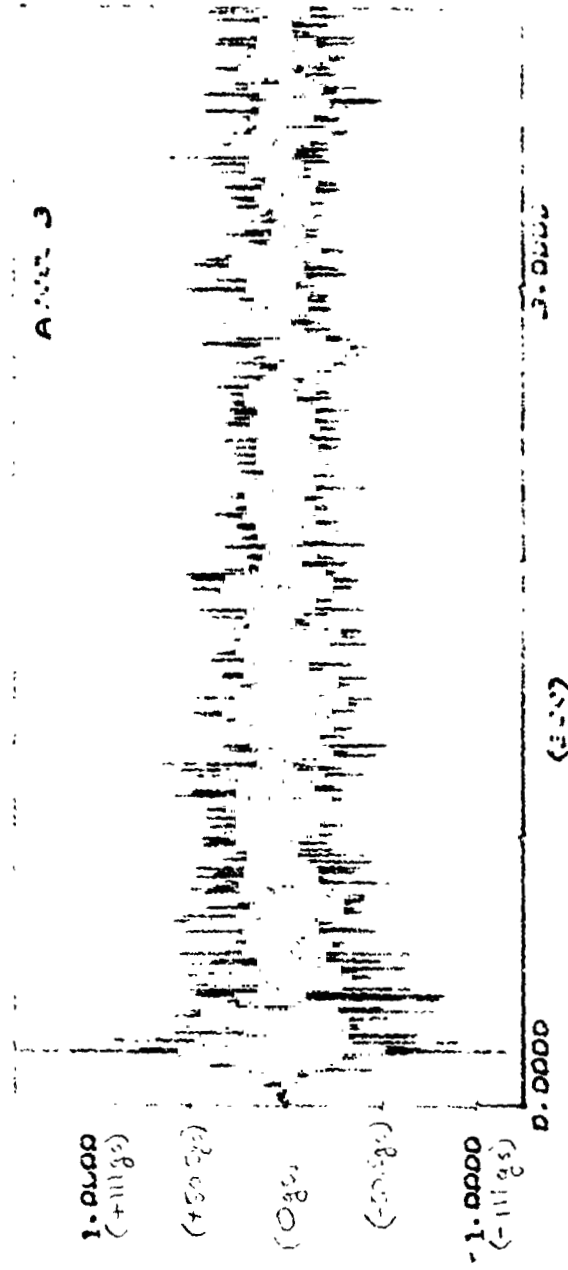
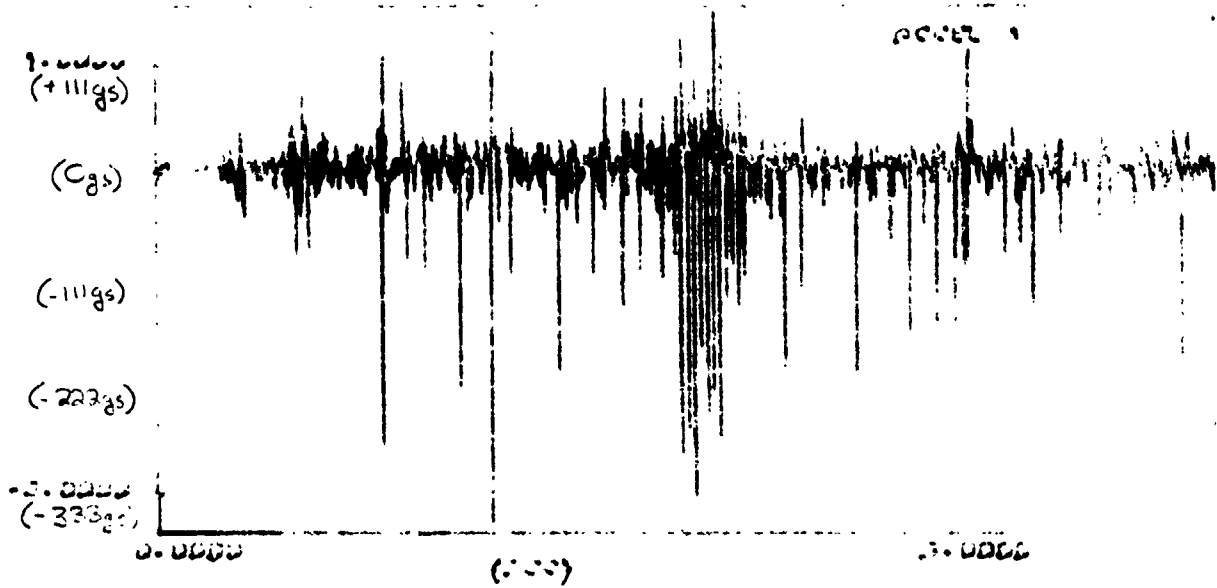
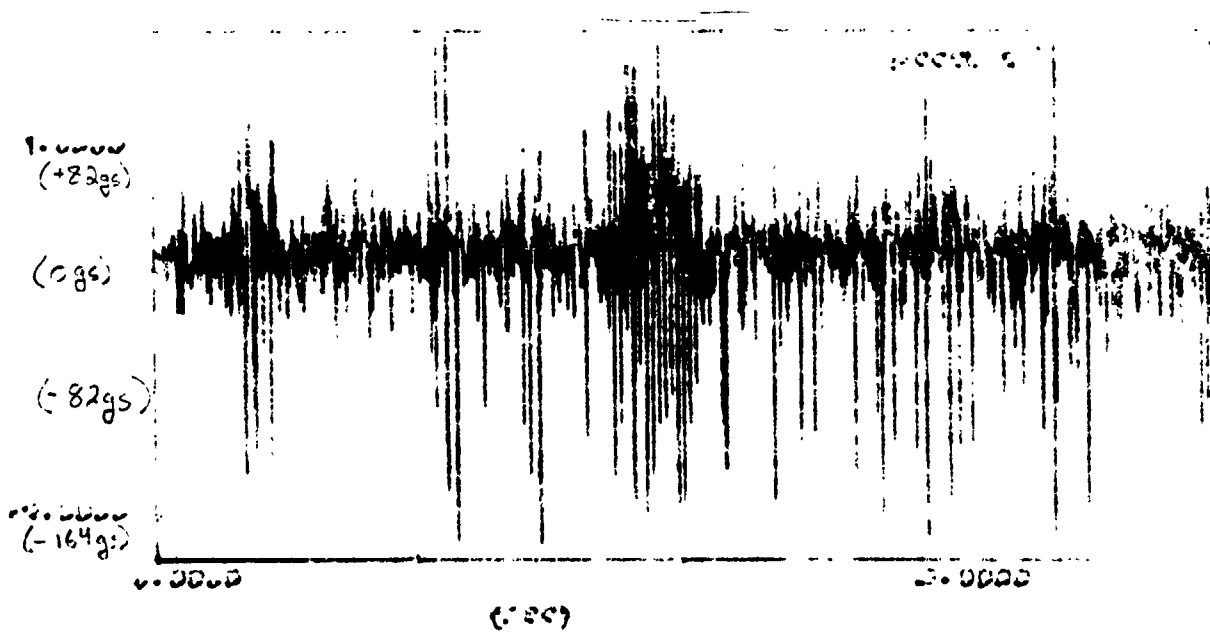
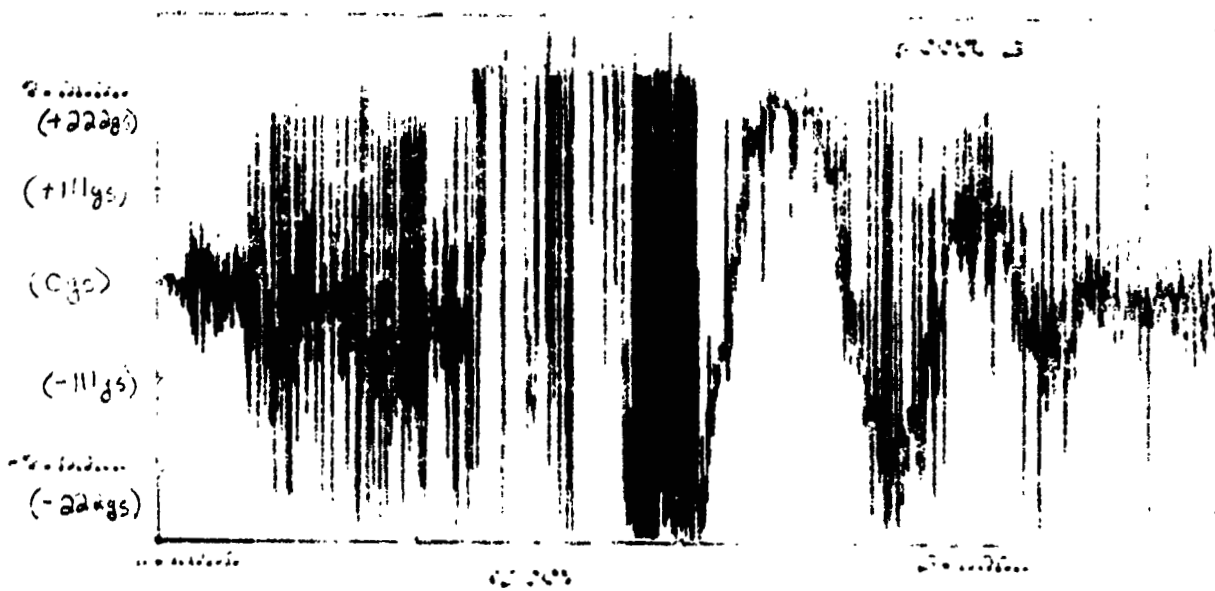
Accelerometer data are shown in Figs. 24 through 29. These g-levels ranged up to approximately 300 g, showing that very severe motion of the curtain occurred. Post-test inspection of the curtain showed that all layers of the blanket burned through. A review of the test movies showed that the curtain outer layers shredded early in the test, indicating severe flutter and flapping of the curtain resulting in the complete shredding by this action. A post-test photograph of the curtain is shown in Figure 30.
