**Lockheed**
Missiles & Space Company, Inc
Huntsville Research & Engineering Center

RESULTS OF TESTS OF THE SRB
AFT SKIRT HEAT SHIELD
CURTAIN IN THE MSFC HOT
GAS FACILITY

February 1982

Contract NAS8-32982

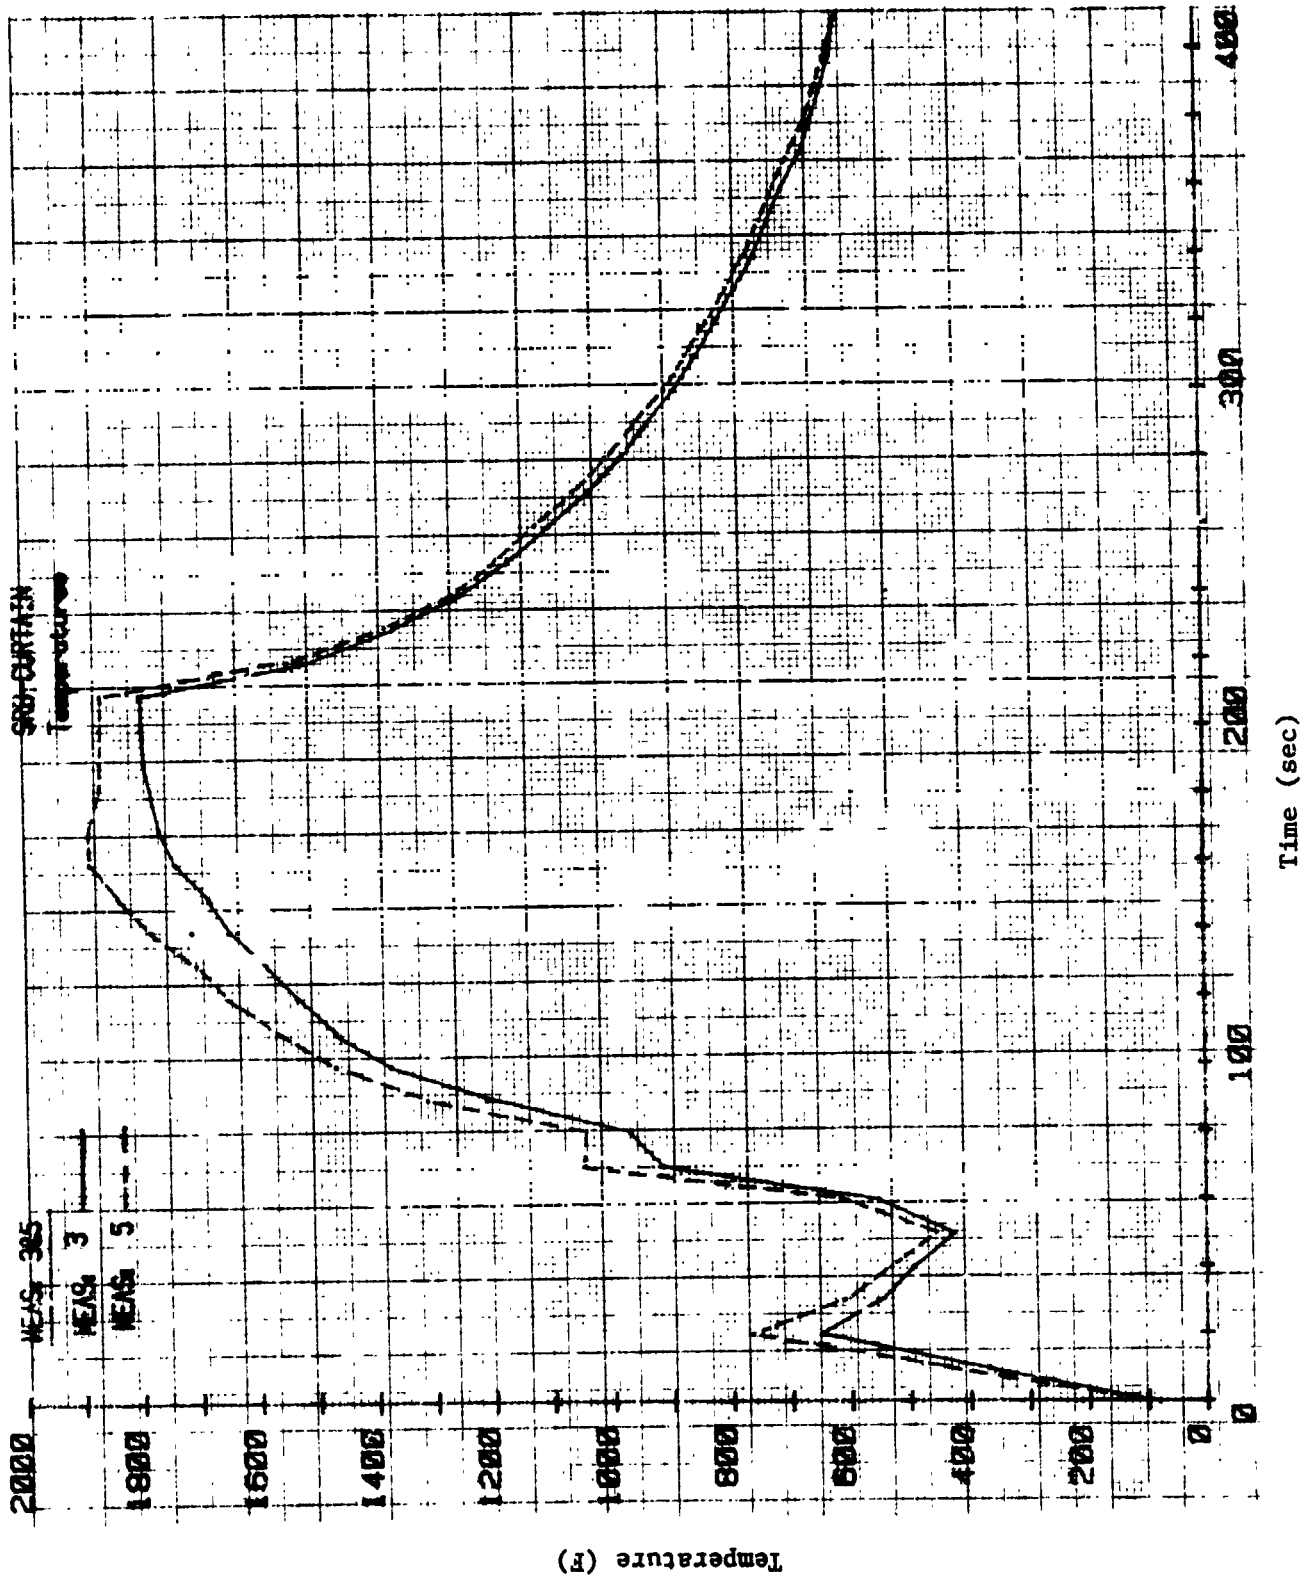
Fig. 31 - Temperature vs Time Results for the Radiant Test of Curtain SSC-2.

The temperature values from the radiant test of the second curtain (SSC-2) are shown in Figure 31. The total test time was approximately 220 sec due to some problems in getting the lamps to respond correctly without kicking off the controller. However, this is not considered to be a major problem because the objective was to get the surface to a maximum temperature rather than to achieve any particular heat load value. The outer layer temperature reached approximately 1880 F and was held there for approximately 50 sec. The rest of the plot (from 220 sec to 400 sec) shows the cooldown period.

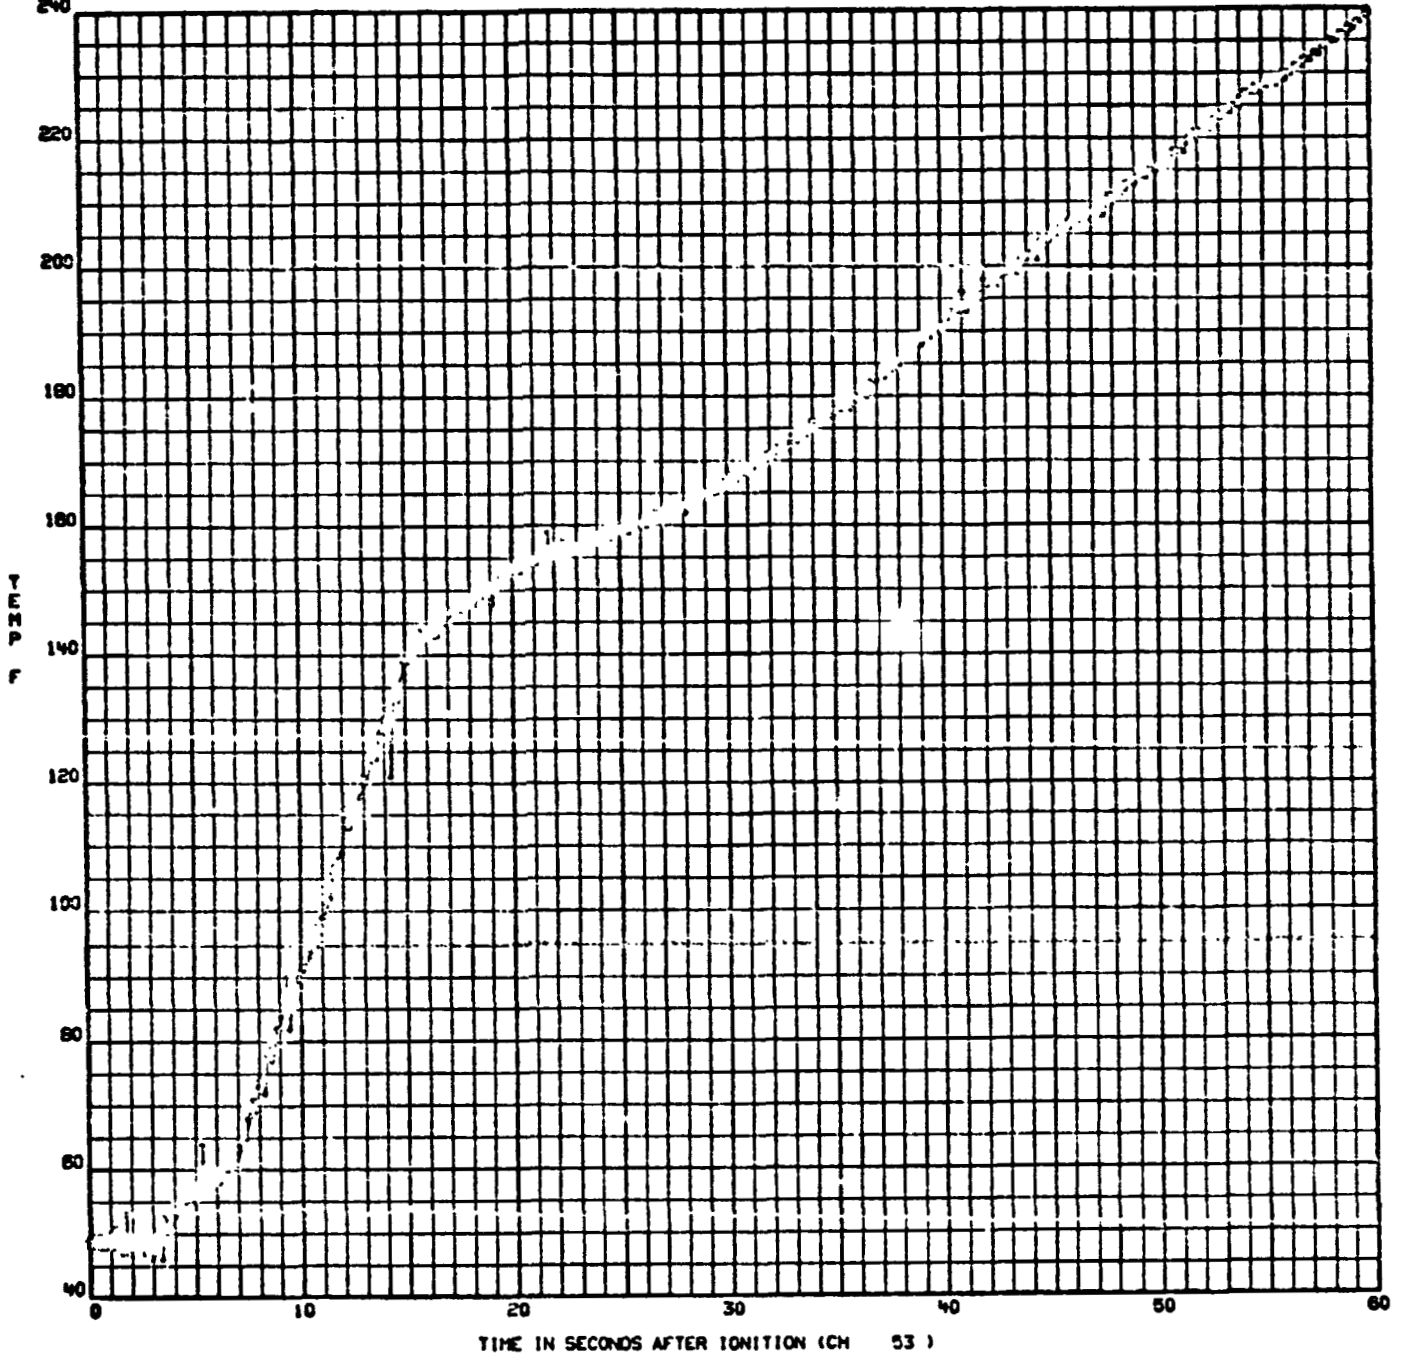
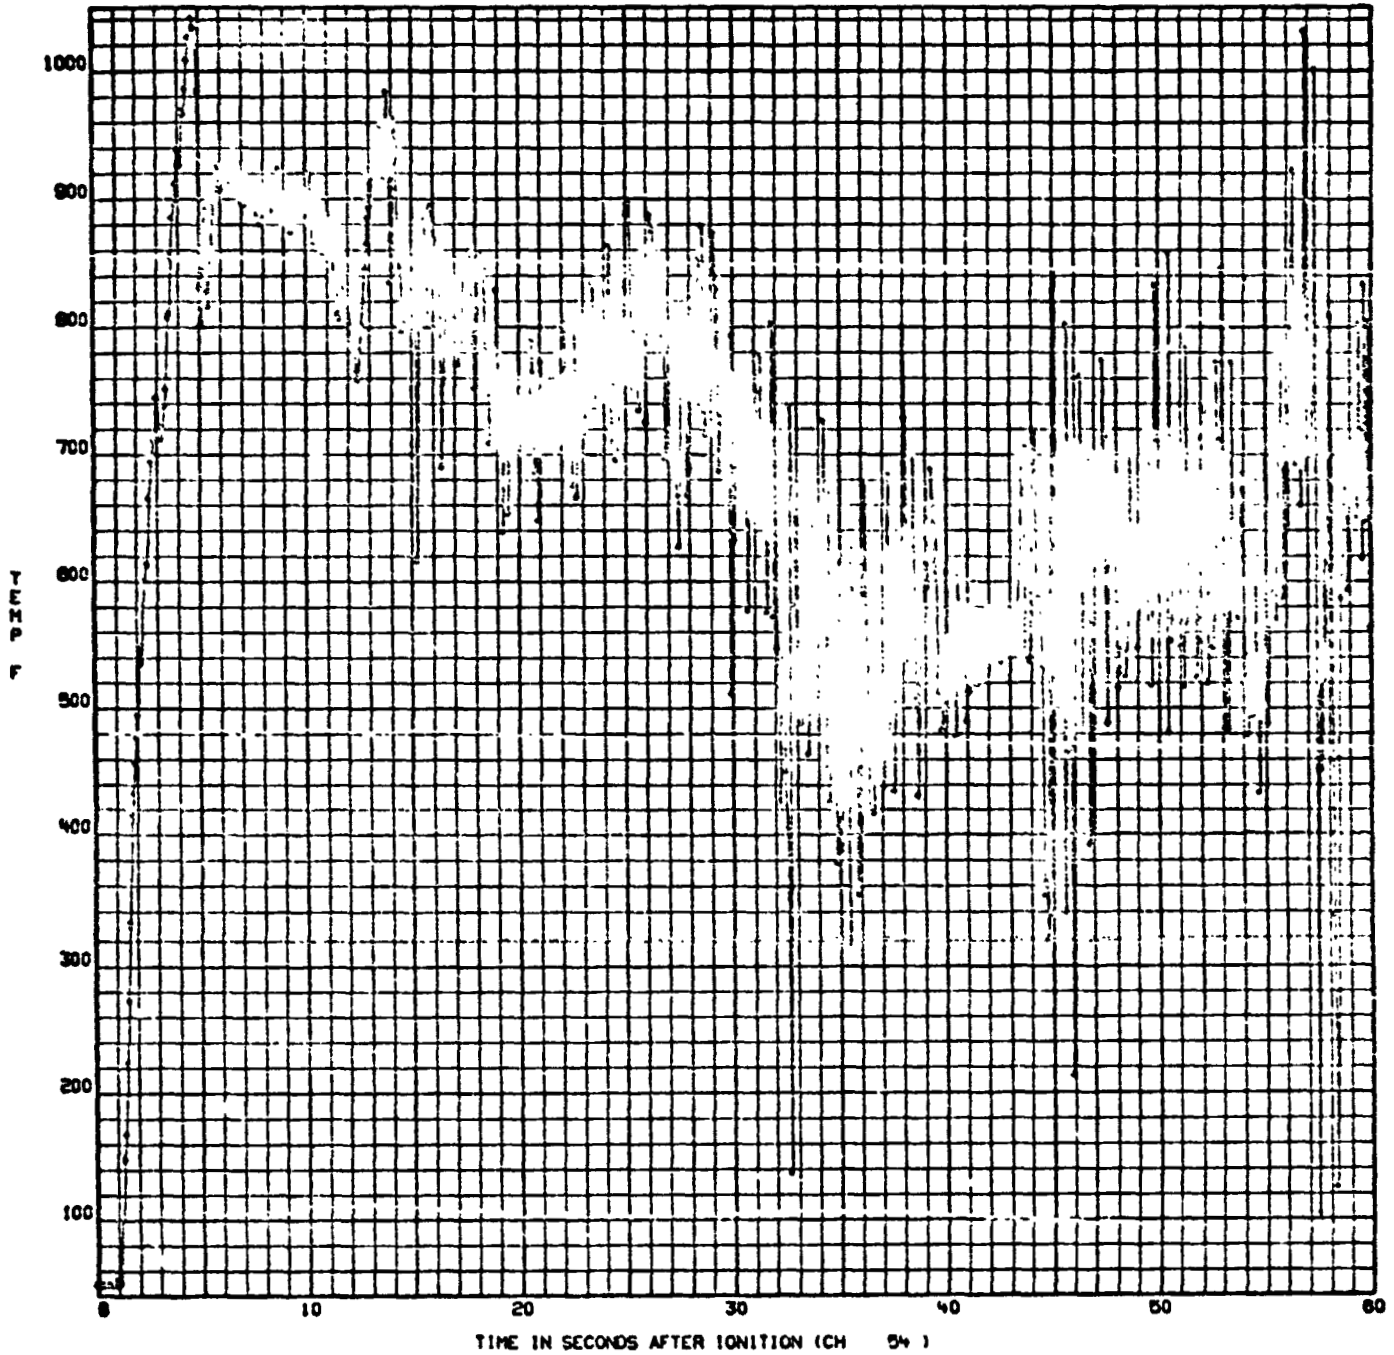
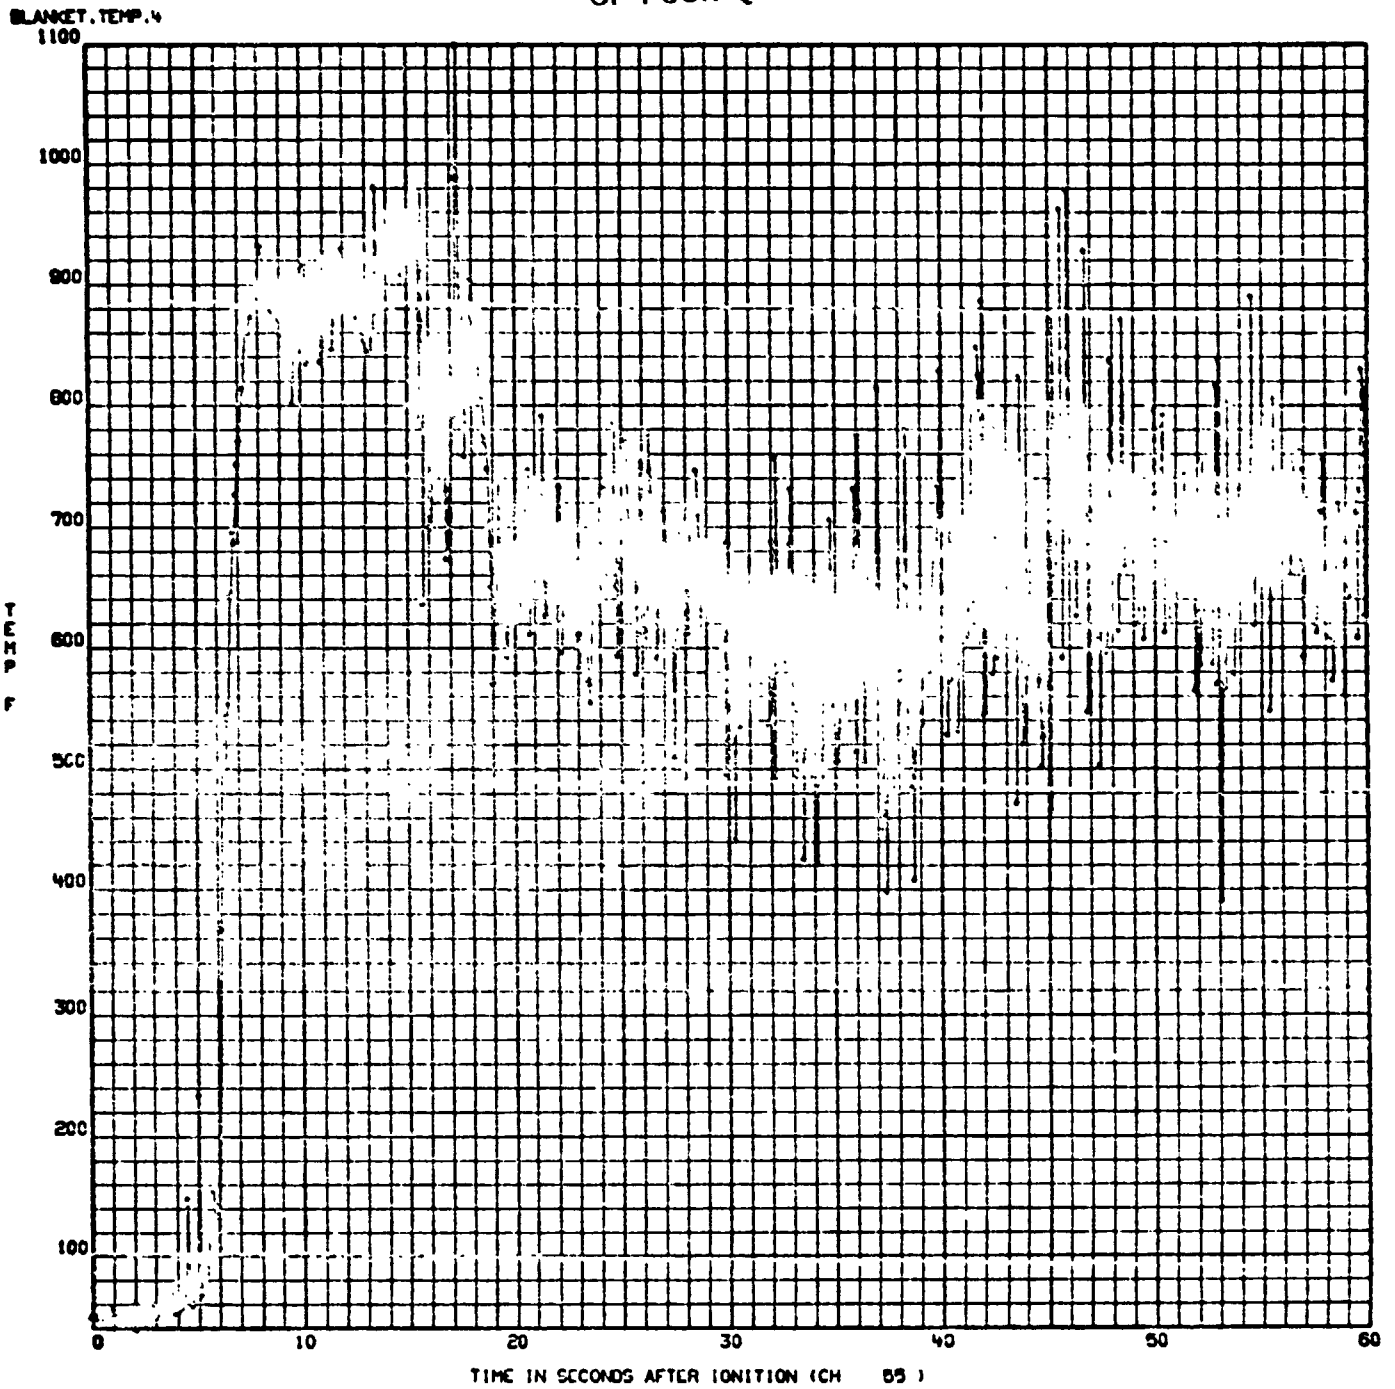
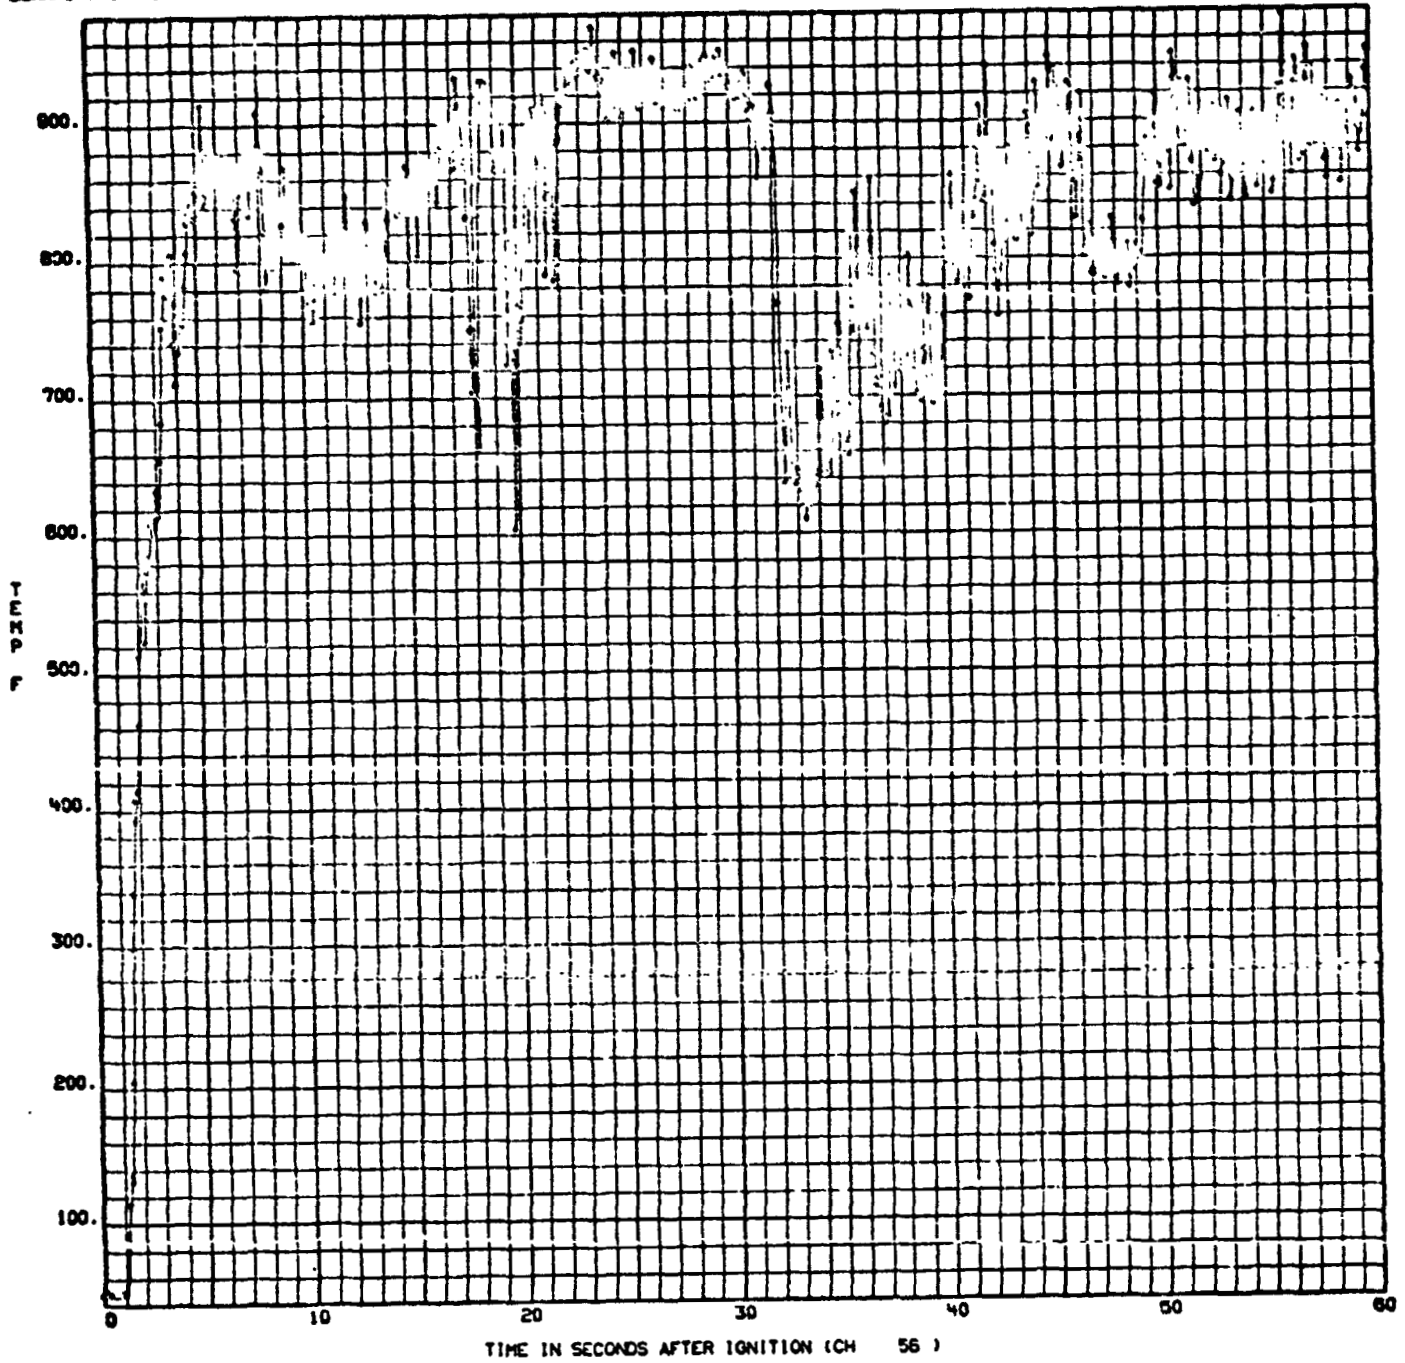
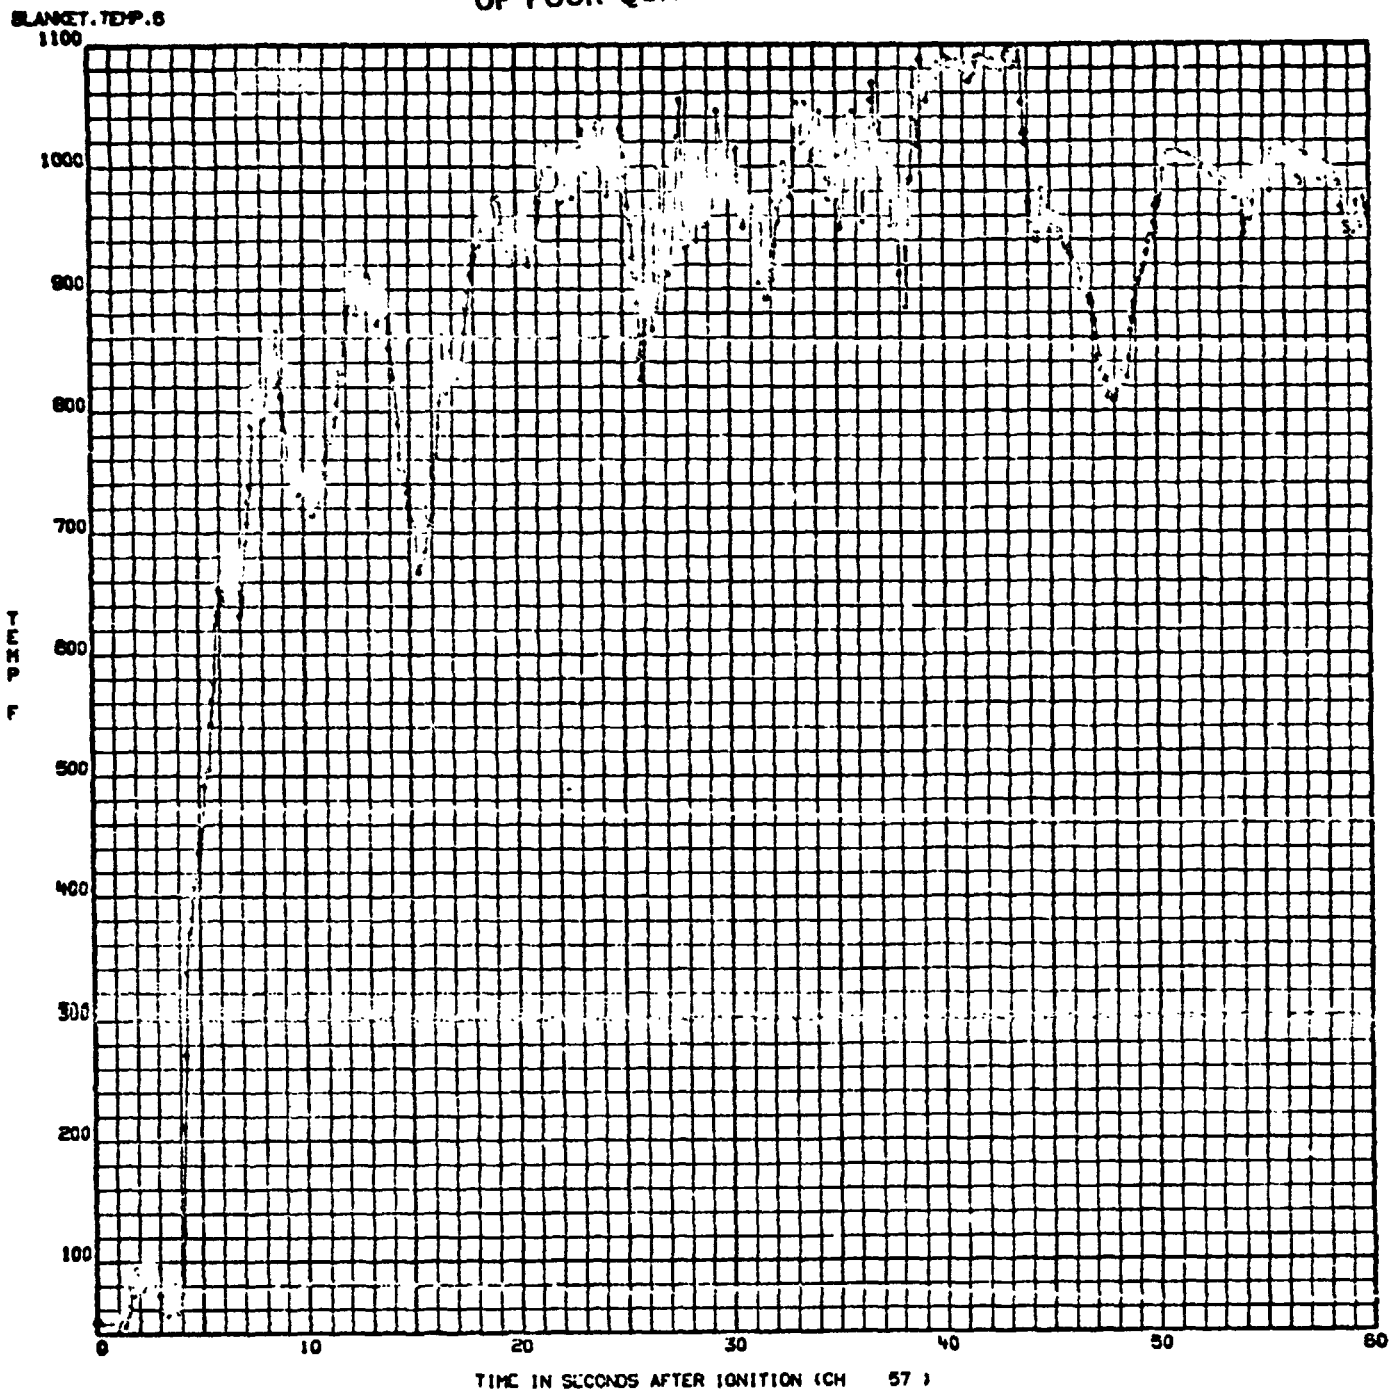
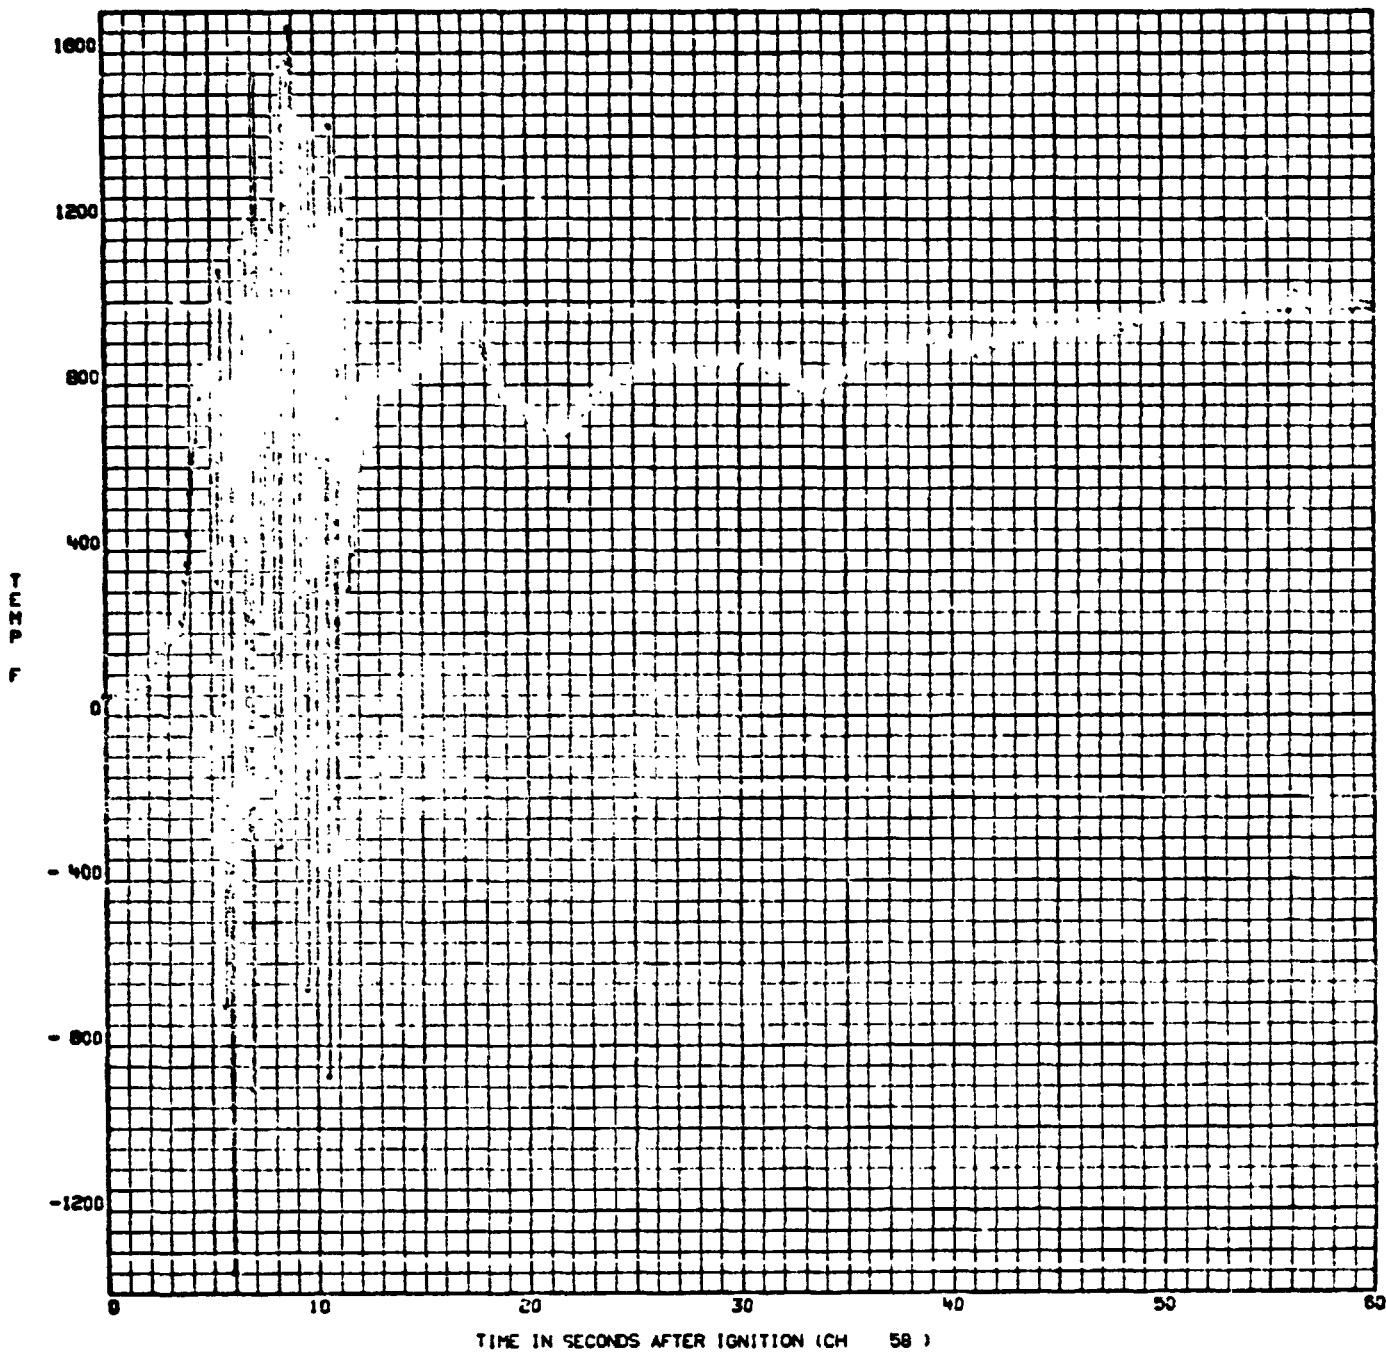
Figures 32 through 49 show the temperature-time plots for the 18 thermocouples of curtain SSC-2 during the HGF test. The outer surface temperatures are very erratic as expected due to the severe flapping of the curtain. The inner blanket temperatures are somewhat more steady. No comparison with analysis was made due to the unsteady nature of the heating rate on a flapping curtain.

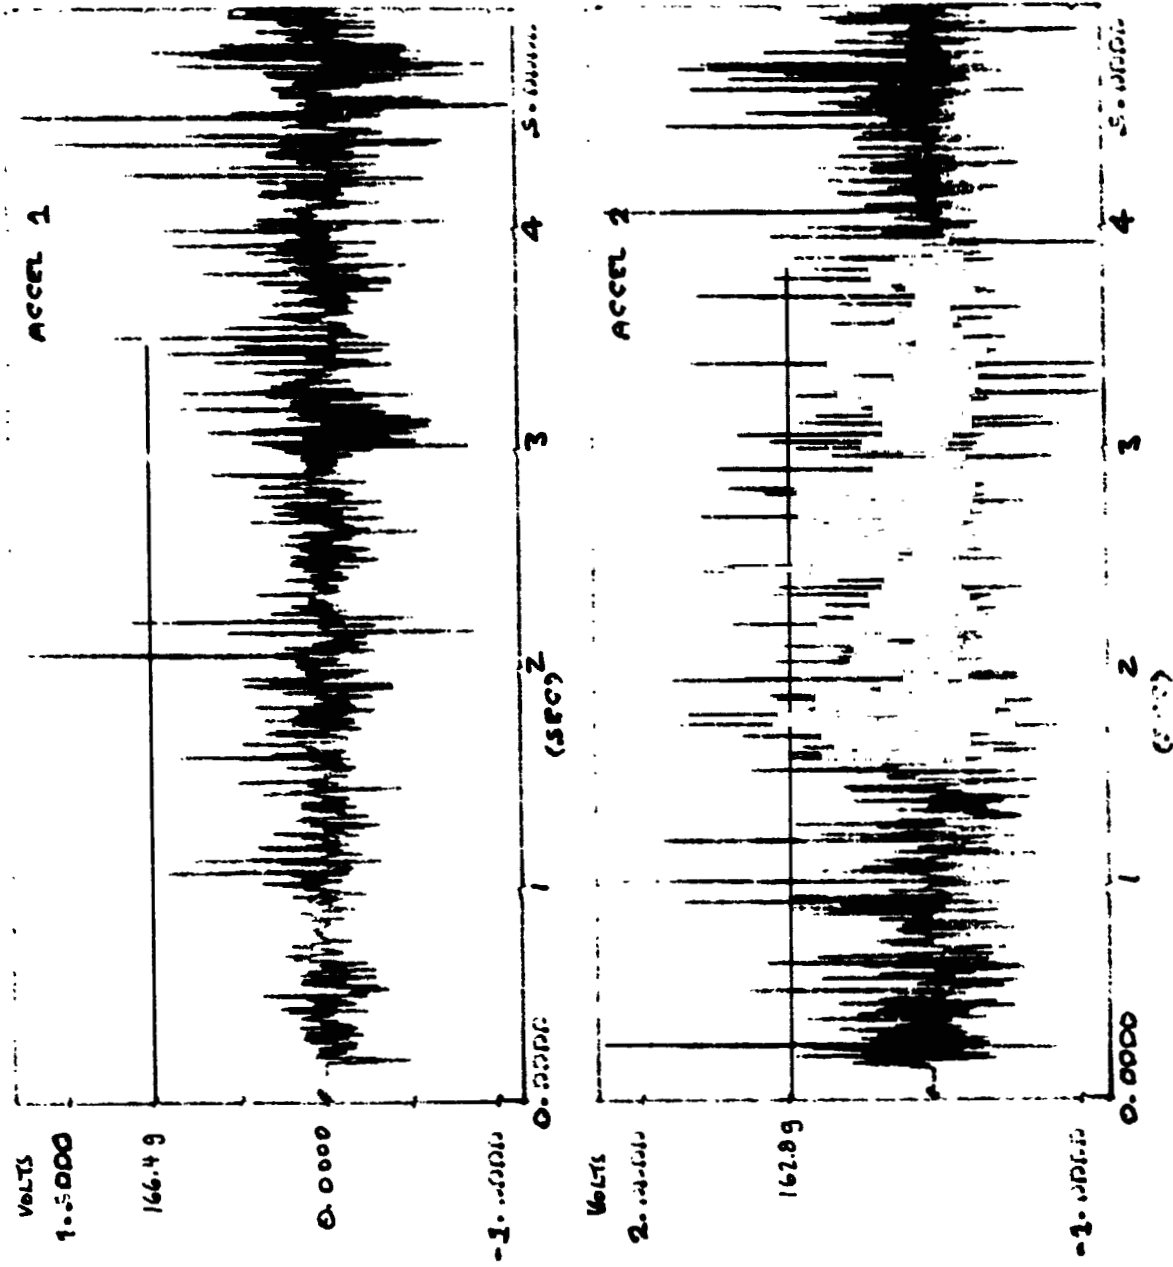
Figures 50 through 53 show accelerometer data from these tests. The peak g-levels exceeded 300 g.

Fig. 50 - Accelerometer Data for First 5.0 sec of Test Run 1052
 (Instruments BT-74, BT-42)

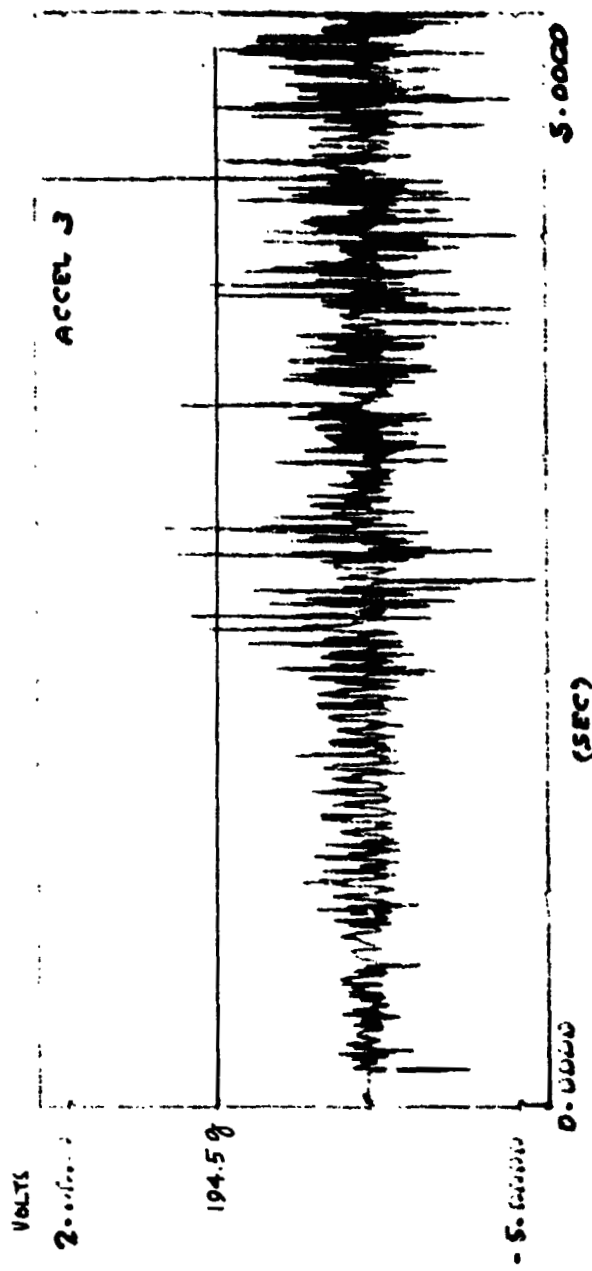
Fig. 51 - Accelerometer Data for First 5.0 sec of Test Run 1052
(Instrument CF11)

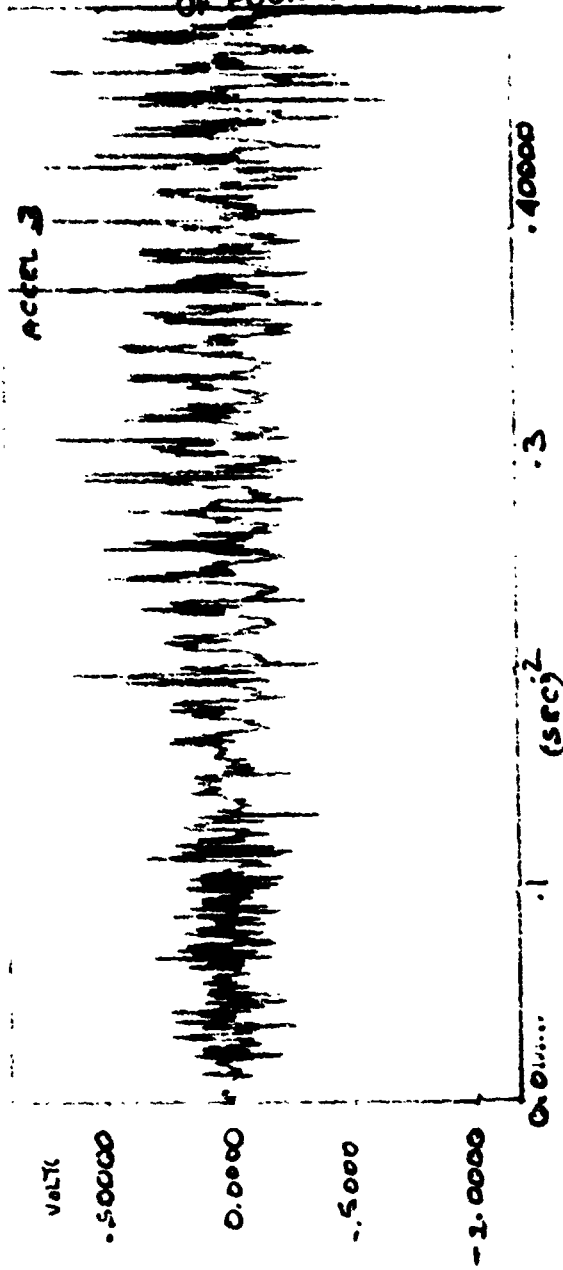
Fig. 52 - Accelerometer Data for First 0.5 sec of Test Run 1052
(Instrument CF11)
