EVALUATION OF HEAD AND FACE INJURY POTENTIAL
OF CURRENT AIRLINE SEATS DURING
CRASH DECELERATIONS

June 1966

Office of Aviation Medicine
FEDERAL AVIATION AGENCY

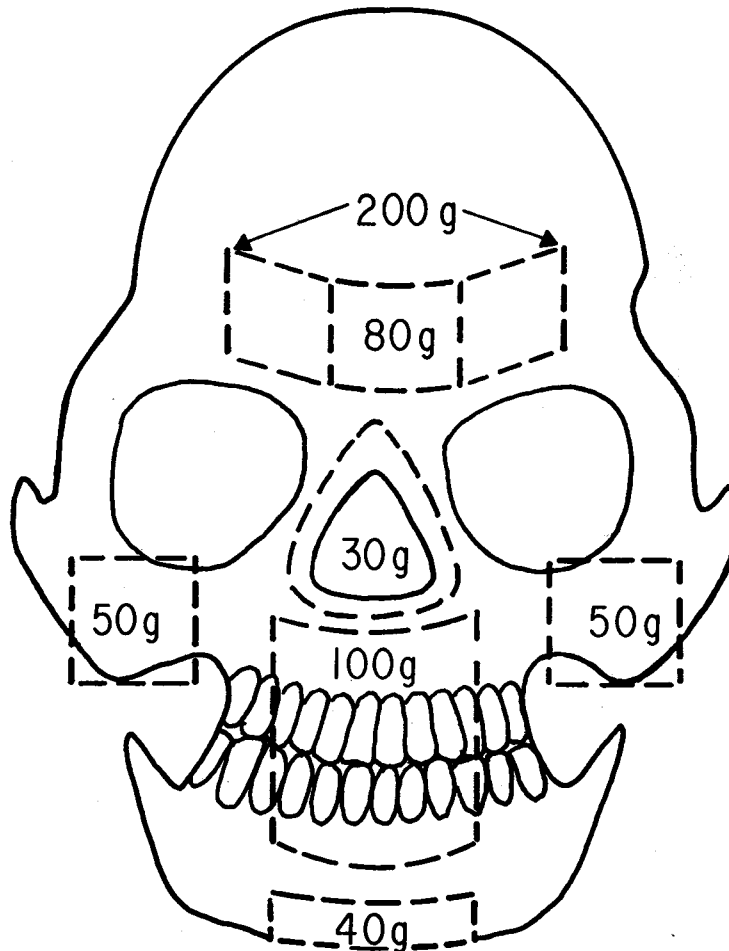
Figure 1 reproduces summary data² showing the tolerances of the human face and head to

FIGURE 1. Summary of maximum tolerable impact forces on a padded deformable surface.

resist fracture during impact against *deformable structures*.
