Supplement to Safety Alert for Operators (SAFO) #08013

Recommendations

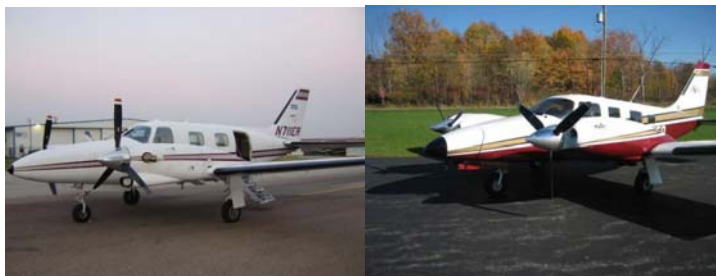
- A. Yes, the PA-42 Cheyenne aircraft have almost identical latching/locking mechanisms. The PA-34 Seneca is similar but uses a rotating handle and bayonet pins rather than a retracting lever and latching arms.

Piper PA-42 Cheyenne

Piper PA-34 Seneca
