Completion Report

Squaw Creek Culvert Fish Passage Improvement Project

Squaw Creek, Little Salmon River Subbasin North Central Idaho

February 2008

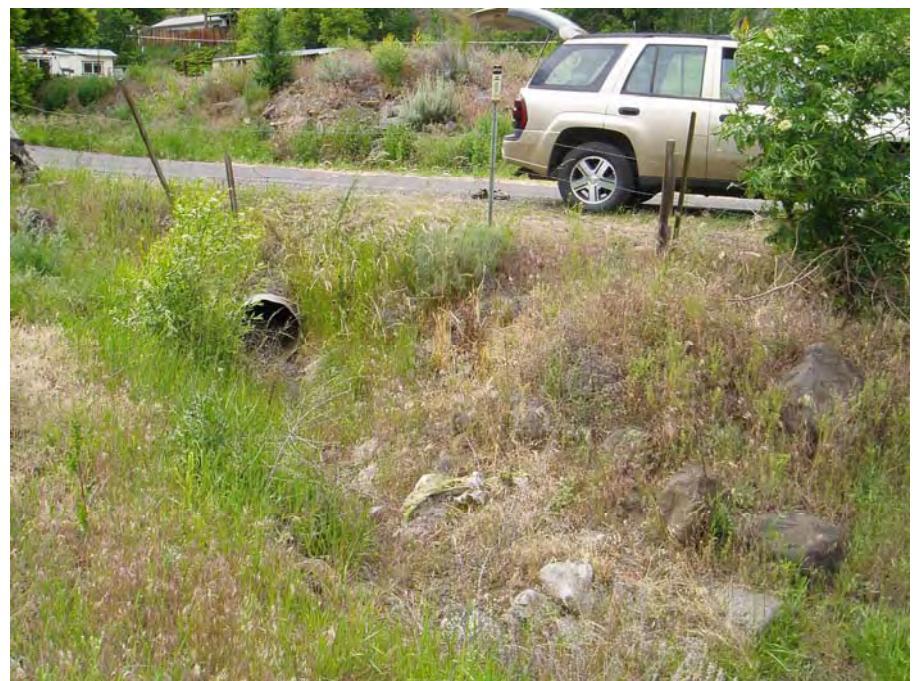
Photograph 2. Close up of the old mouth of Papoose Creek downstream of the culvert. This channel is now blocked by the road and the creek has been moved upstream of the culvert. Photo by D. Weigel, Reclamation.

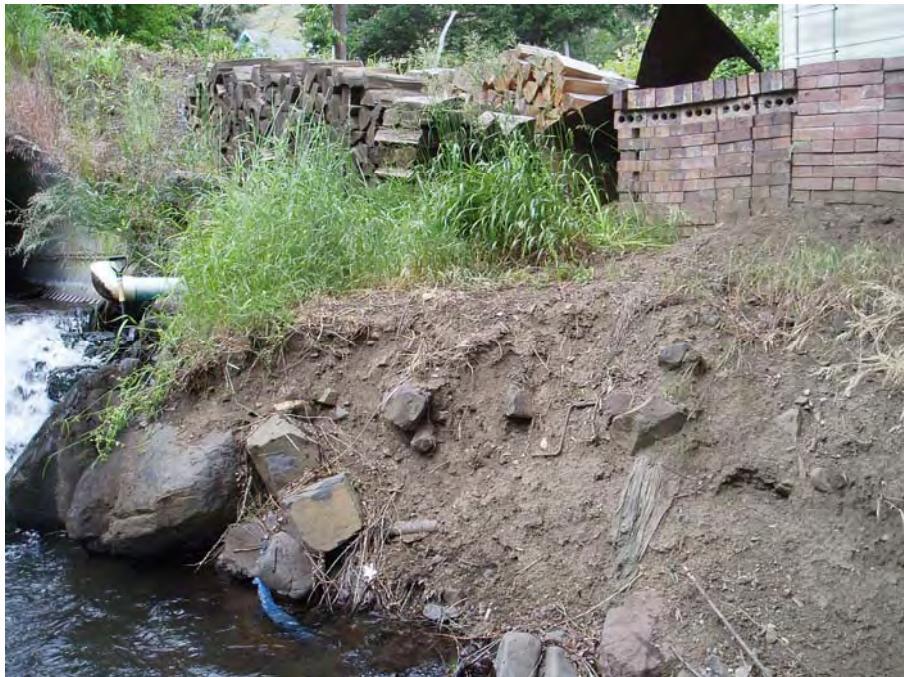
Photograph No. 3. Squaw Creek downstream of culvert. Landowner's property backs up to Squaw Creek. Photo by D. Weigel, Reclamation

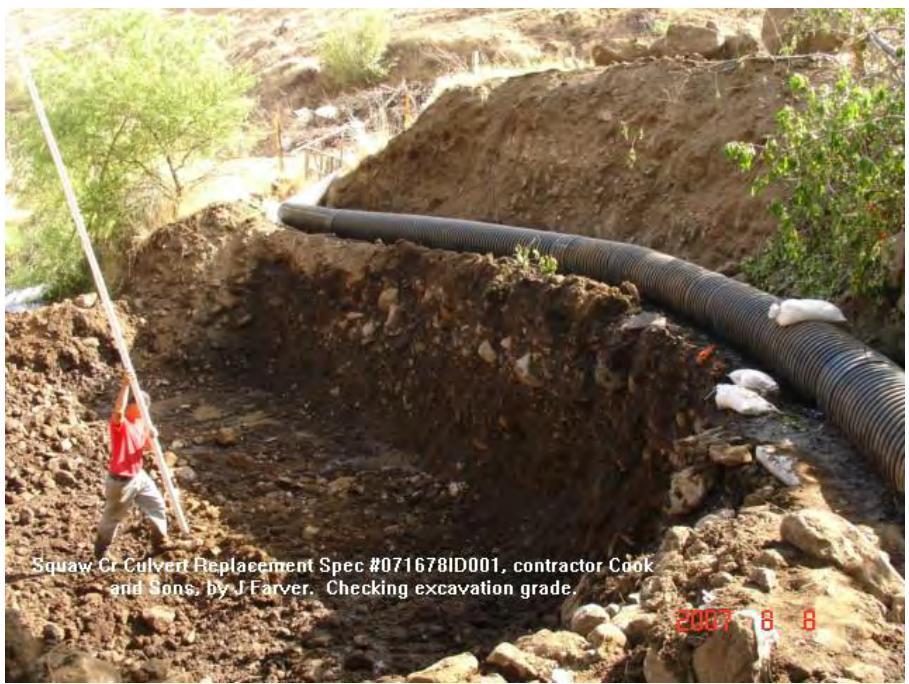
Photograph No. 6. Checking excavation grade. Photo by J. Farver.

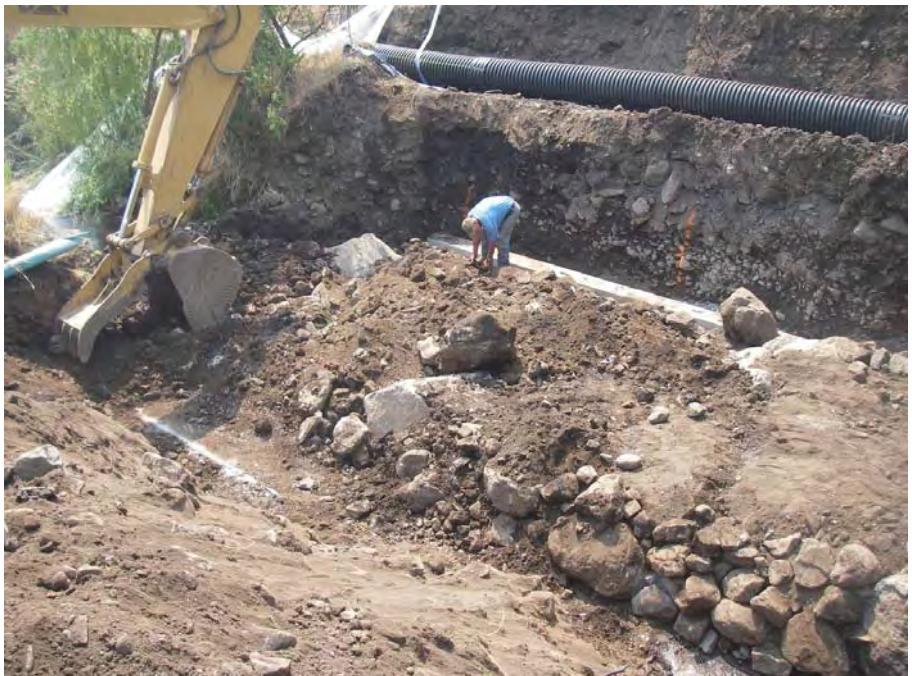
Photograph No. 7. Left side footers in place and completing installation. Photo by J. Farver.

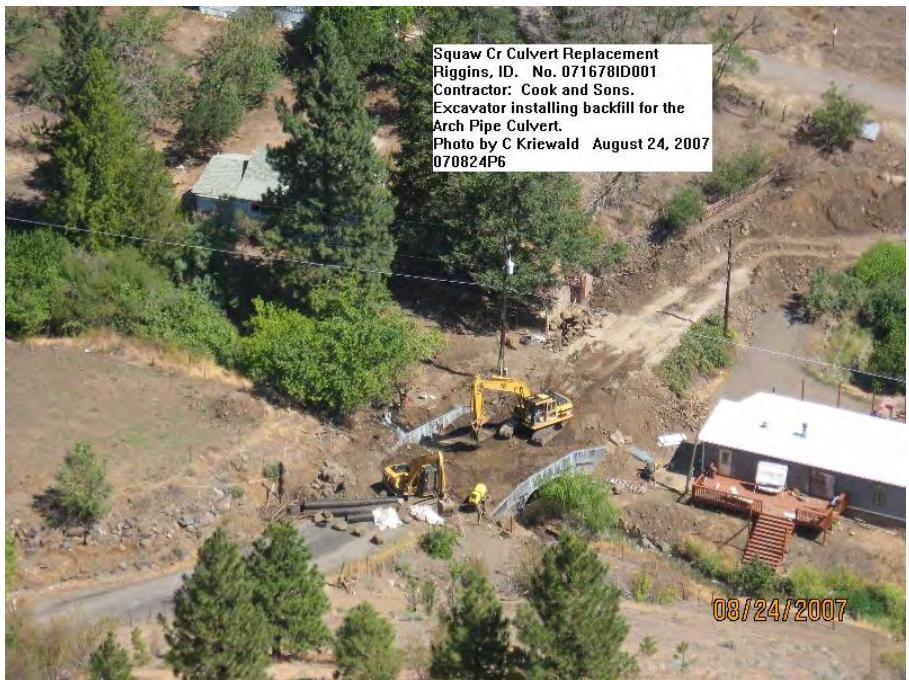
Photograph No. 9. Excavator installing backfill for arch pipe culvert. Photo by C. Kriewald.

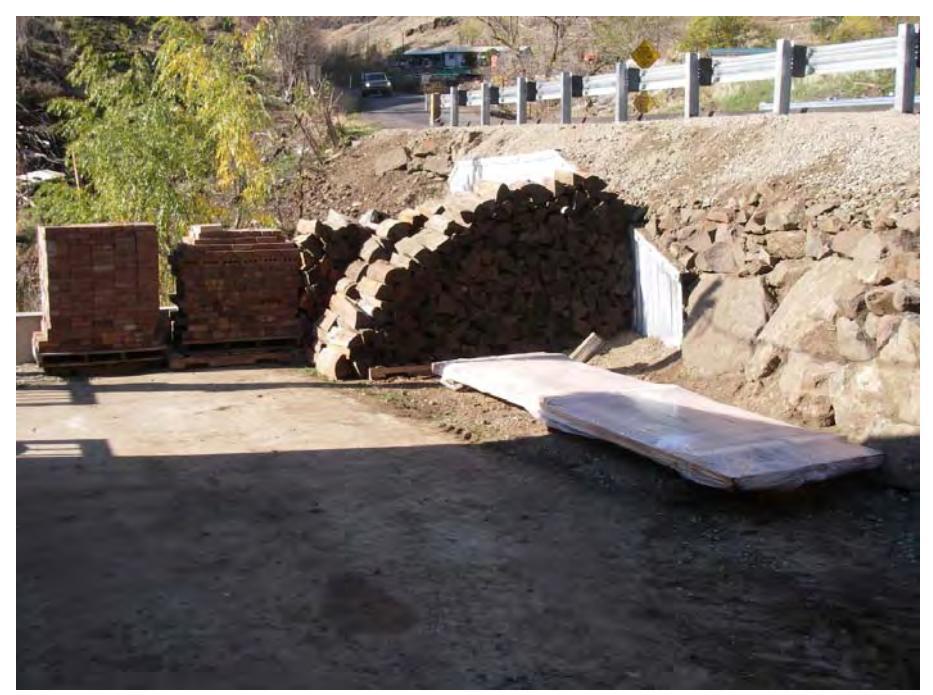
Photograph No. 14. Clean-up of property owners' driveway after restacking bricks and firewood. Photo by J. Chan, Reclamation.
