Chapter 8

The Grounding of the *Royal Majesty*

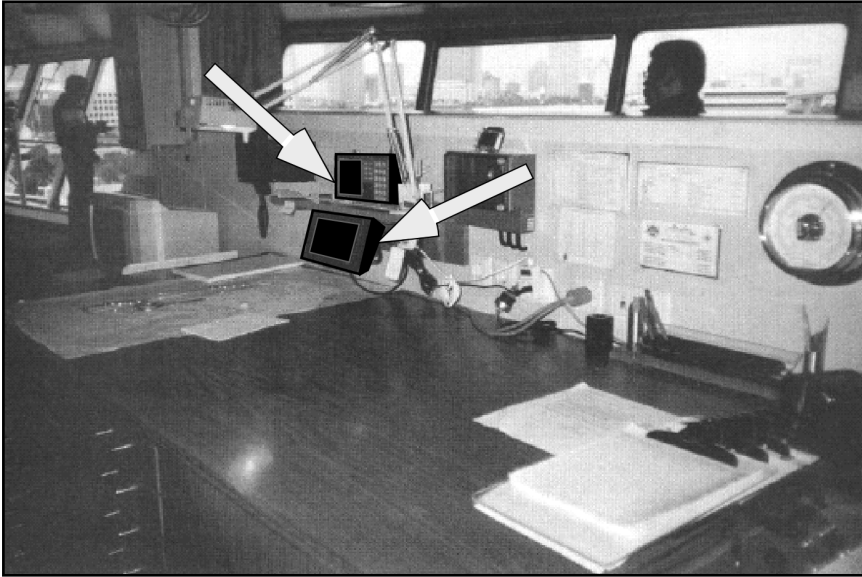
Figure 8.2. The chart table and the bridge. The left arrow points to the GPS unit, the right arrow points to the LORAN-C unit. Source: National Transportation Safety Board (the photo has been enhanced).

waves. The roof above the bridge of a vessel is called the “flying bridge.” Passengers were never allowed to walk on the roof, and the officers hardly ever used it during a passage, but electricians and technicians would climb up there on a fairly routine basis to check the cables and maintain the GPS and LORAN-C antennas. The *Majesty’s* flying bridge was just like any other—a low railing all around, antennas of all sorts, satellite receiving domes, and bundles of connecting wires—except that the gray coaxial cable coming out from the closed bridge and leading to the antenna of the global positioning system was hanging loose; it wasn’t sufficiently secured or strapped to the flying bridge’s roof.

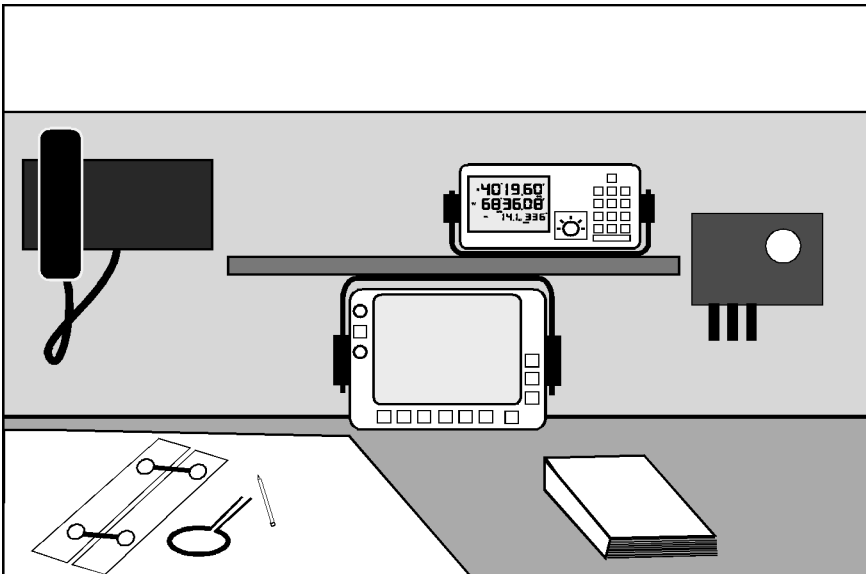
But what neither of them noticed was that in addition to the latitude and longitude coordinates and all the usual data, the GPS display showed two small, innocent-looking text symbols—**SOL** and **DR** (figure 8.5[b]). But these two symbols were hardly innocent—they portrayed a serious problem in the GPS. **SOL** stands for **SOLUTION**, indicating that the GPS was *no longer* computing an accurate position solution. Actually, it had not been producing accurate position solutions for quite some time—ever since the connector between the cable and the GPS antenna had given up an hour after departure, the unit was unable to receive any satellite signals and update its true location.

Figure 8.5 (a). The chart table and the GPS unit (top shelf) and LORAN-C unit (bottom of shelf).
