**A STUDY OF THE PERFORMANCE OF
PETROLEUM STORAGE TANKS DURING
EARTHQUAKES, 1933-1995**

Thomas W. Cooper
T.W. Cooper, Inc.

June, 1997

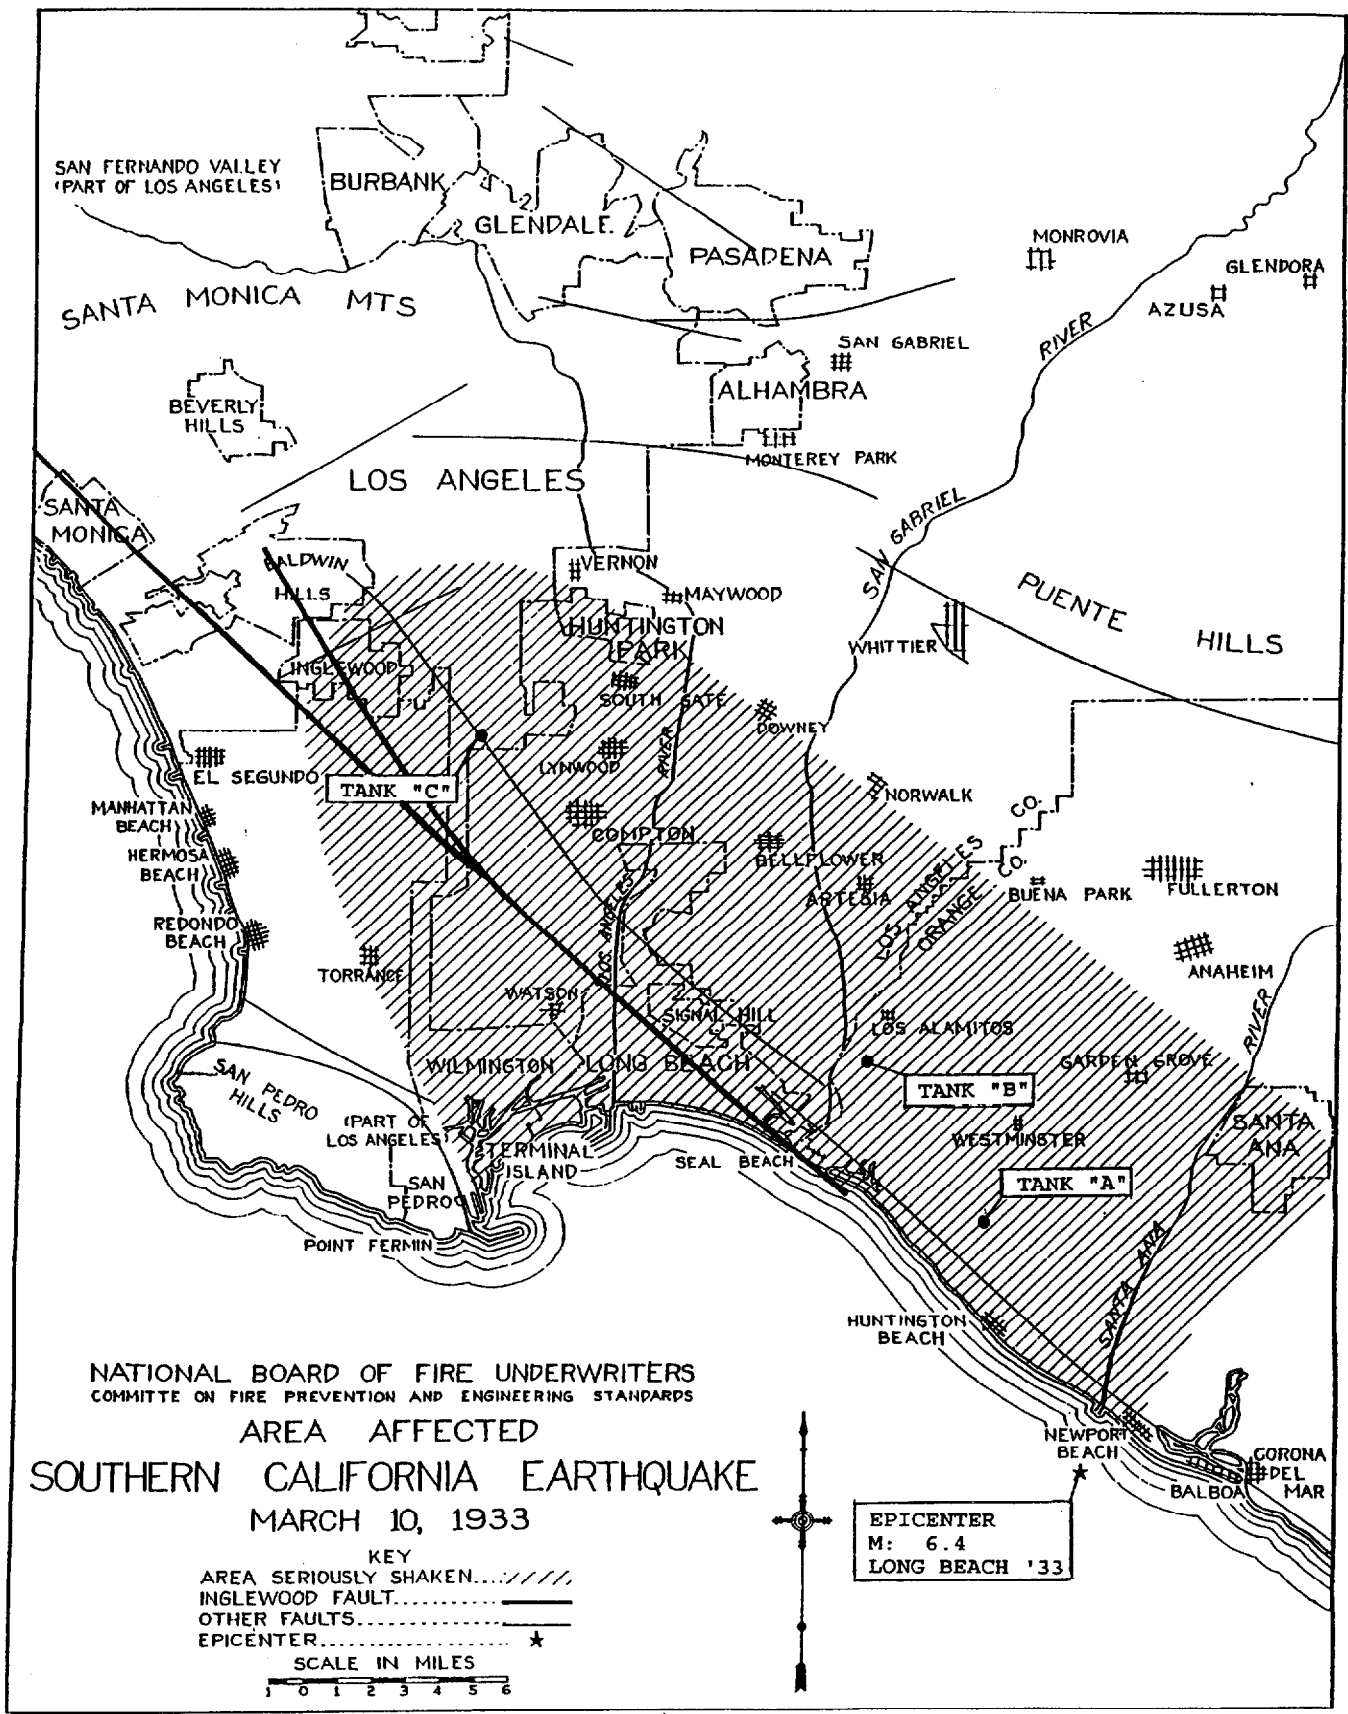
Figure 2.1 1933 Long Beach Earthquake Area Map [10]

This magnitude 6.4 earthquake on March 10, 1933 originated offshore on the Newport-Inglewood fault. Recent work has placed the epicenter on shore. Considering the concentration of oil production, storage, refining, and transport facilities in the affected area, actual failures were few. Tank damage, while not widespread, occurred enough times to warrant attention. All tanks that failed, or sustained damage, were of riveted construction. The failures were in the shell plates and butt or tension straps, and are not comparable to the failures experienced by welded tanks in later earthquakes. The roof/shell damage experienced in this earthquake seems to have its equivalent in later earthquake damage to welded tanks. Sloshing in floating roof tanks also occurred in this earthquake, causing damage to the seals. Only one possible case of elephant foot buckling was noted in one of the reports of the earthquake; this was to a water tank. Examination of the extant damage reports indicates that nearly all tanks reporting damage were full, or nearly full [9] [10]. The general area affected by the earthquake, as well as the locations of some tank failures, is shown in Figure 2.1.

Tank "A" located in Huntington Beach was a spectacular failure. This tank was nearly full (98%), in close proximity to the epicenter (3.5 km) and to the fault (2 km). The tank was in a block with three other tanks which were partially full at the time of the earthquake. These tanks sustained no damage. The failed tank had a diameter of 28.9 m (95.5 ft) and a height of 8.8 m (29.1 ft); its roof was of galvanized iron on wooden supports. Oil splashed to the top of the shell of an adjacent 12.1 m (40 ft) high tank, 15.2 m (50 ft) distant from the failed tank. The released oil traveled over 91.8 m (300 ft), went over a firewall, and broke windows on an adjacent garage. Fortunately, no fire resulted [11].

Tank "B" was a 118,000 bbl tank located 5 km from the fault and $15 \pm$ km from the epicenter. This tank was at a tank farm with 43 other identical tanks, none of which failed. Few details are available on tank geometry or failure mode, other than it was a total failure with both shell and roof sustaining damage.

Tank "C" was a tank 45.4 m (150 ft) in diameter and 19 m (63 ft) high which had a 14.5 m (48 ft) water depth at the time of the earthquake. This tank had eleven shell courses and the failure was at the top of the fourth shell course. Portions of the tank shell were up to 60 m (200 ft) from the tank after the failure. This tank was 45 km from the epicenter and was probably within 1-2 km of the fault; see Figure 2.2 [10].

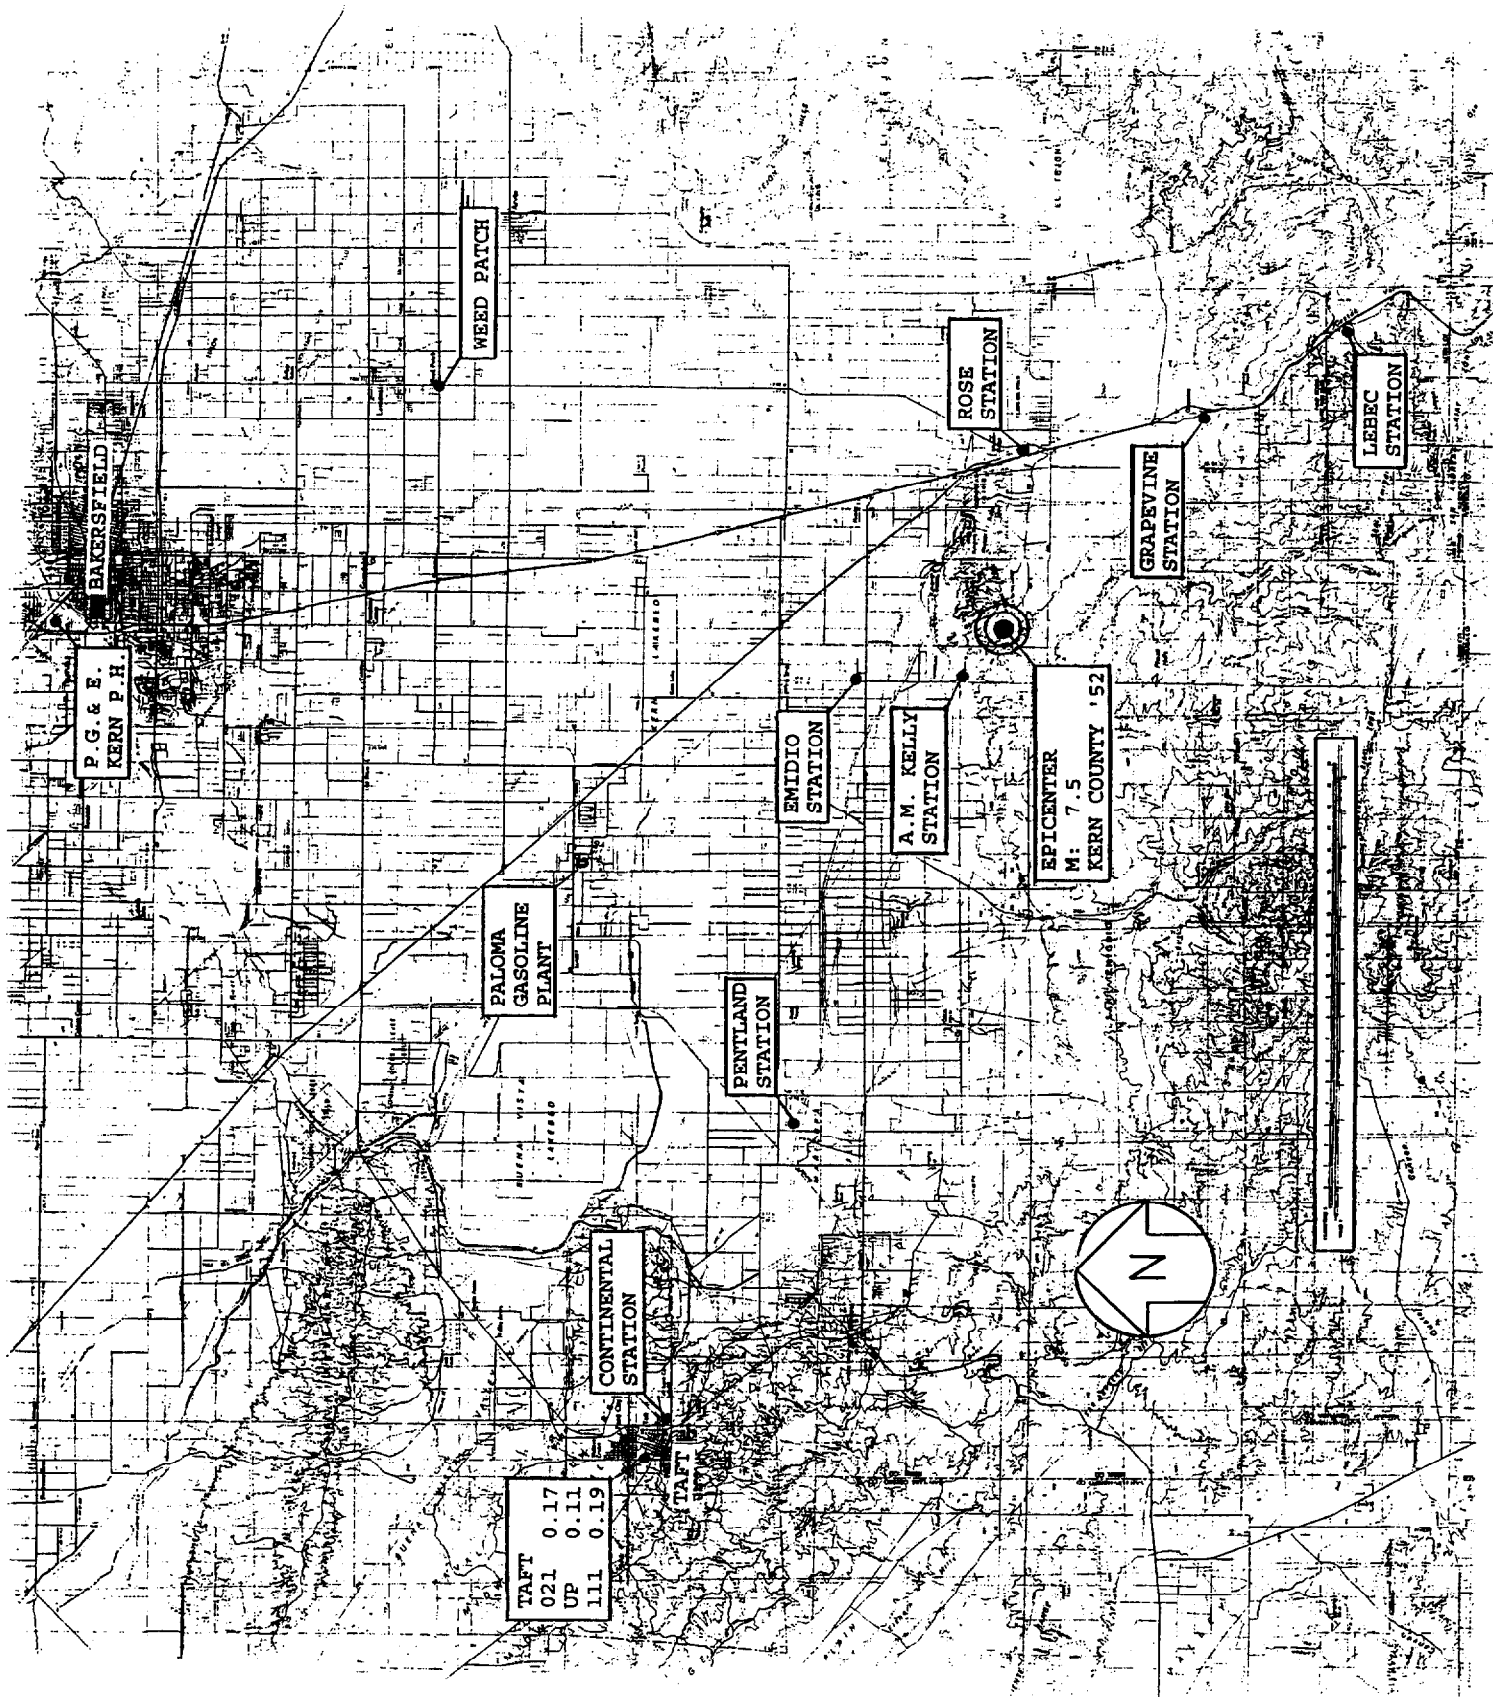
Figure 3.1 1952 Kern County Earthquake Area Map.

This magnitude 7.5 earthquake occurred on July 21, 1952, and was followed by a series of strong aftershocks in a rather extended area in the northeast direction from the initial epicenter. The initial earthquake occurred in a sparsely populated area, but an area in close proximity to a number of tanks. Table 3.1 [13] lists the damage to the then General Petroleum tanks on their pipeline system from the San Joaquin Valley to the Los Angeles Basin. Figure 3.1 shows the general location of the various facilities affected as well as the epicenter of the initial earthquake. Table 3.2 gives the distance from the epicenter to the specific location of the tanks. Ground displacement occurred generally to the northeast of the epicenter. There were a number of smaller diameter bolted "production" tanks which either failed by elephant foot buckling, or in at least one case, the tank collapsed and fell over. This collapsed tank was nearly full. Adjacent tanks which were not full suffered no damage. Most production tanks have heights and diameters that are approximately equal, and are of bolted shell construction.

Virtually all of the tanks listed in Table 3.1 were riveted tanks, with thick shells to allow for acceptable tensile stresses at the riveted splice between the shell plates. Considering the proximity of the facilities to the epicenter and severity of the earthquake, one would expect more tank damage, especially considering the extensive damage to older buildings from this earthquake. Continental Station, not listed in Table 3.1, sustained no damage. Damage to the tanks at the A.M. Kelly Station was reported not significantly different from that at the General Petroleum Stations listed in Table 3.1. Figure 3.2 shows the elephant foot buckling on a bolted tank at the General Petroleum Emidio Station.

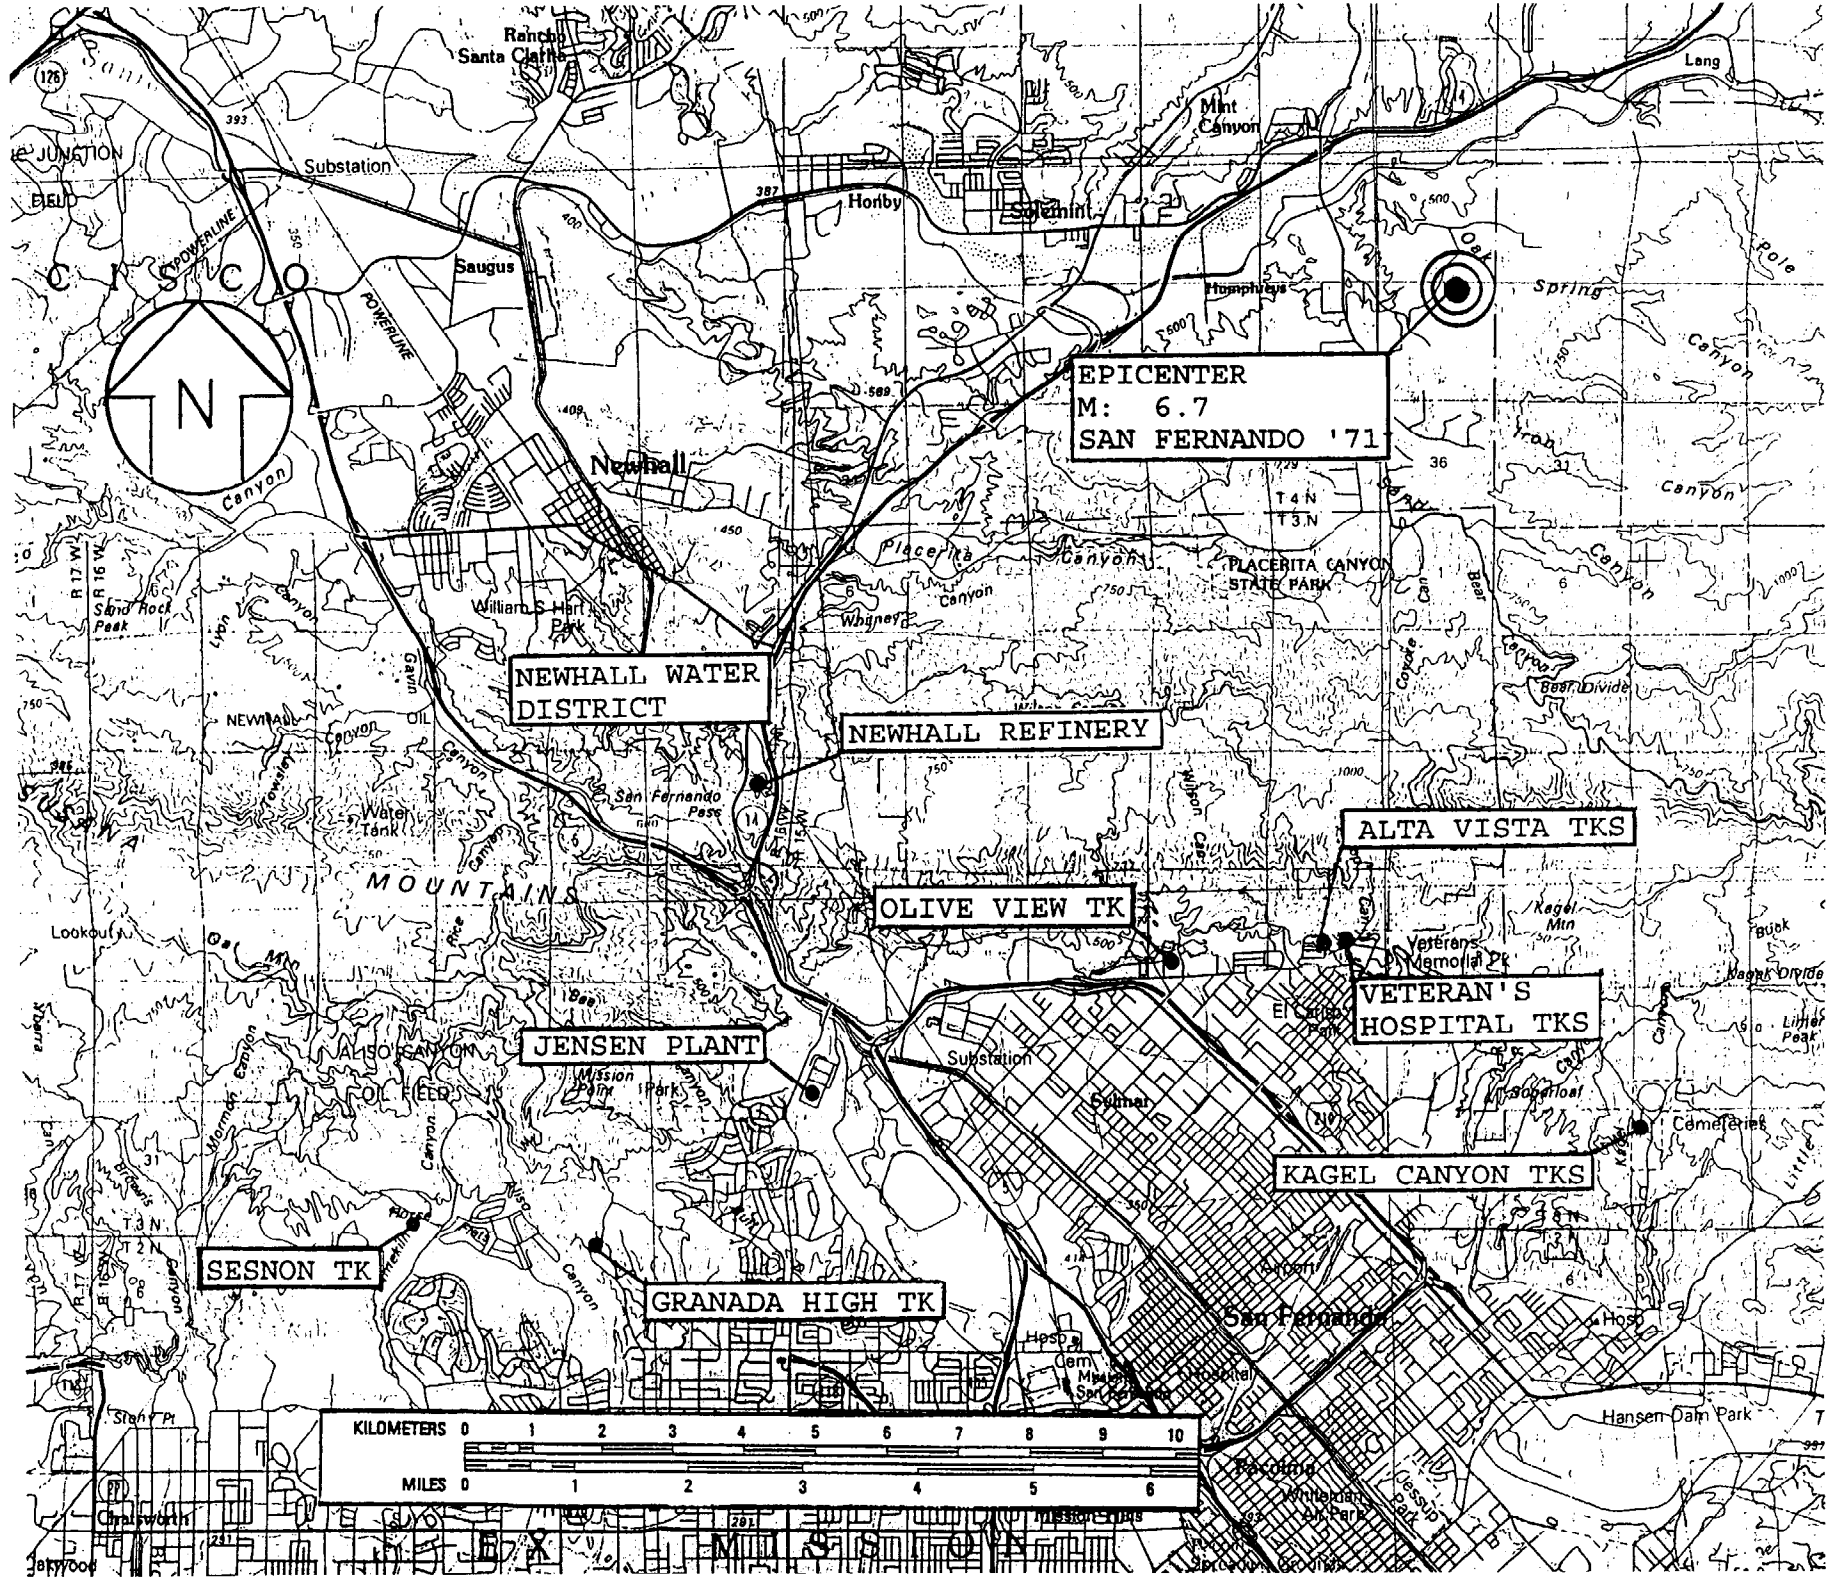
Figure 5.1 1971 San Fernando Earthquake Area Map.

This magnitude 6.7 earthquake had its epicenter about 21 km north of the City of San Fernando in the mountains north of the San Fernando Valley. There was ground breakage or surface faulting south of the epicenter, in the valley surface. Most of the heavy damage was north of this faulting [20]. Figure 5.1 shows the general area and notes specific features.

The Newhall refinery was located 12km from the epicenter and 4-5km from the surface faulting. This facility had about 400,000bbls of tank storage. Three 20,000bbl tanks, 18.5m (60ft) in diameter by 12.2m (40ft) high, which were full of Jet Fuel had elephant foot buckling on one side. Two 37m (120ft) in diameter by 12.2m (40ft) high tanks had no damage. There was minor piping damage but no serious problems developed.

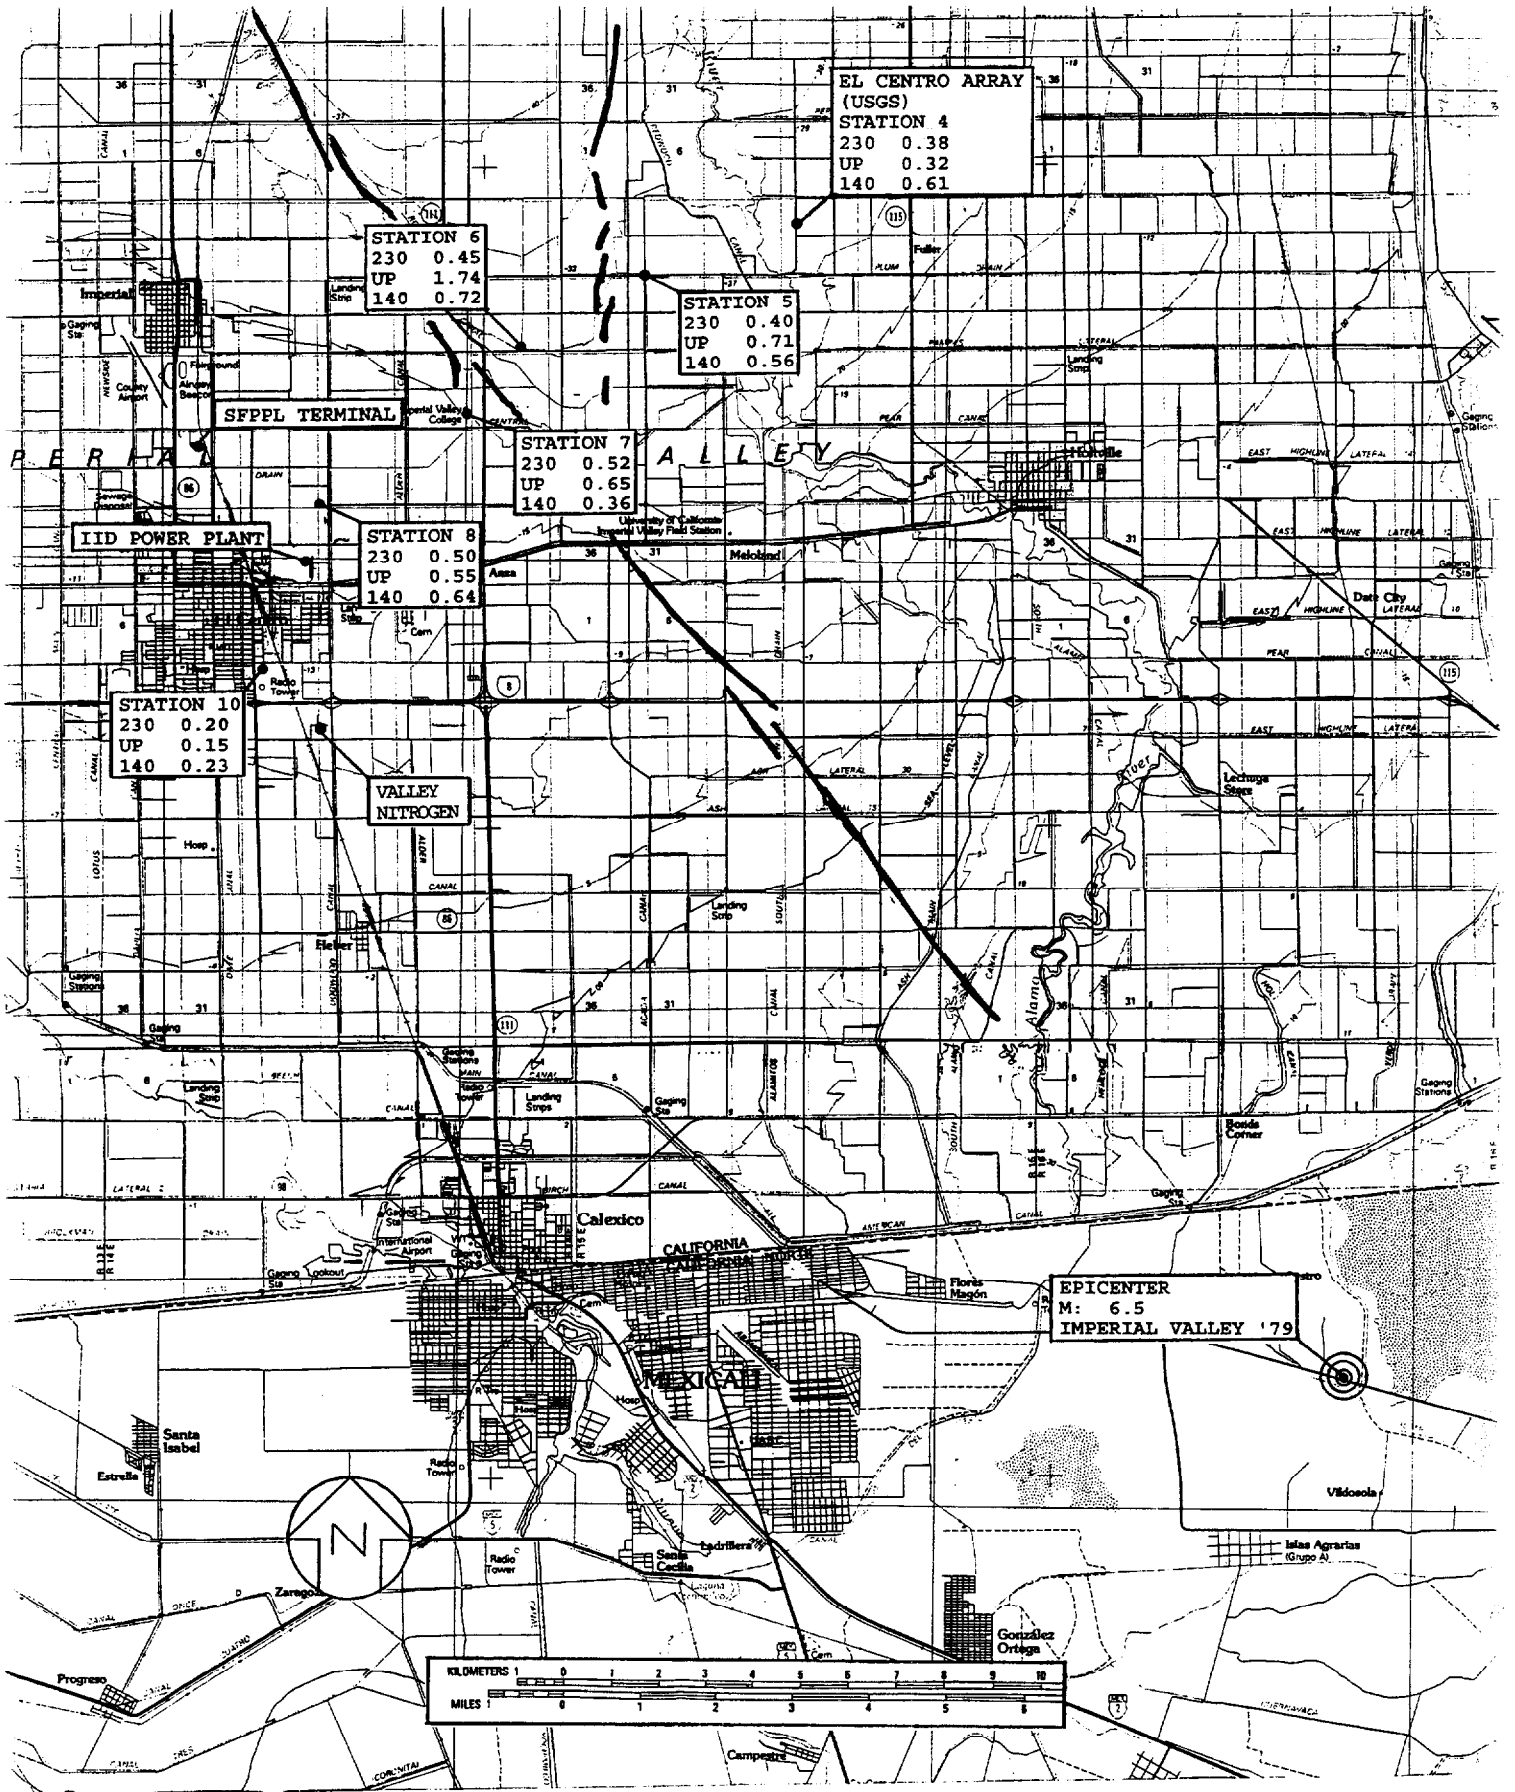
Figure 6.1 1979 Imperial Valley Earthquake Area Map

Figure 6.1 shows the location of the tanks relative to the epicenter and displaced sections of the Imperial fault, and gives the USGS accelerometer array readings in the vicinity of the tanks.

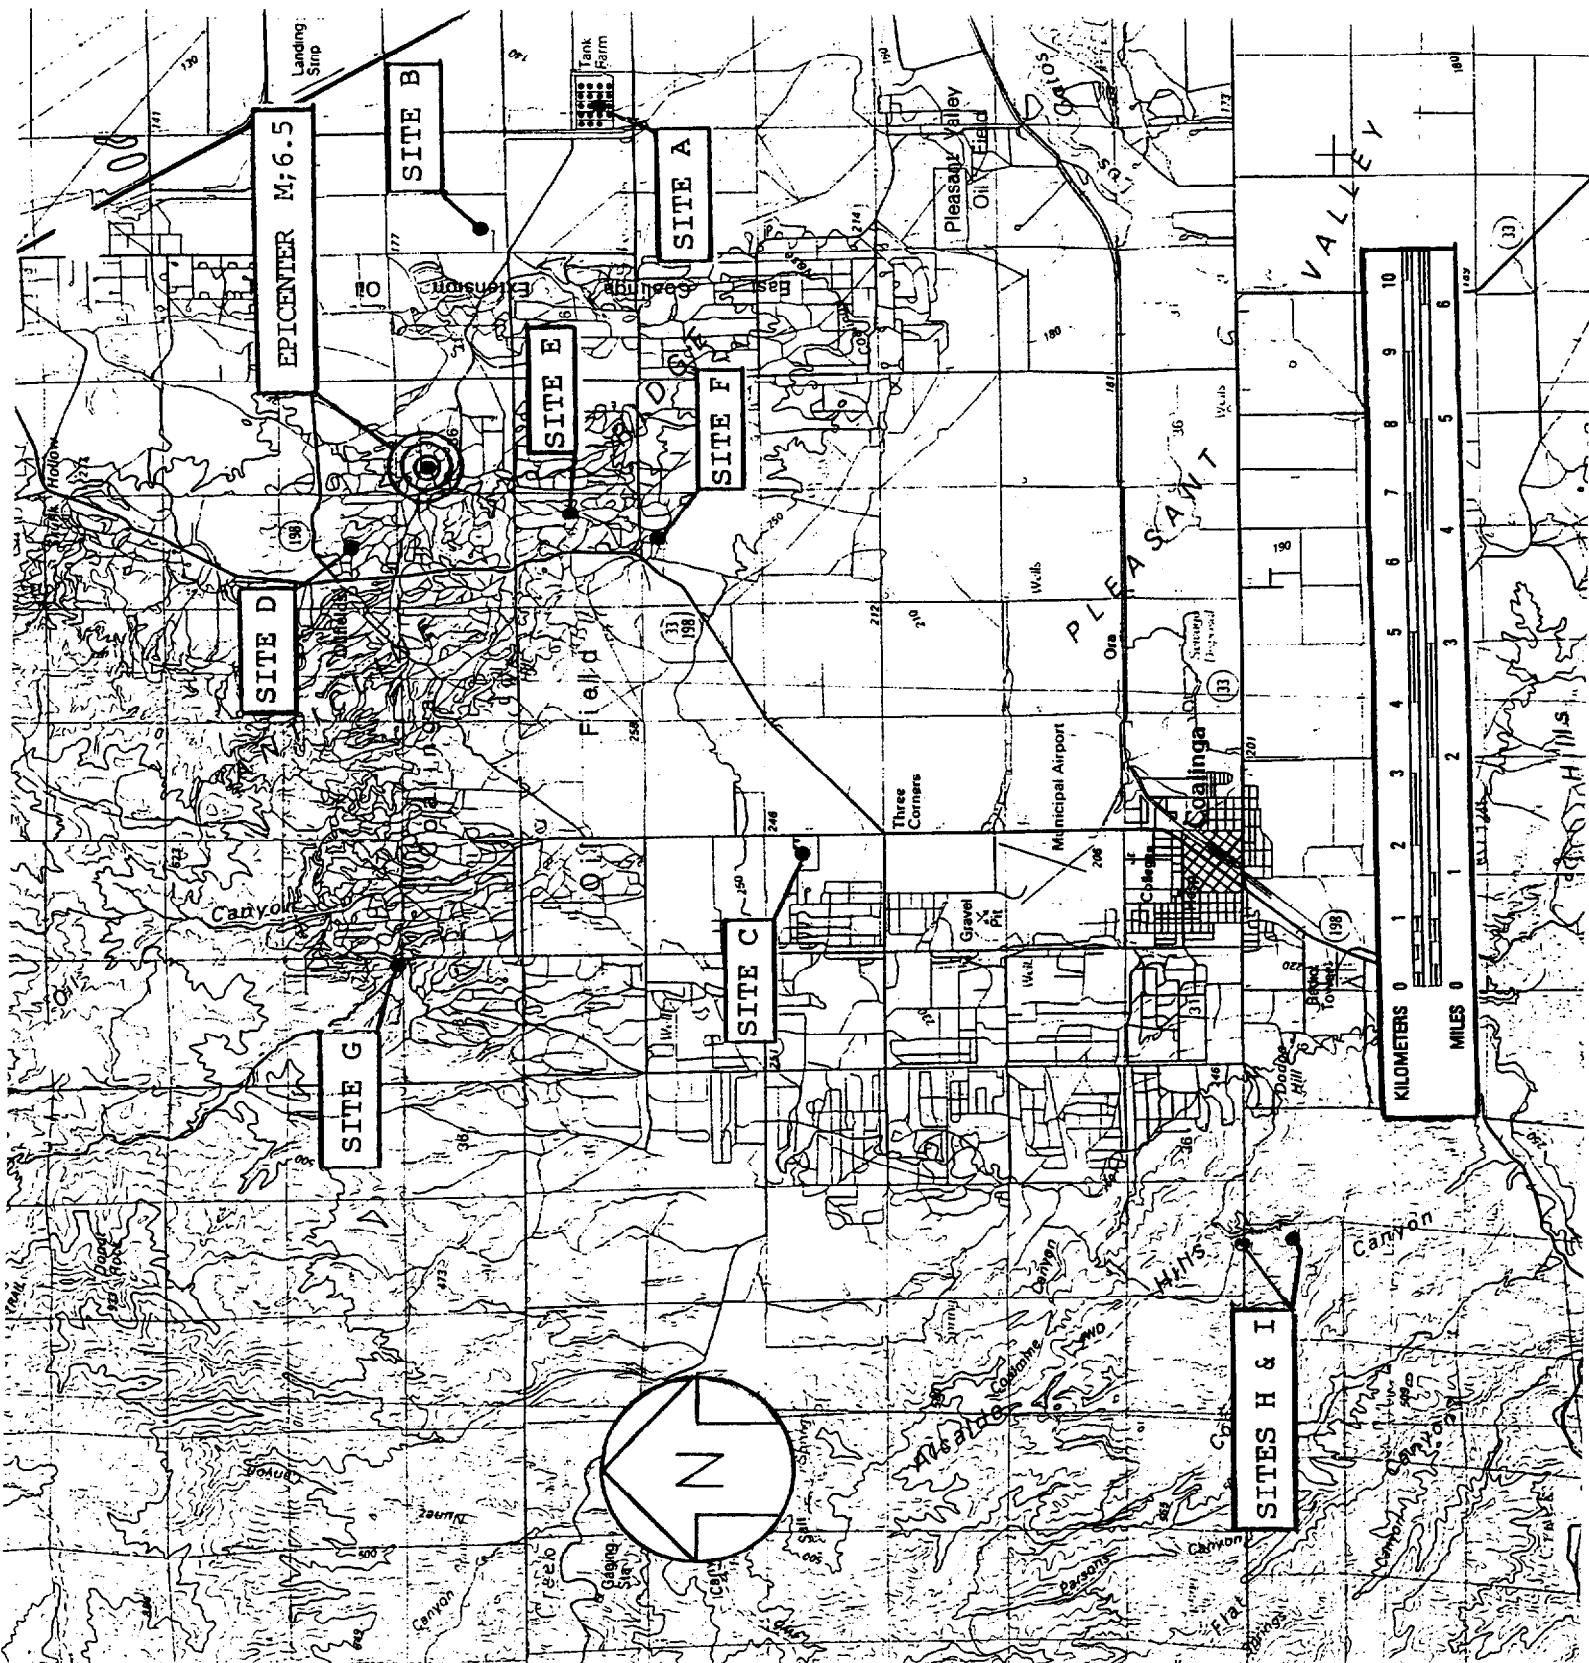
Figure 7.1 1983 Coalinga Earthquake Area Map

There were a number of large diameter (over 31 m or 100 ft) oil storage tanks within 6.4 km of the epicenter. There also were two large diameter water tanks within 5 km of the epicenter. Most of the large oil storage tanks had floating roofs, and many had seal damage with some having pontoon or roof damage. Figure 7.1 shows a map of the area.

Site "G" was a crude oil treatment facility which had a number of bolted tanks. Two tanks of 17 m (55 ft) diameter by 10 m (32 ft) high suffered elephant foot buckling. Both tanks were about three-quarters full. Other tanks at this site developed leakage at bolt holes, with other minor damage. Most of those other tanks were less than or equal to half-full. This site was about 6.5 km west of the epicenter [29].

Sites "H and I" are located west of Coalinga, about 16 km from the epicenter. Damage was not extensive at these facilities and consisted principally of sloshing losses from tanks and some damage to piping [30].

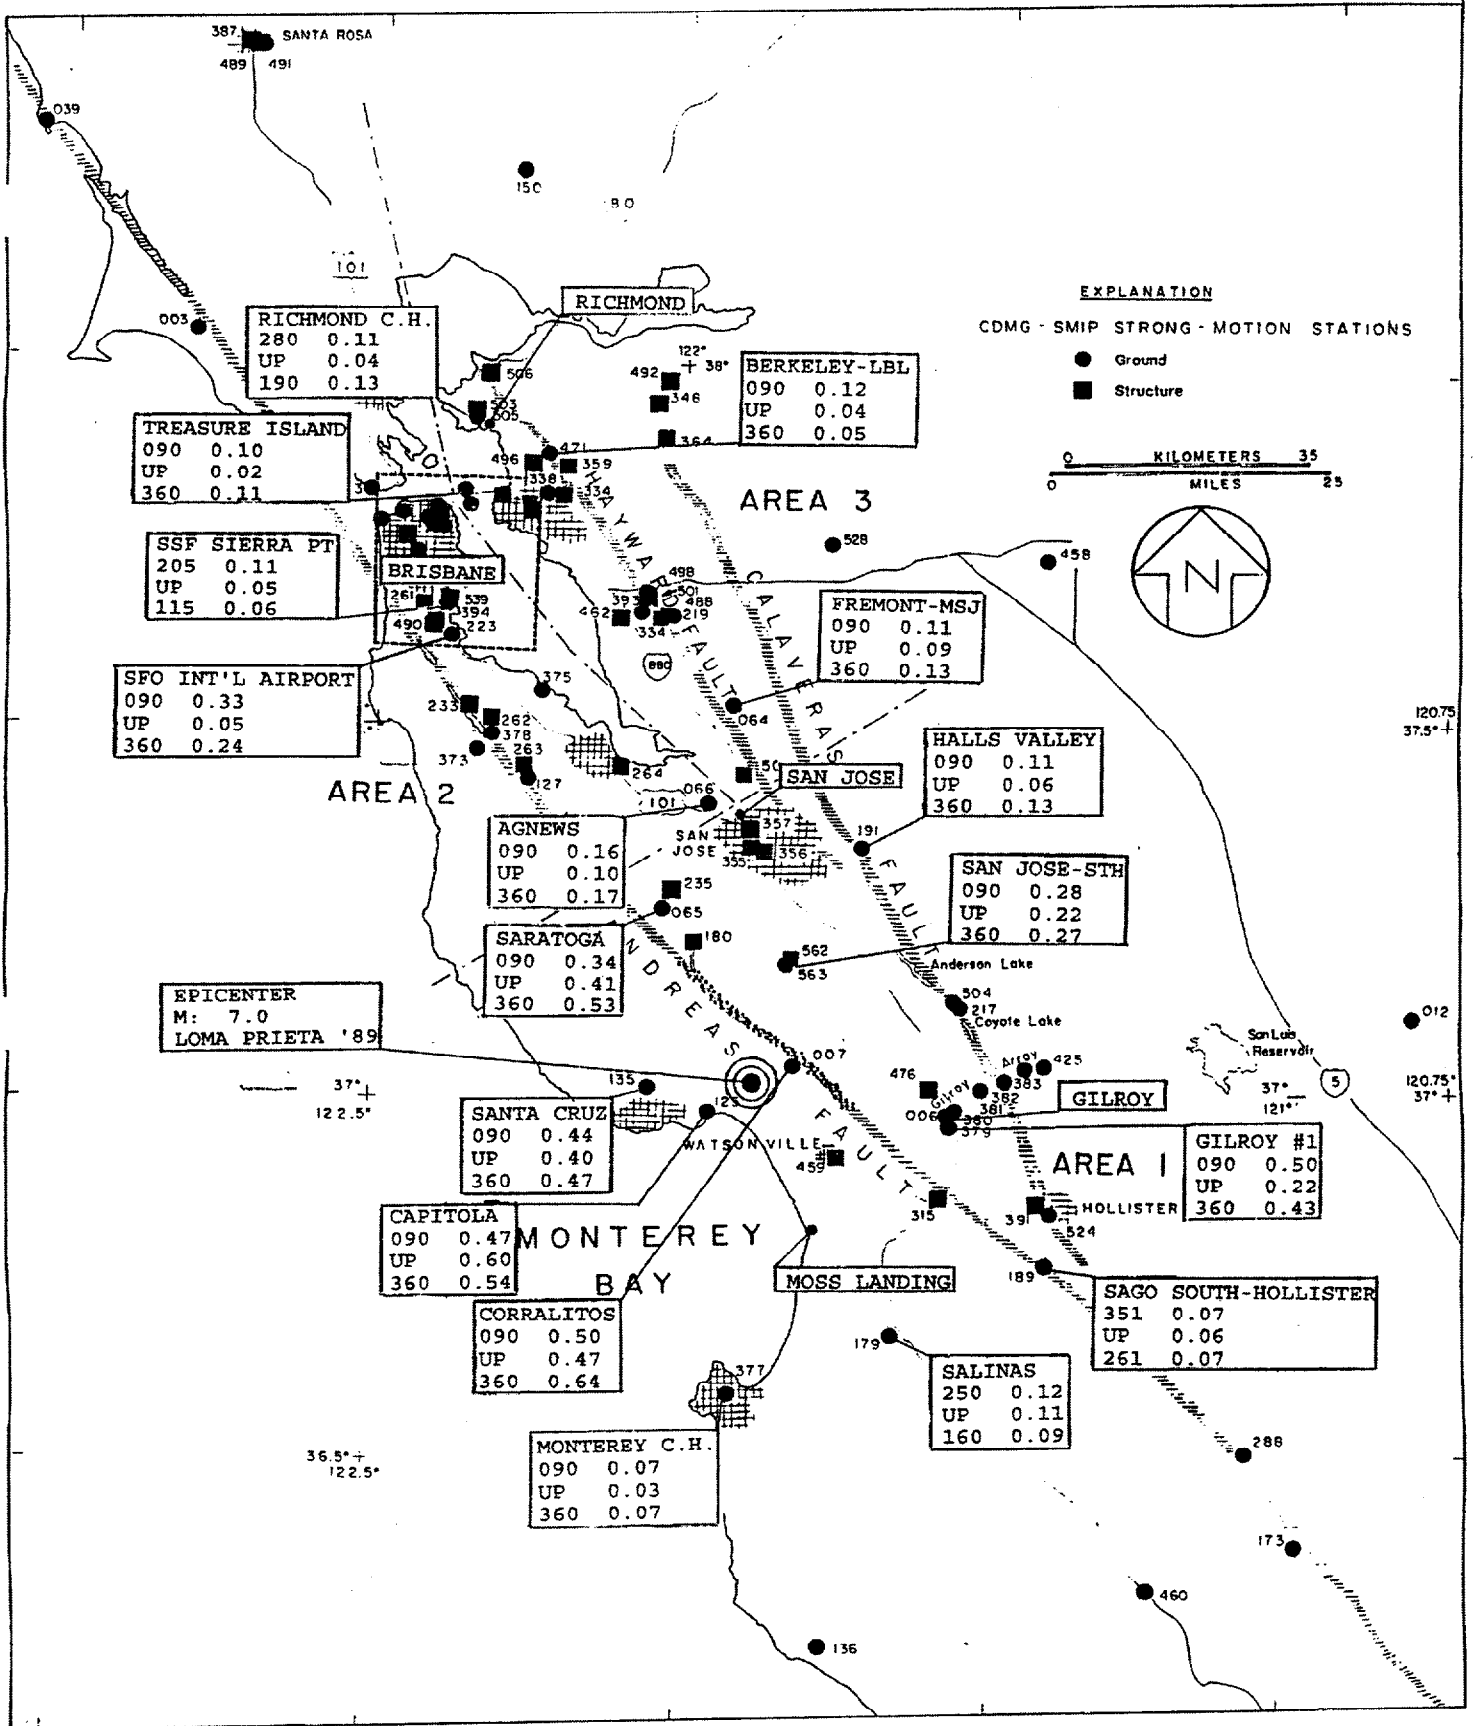
Figure 8.1 1989 Loma Prieta Earthquake Area Map [34]

The Loma Prieta magnitude 7.0 earthquake of October 17, 1989 caused considerable tank damage; fortunately no catastrophes followed. Some of the most severe damage was at a location far from the epicenter. Three petroleum tank locations are considered in this report. In addition, two specific water tank locations are examined. Figure 8.1 is a map of the area showing five sites and some accelerometer values in the general area.

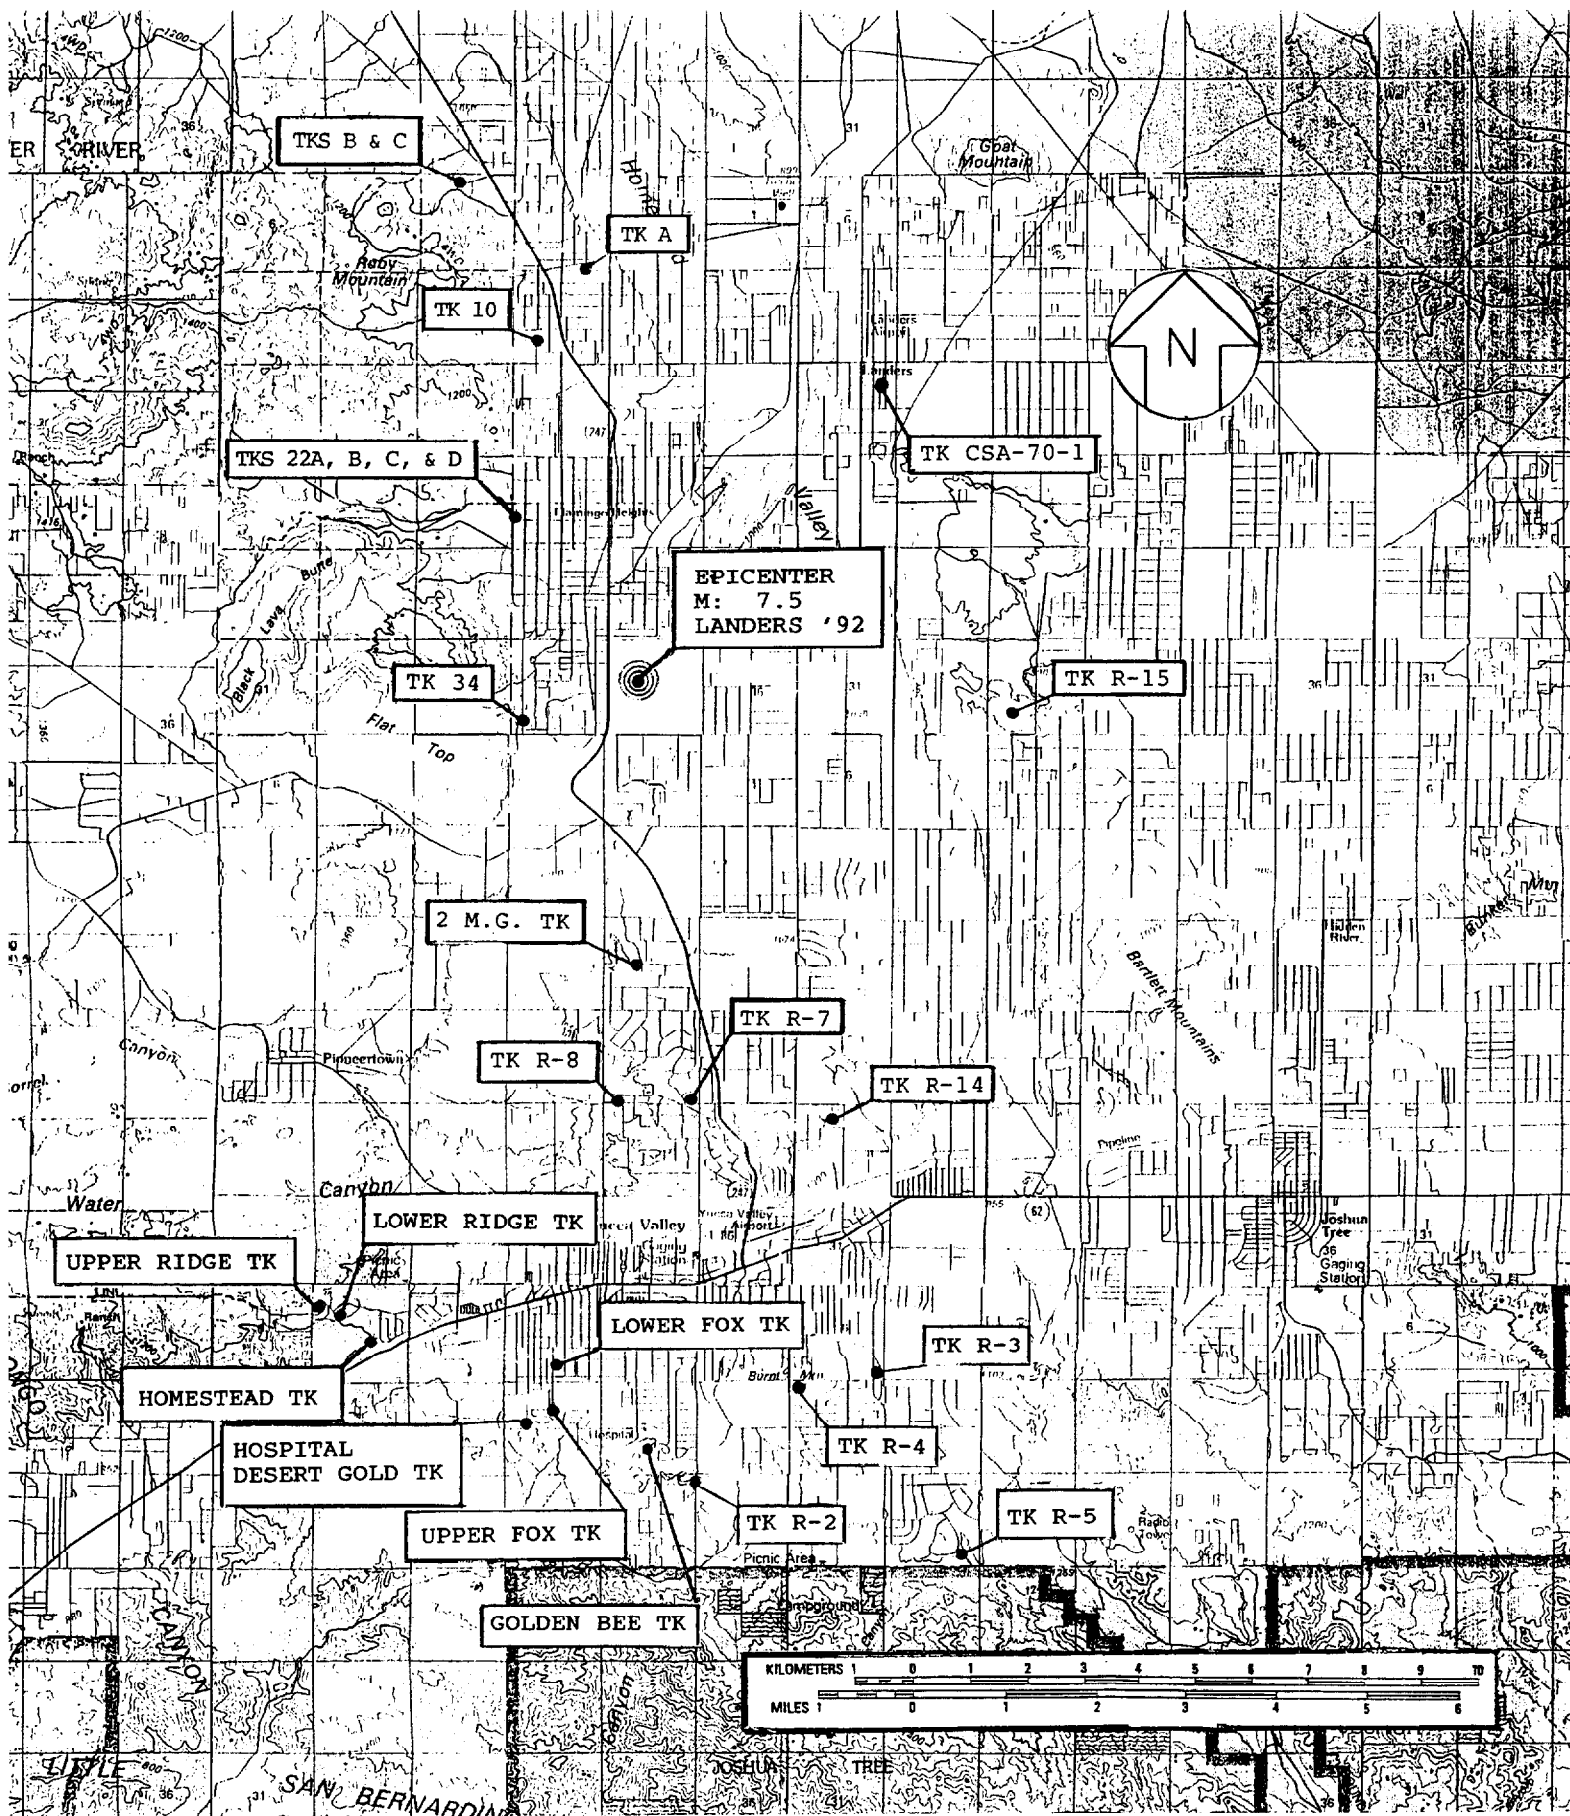
Figure 9.1 1992 Landers Earthquake Area Map

The magnitude 7.3 Landers earthquake occurred at 4:58 a.m. on June 28, 1992; this was shortly followed by the Big Bear magnitude 6.5 earthquake at 8:02 a.m. of the same day. Since all tank damage was in or near the Landers area, this report is directed solely to the Landers event. There were no petroleum storage tanks in the immediate area, hence this section almost totally discusses water tanks. Although a sparsely populated desert area, the area strongly affected by the Landers earthquake contained over 27 water tanks. Of these, only two failed. Figure 9.1 shows the location of the tanks. Figure 9.2 shows the surface faulting near the failed tanks. Figure 9.3 gives accelerometer values in the general area.
