**A STUDY OF THE PERFORMANCE OF
PETROLEUM STORAGE TANKS DURING
EARTHQUAKES, 1933-1995**

Thomas W. Cooper
T.W. Cooper, Inc.

June, 1997

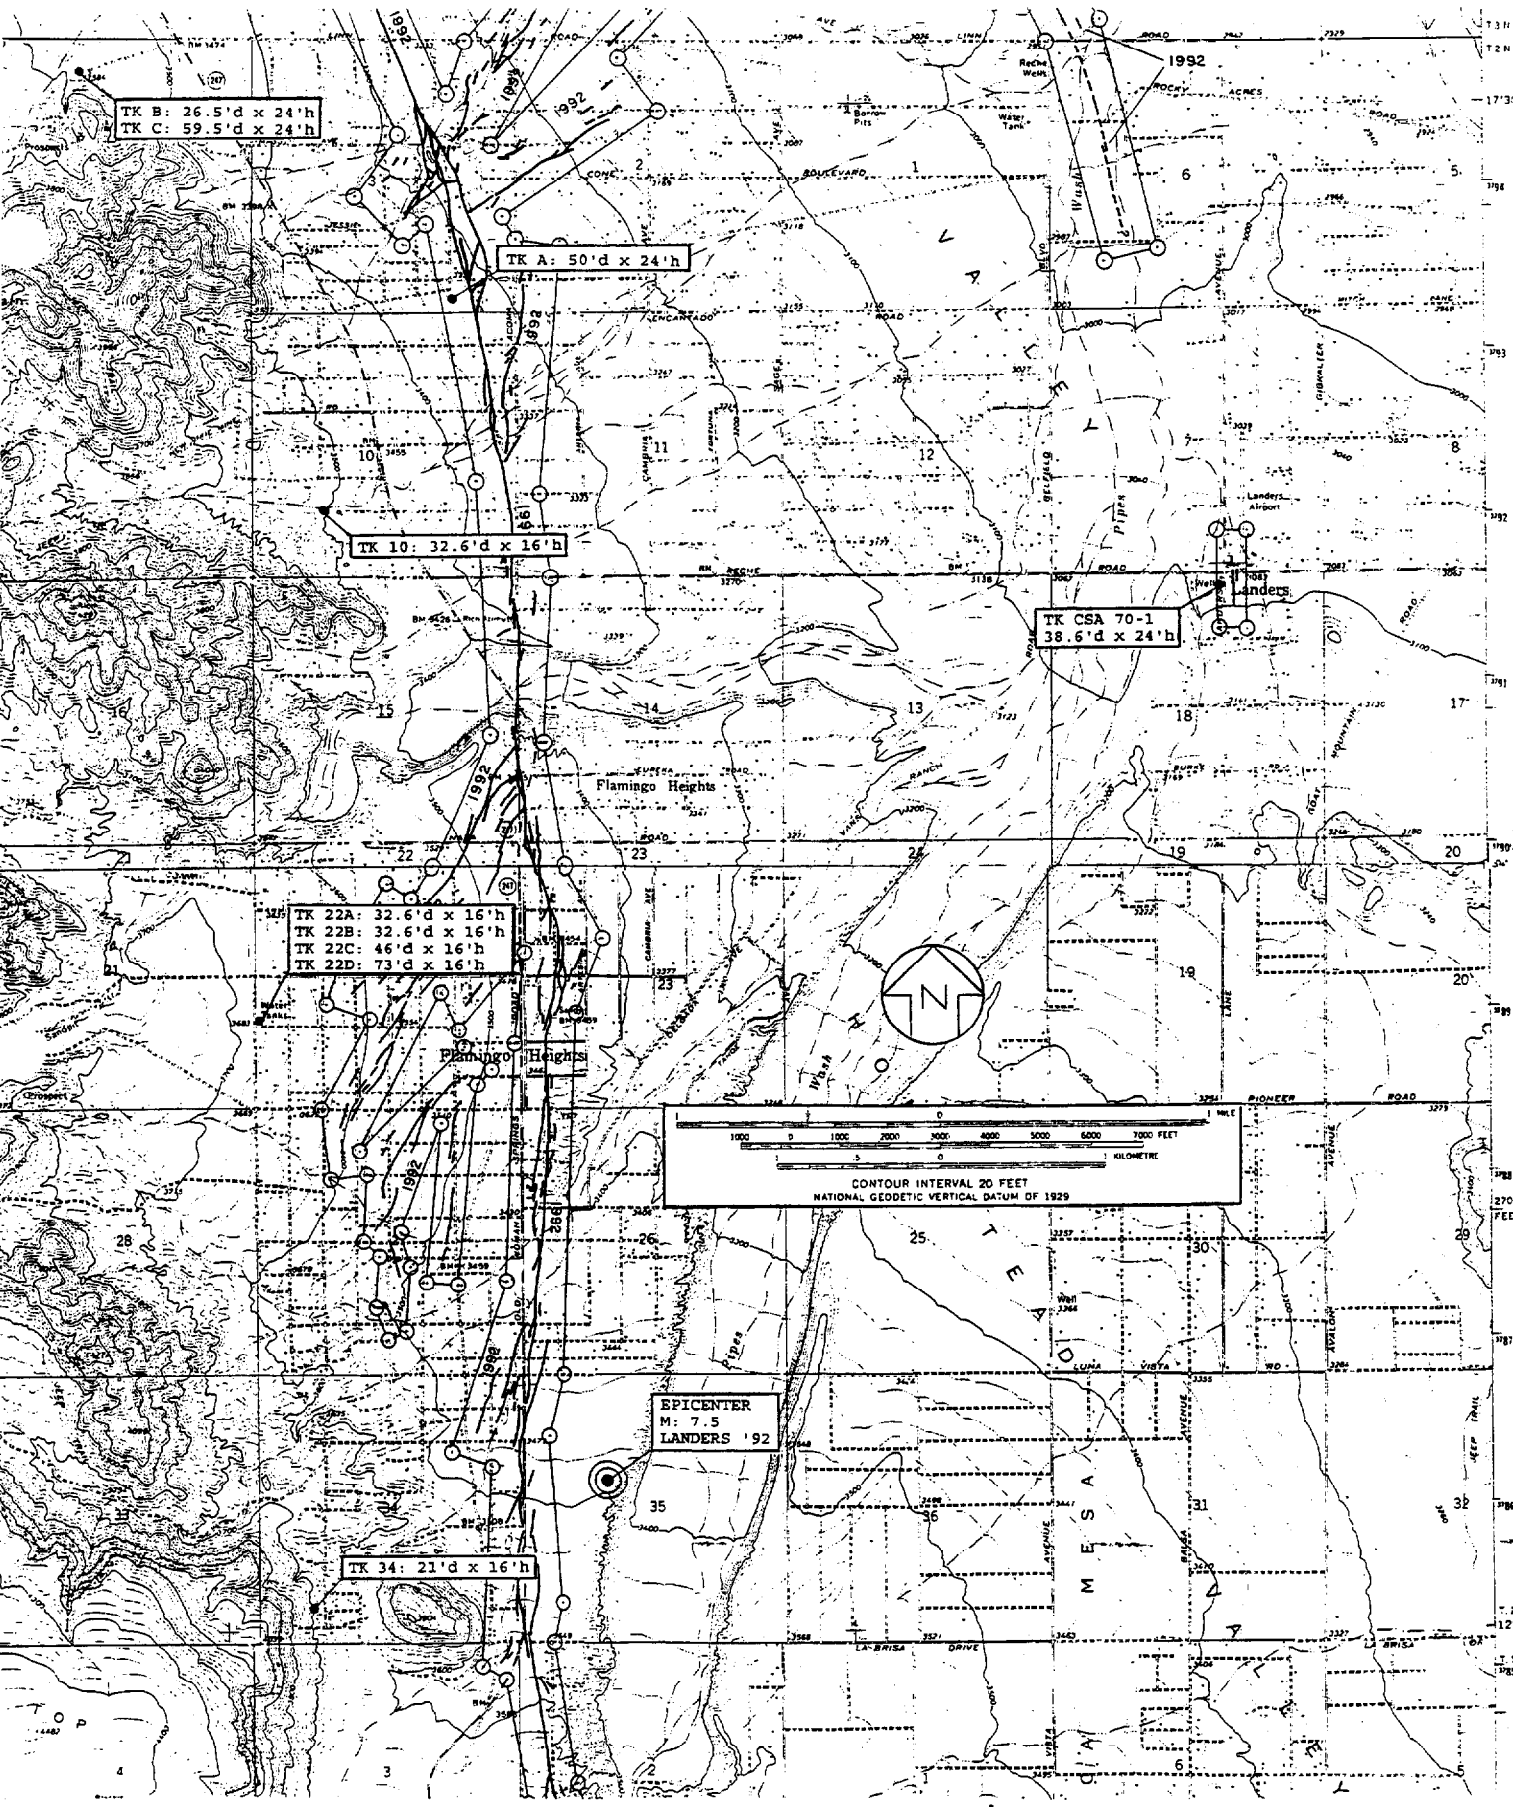
Figure 9.2 1992 Landers Earthquake Tank Locations Near Faulting [State of California Earthquake Fault Zones, Landers Quadrangle]

The magnitude 7.3 Landers earthquake occurred at 4:58 a.m. on June 28, 1992; this was shortly followed by the Big Bear magnitude 6.5 earthquake at 8:02 a.m. of the same day. Since all tank damage was in or near the Landers area, this report is directed solely to the Landers event. There were no petroleum storage tanks in the immediate area, hence this section almost totally discusses water tanks. Although a sparsely populated desert area, the area strongly affected by the Landers earthquake contained over 27 water tanks. Of these, only two failed. Figure 9.1 shows the location of the tanks. Figure 9.2 shows the surface faulting near the failed tanks. Figure 9.3 gives accelerometer values in the general area.

Tank A was located approximately 100 m west of the fault. It failed at the shell bottom plate joint at two locations. One was a 2.75 m (9 ft) rip on the north side of the tank, the other a similar failure at and below a manway on the west side. There was elephant foot buckling around the entire tank, with the most severe on the north side and the least severe on the southeast side. There was a 150 mm (6 in) riser pipe on the south side of the tank which lifted about 0.6 m (2 ft) out of the ground. This riser pipe was then bent and torn from the tank when the tank shell came back to grade. There appeared to be an 80 mm (3 in) horizontal movement of the tank to the north. Figures 9.4 and 9.5 show some of the damage to Tank A.

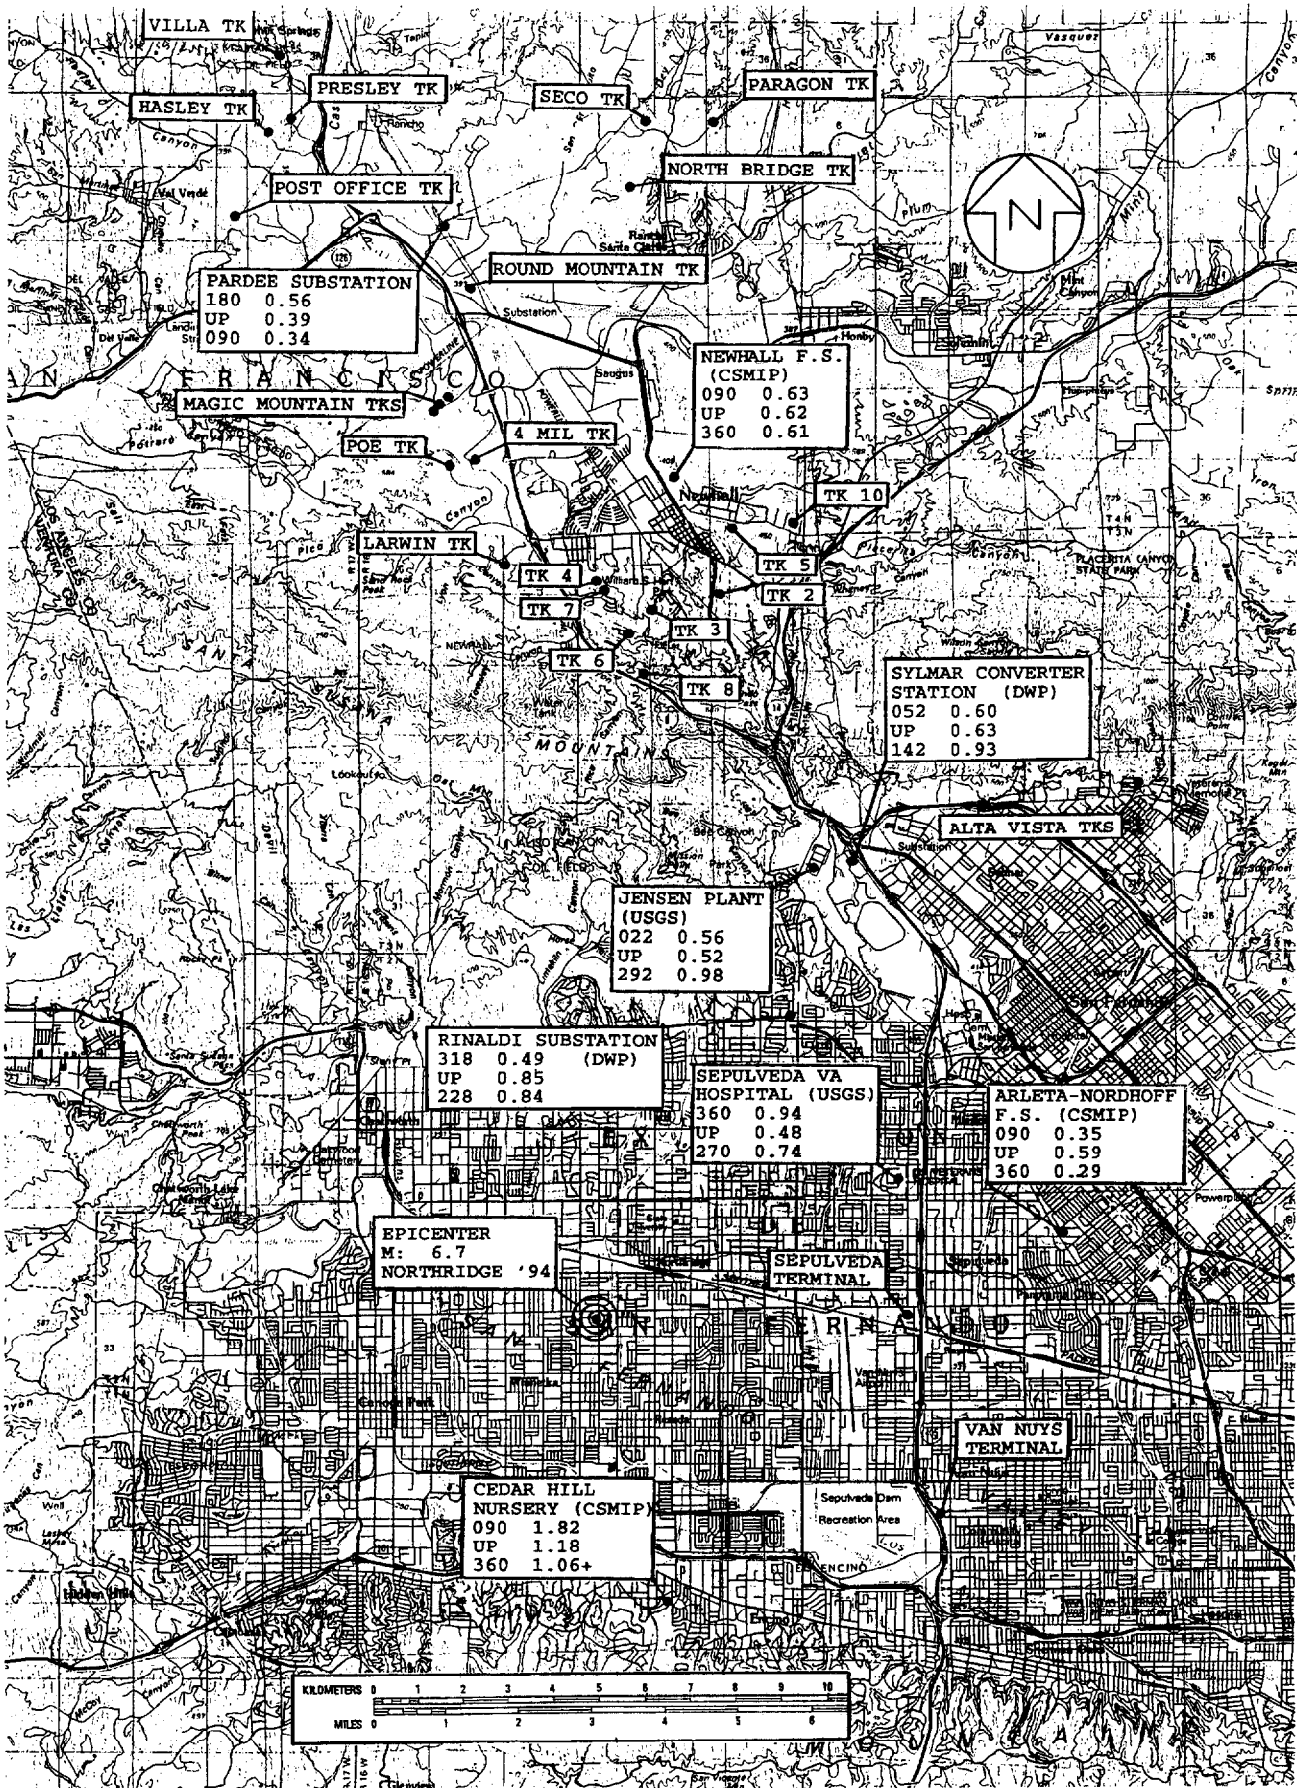
Figure 10.1 1994 Northridge Earthquake Area Map - San Fernando Valley and North

This magnitude 6.7 earthquake occurred on January 17, 1994. It occurred on a blind thrust fault with the epicenter located in the San Fernando Valley near the community of Northridge. The area is shown on Figure 10.1. Tank damage was extensive and occurred over a wide area. Effects on petroleum tanks are covered first, followed by the effects on water tanks.

The service area for this company is north and slightly west of Northridge, about 20 km from the epicenter. The area is a foothill setting, similar to the adjacent Newhall County Water District, and sets generally on each side of Interstate Highway 5. Three tanks failed and another was damaged. The location of the Valencia Water Company tanks is shown on Figure 10.1. Table 10.5 lists each tank and its characteristics and performance. All welded tanks were constructed to the AWWA Standard D100 or similar criteria. All tanks were 90 - 95% full when the earthquake occurred.

The service area for this district is located approximately 19 km almost directly north of the epicenter of the Northridge earthquake. It is set in a foothill region north of the fork of the State Highway 14 and Interstate 5 freeway. The location of the districts tanks are shown on Figure 10.1. Table 10.6 identifies each tanks characteristics and the damage sustained. It is believed that all tanks were at least 90% full at the time of the earthquake. All tanks were welded and were constructed to the AWWA Standard D100, or to criteria near equivalent. None of the tanks were anchored [45]. Figure 10.13 shows a tank which had a thicker annular ring and did not elephant foot.

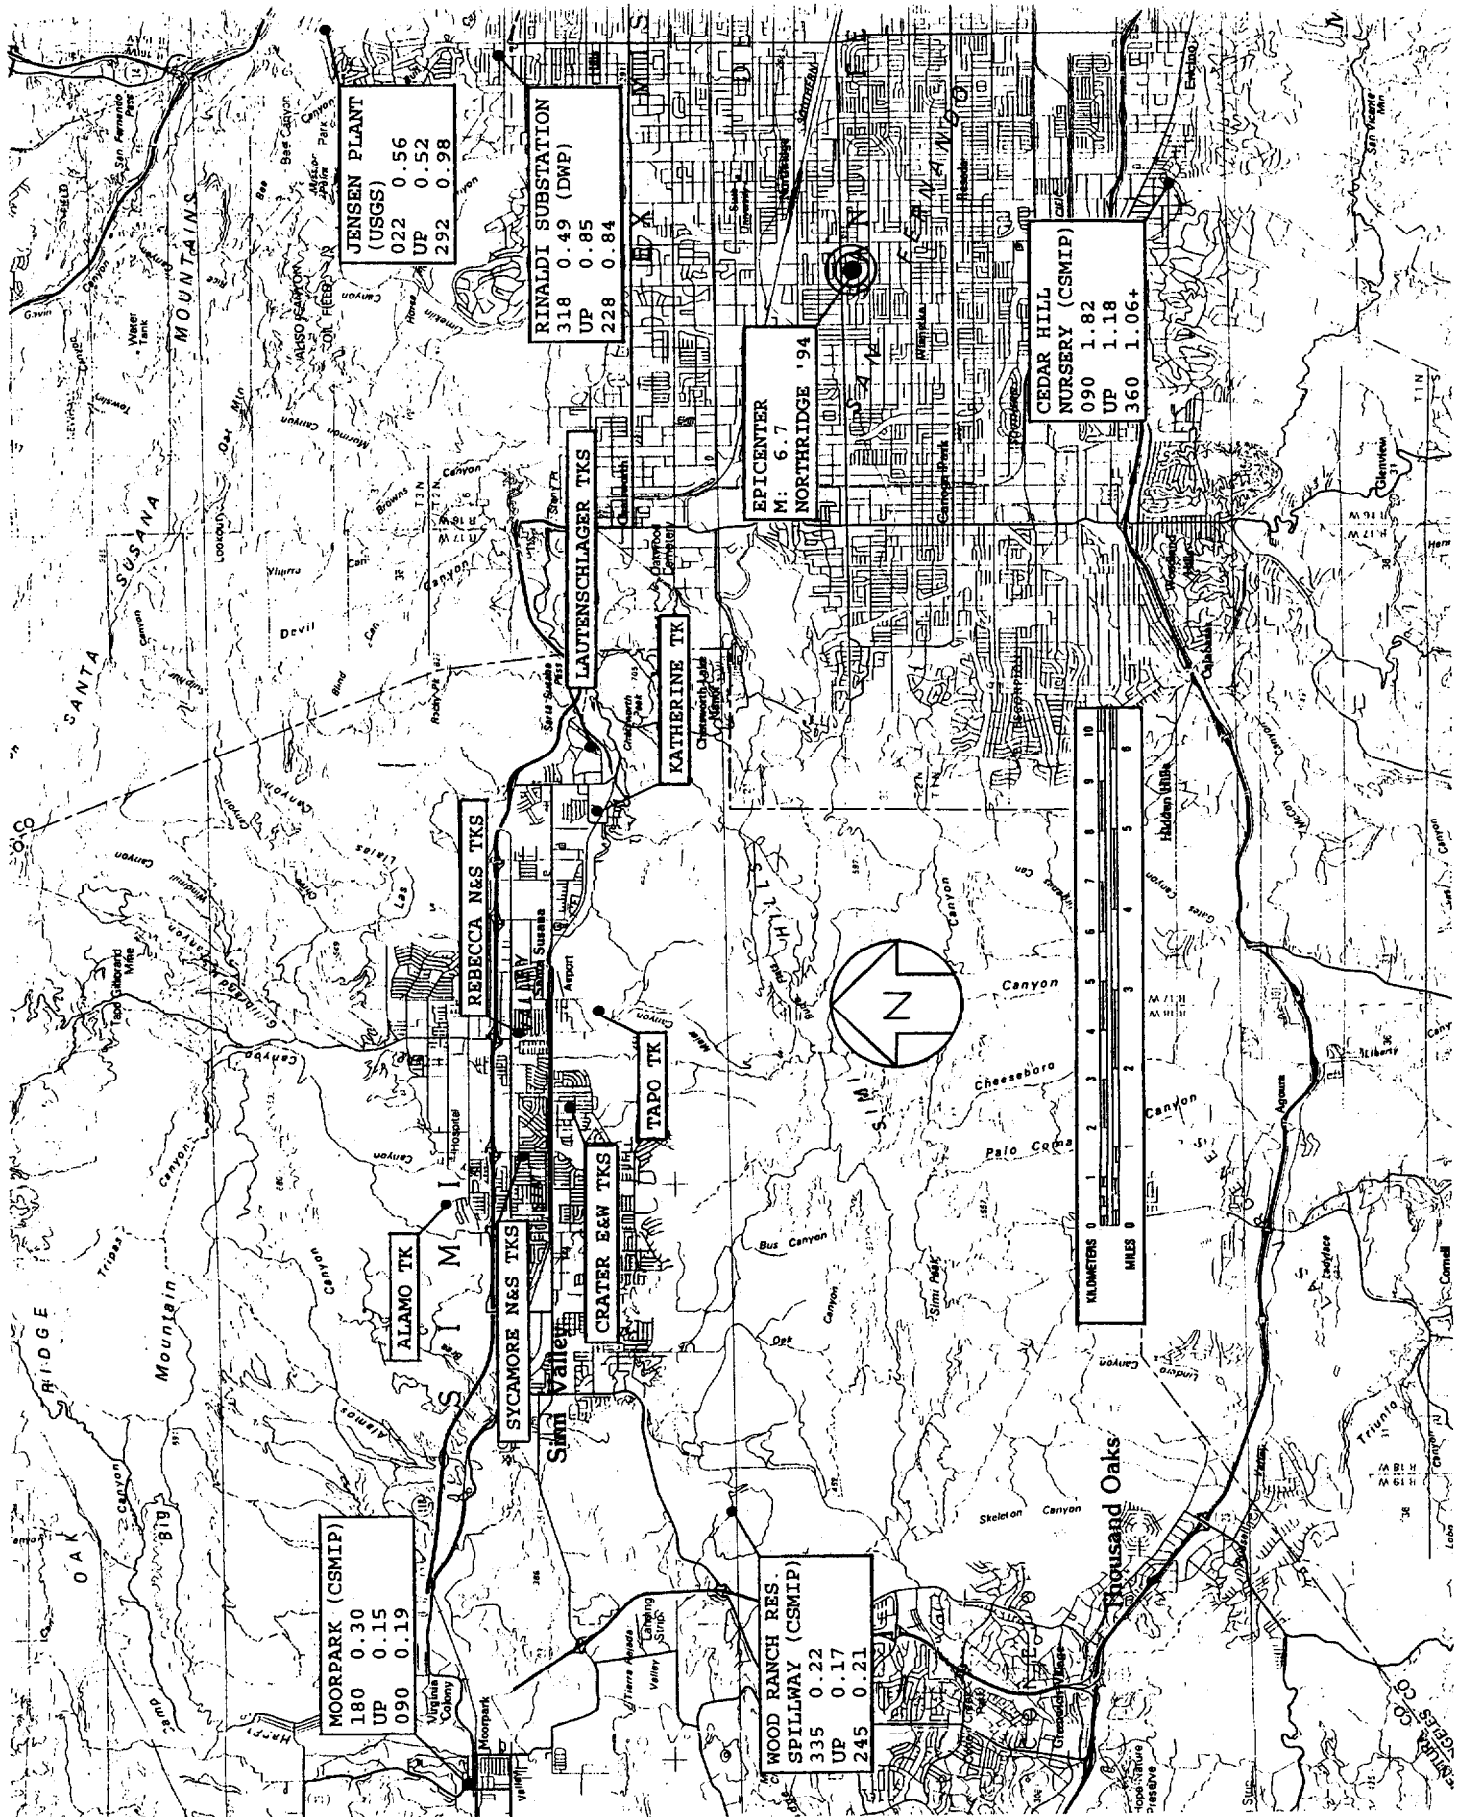
Figure 10.2 1994 Northridge Earthquake Area Map - Simi Valley

The Simi Service area of the SCWC lies west of Northridge, approximately 14.5 km from the epicenter, at the east end of the Simi Valley (see Figure 10.2).

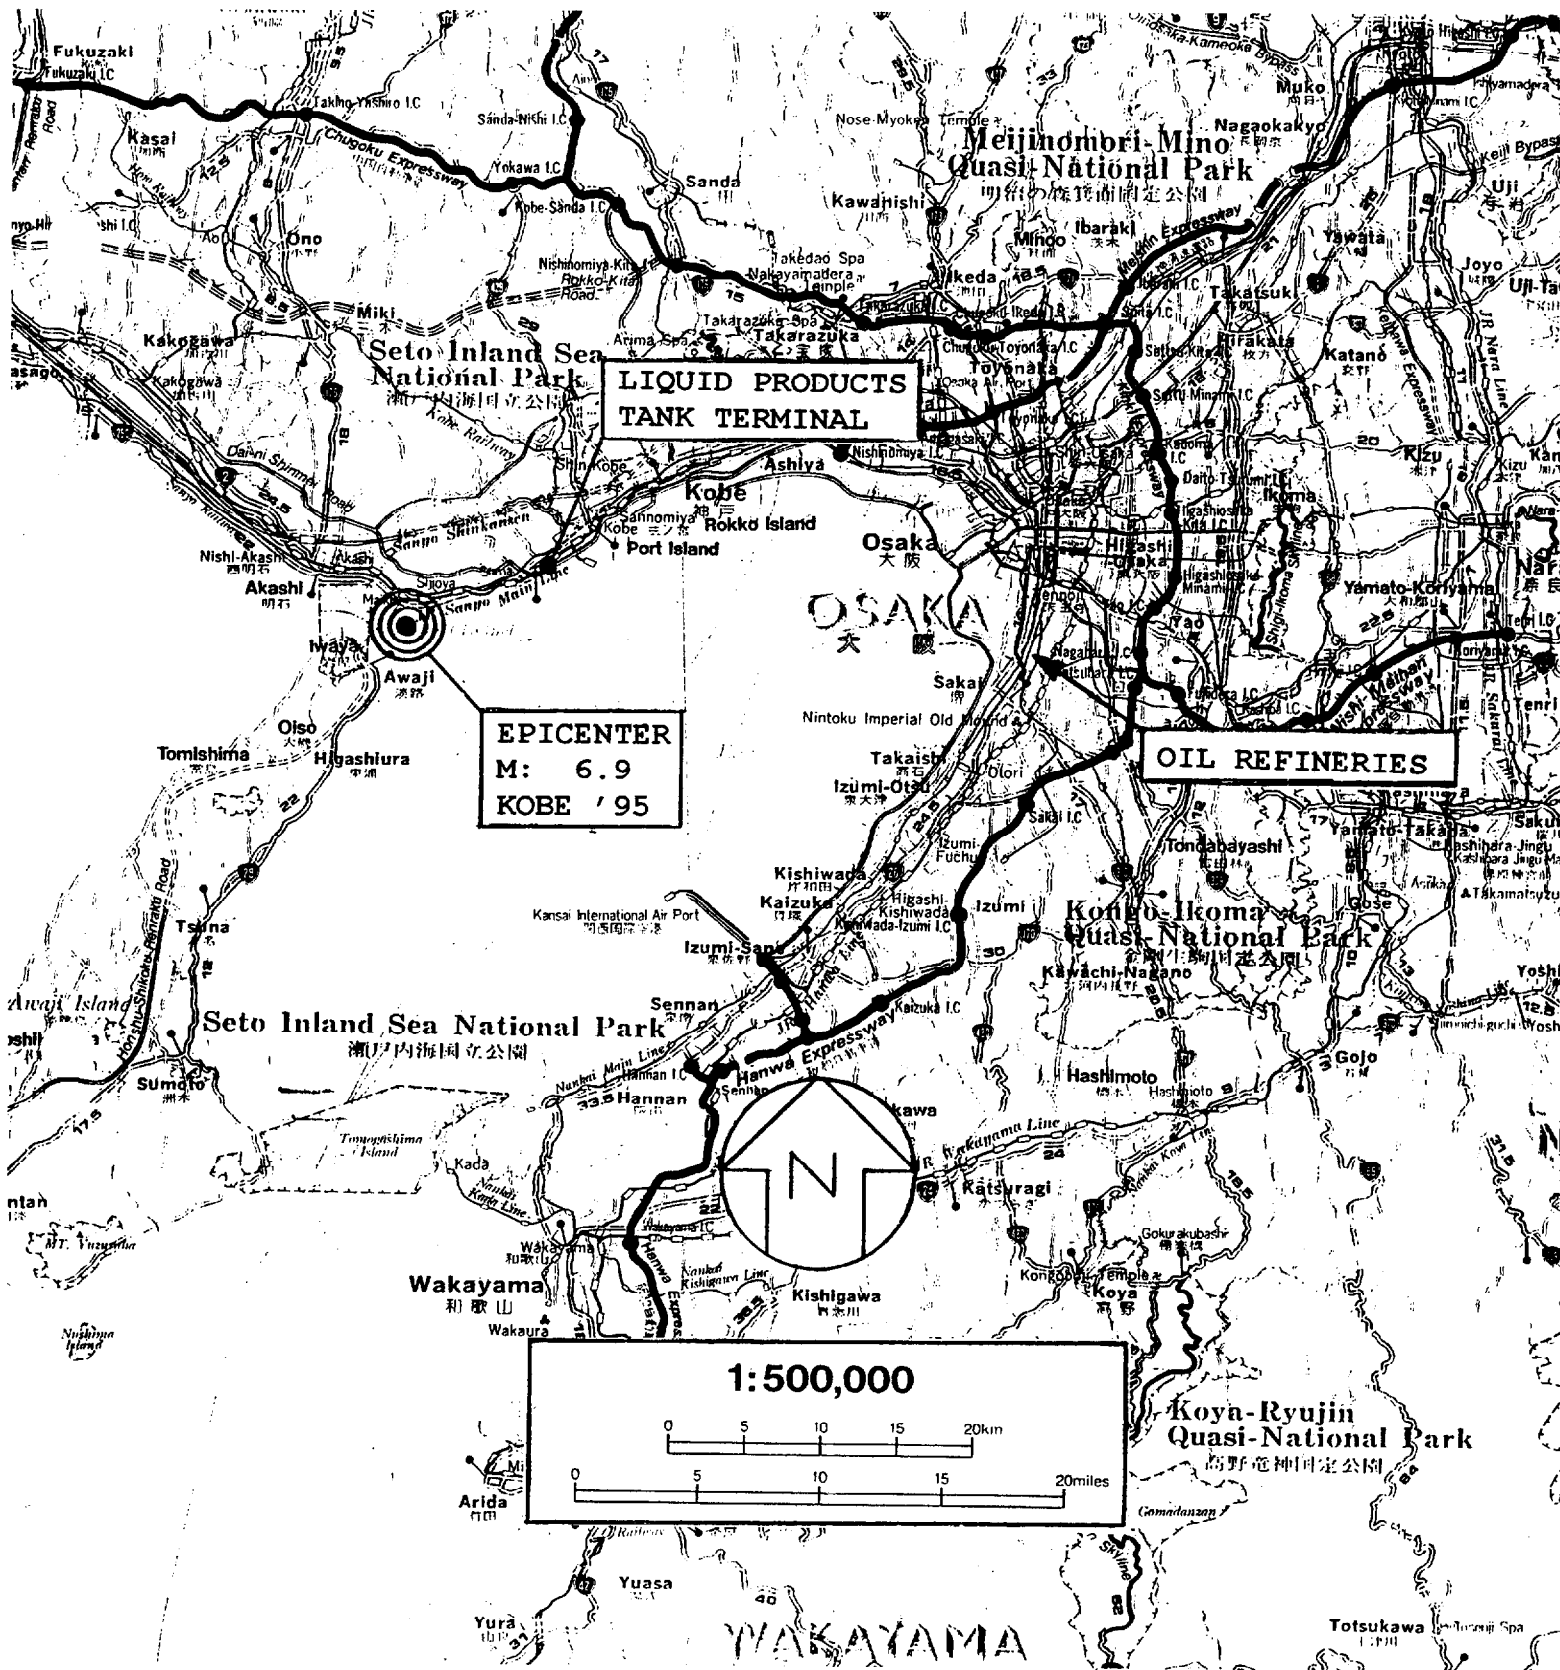
Figure 11.1 1995 Kobe Earthquake Area Map

A liquid storage tank terminal, about 10km east of the epicenter and on the waterfront, was damaged from site liquifaction. There was no loss of product from damaged tanks. This terminal is built on reclaimed ground and probably experienced peak accelerations of 0.6-0.8g. The terminal setting is 2-4km from active faulting. The damage is shown in Figures 11.2 thru 11.5, and consists principally of tank tilting, pipe support/piping loss of foundation supports, and walkway-platform loss of support. Figure 11.6 shows the seawall which is on two sides of the terminal, and some tilted tanks. Liquifaction was the principal cause of damage at this waterfront location.
