**RESULTS OF INVESTIGATIONS OF
FAILURES OF GEOTHERMAL
DIRECT-USE WELL PUMPS**

**U.S. Department of Energy
Contract No.: DE-FG07-90ID 13049 A007**

**Geo-Heat Center
Oregon Institute of Technology
Klamath Falls, OR**

December 1994

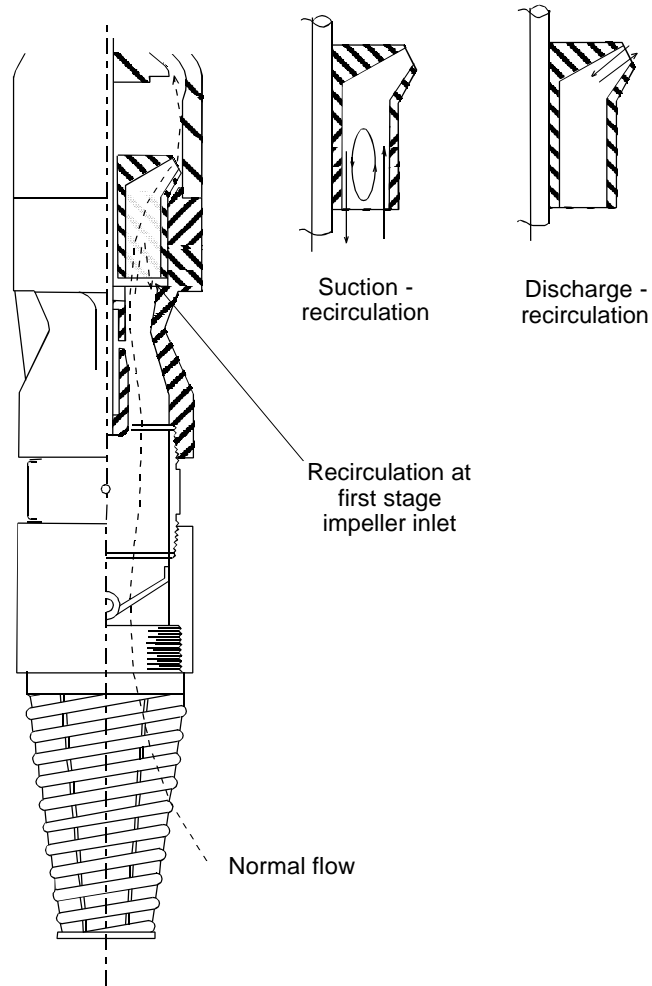
Internal recirculation (Figure 16) is a phenomenon occurring in all centrifugal pumps at certain reduced flows. This results in flow reversals in both the suction and discharge areas of the impeller. The result of these reversals is the formation of vortices creating low pressure and the formation of vapor bubbles in these areas. The subsequent collapse of these bubbles results in greatly increased vibration and pressure pulsations, and erosion of impeller vanes similar to cavitation caused by insufficient net positive suction head (NPSH), but on the hidden high-pressure side of the vanes instead of the low-pressure side.

Figure 16. Suction and discharge recirculation.

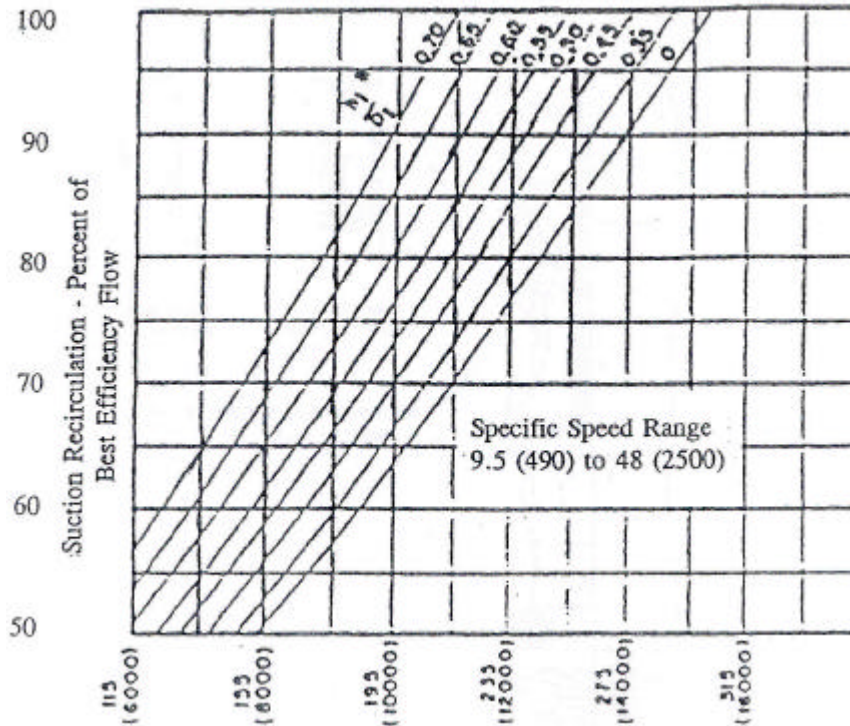
In 1981, W. H. Fraser published a paper (Fraser, 1981) presenting a mathematical analysis of the flow at which recirculation is initiated based on the geometry of the impeller; and graphs (Figures 17 and 18) that can be useful in initial selection and application of pumps and when details of the impeller design are unknown.

Although so far as is known, recirculation cavitation damage has not been noted on direct-use pumps; it may be that vibrations caused by recirculation are causing bearing failures and the problem is being attributed to bearing problems. The OIT pumps seem to provide at least circumstantial evidence of this.

Figure 17. Recirculation as a function of specific speed and the hub-to-eye diameter ratio.

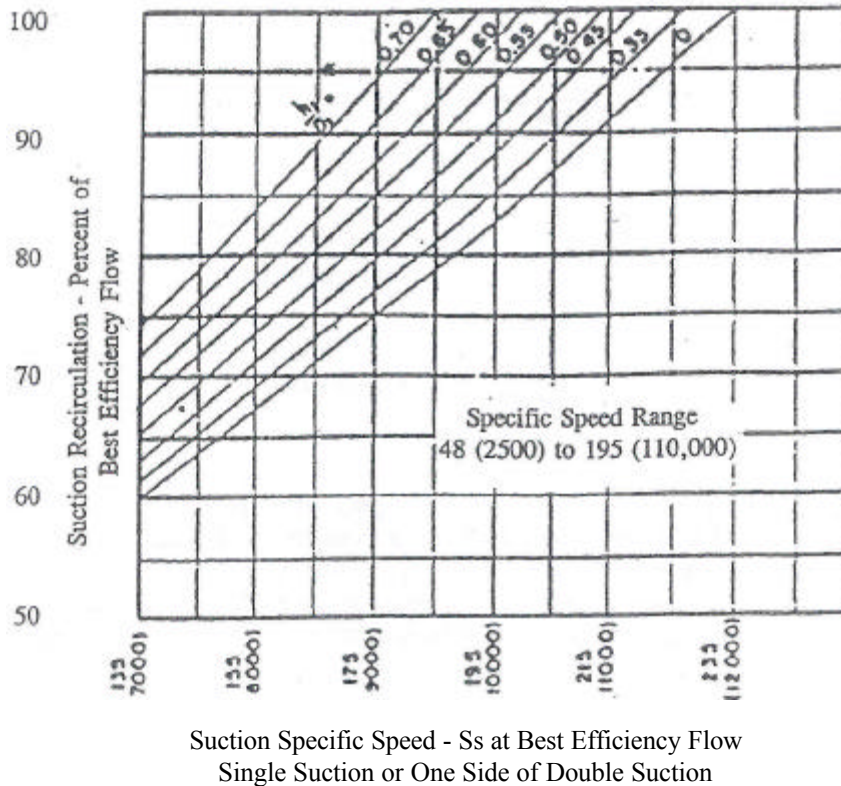
3. For pumps rated at 2500 gpm or less, the suction recirculation values can be reduced by 50 percent for continuous operation and by 75 percent for intermittent operation.
4. For hydrocarbons, the suction recirculation values can be reduced by 60 percent for continuous operation and by 75 percent for intermittent operation.
