Failure Report on HPR/CR at KEK/Nomura

SMTF meeting

6 October 2005

Takayuki SAEKI (KEK)

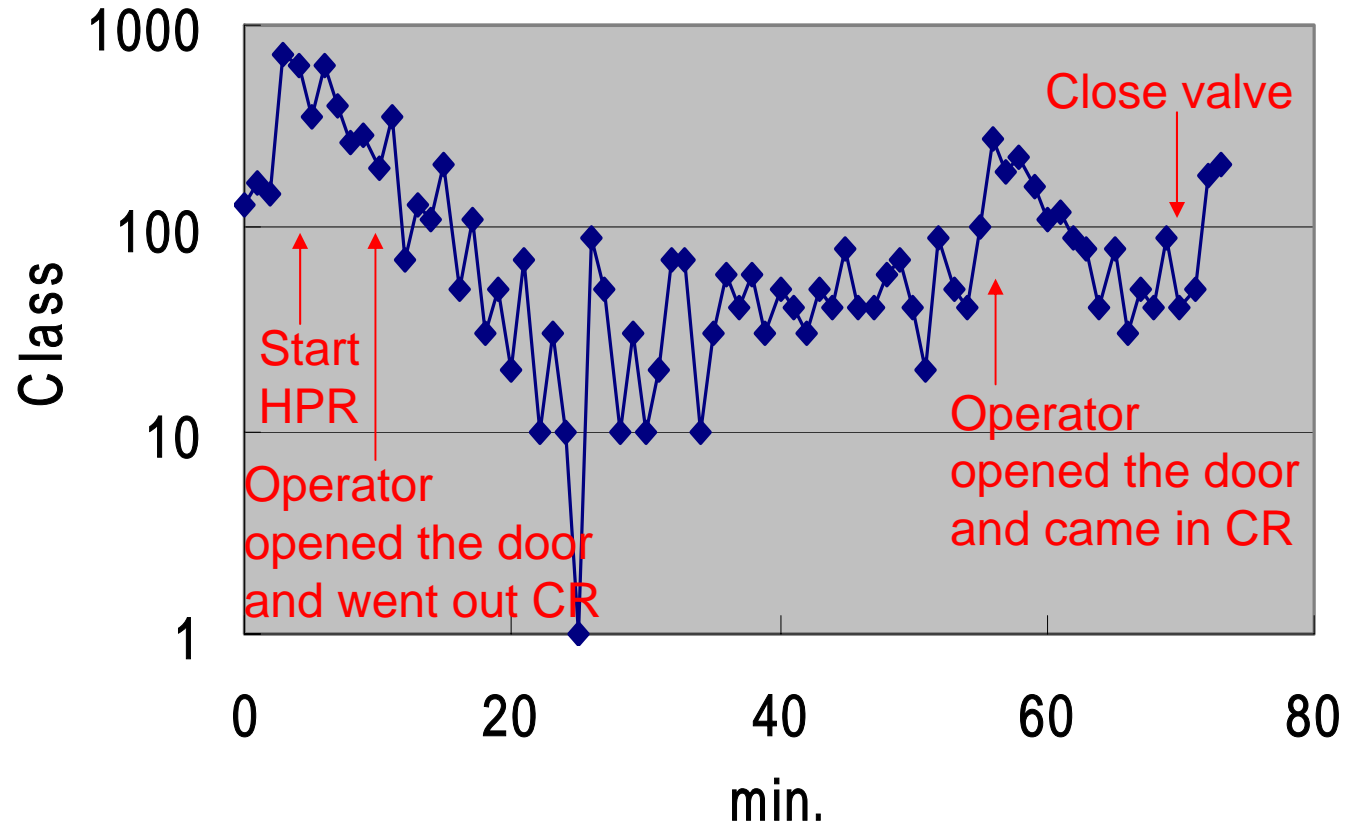
2005Sep14 Nomura HPR

RE cavity HPR at Nomura

Class = # of particles (>0.5 um) per CF

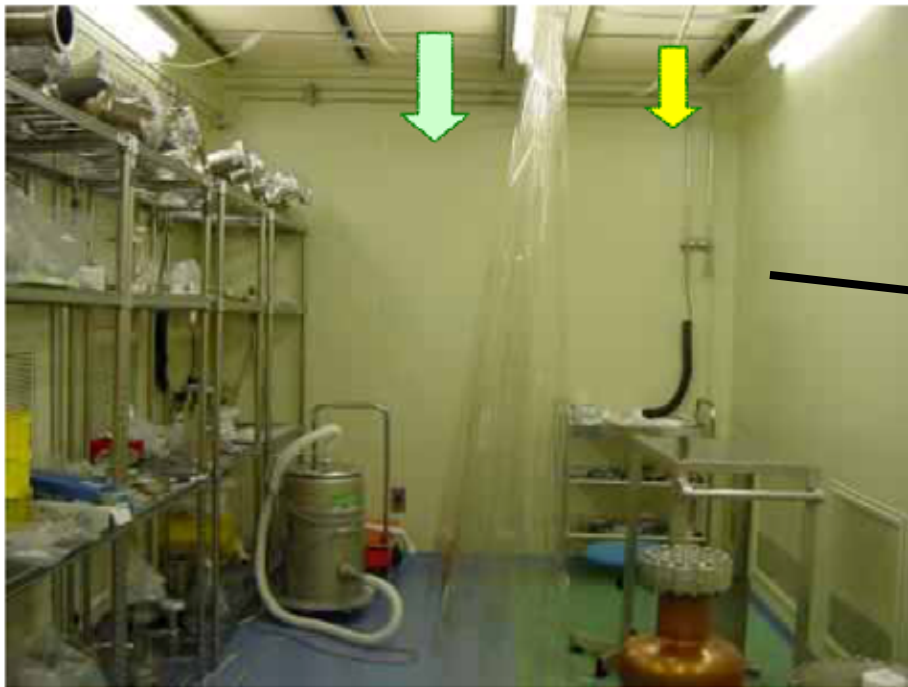
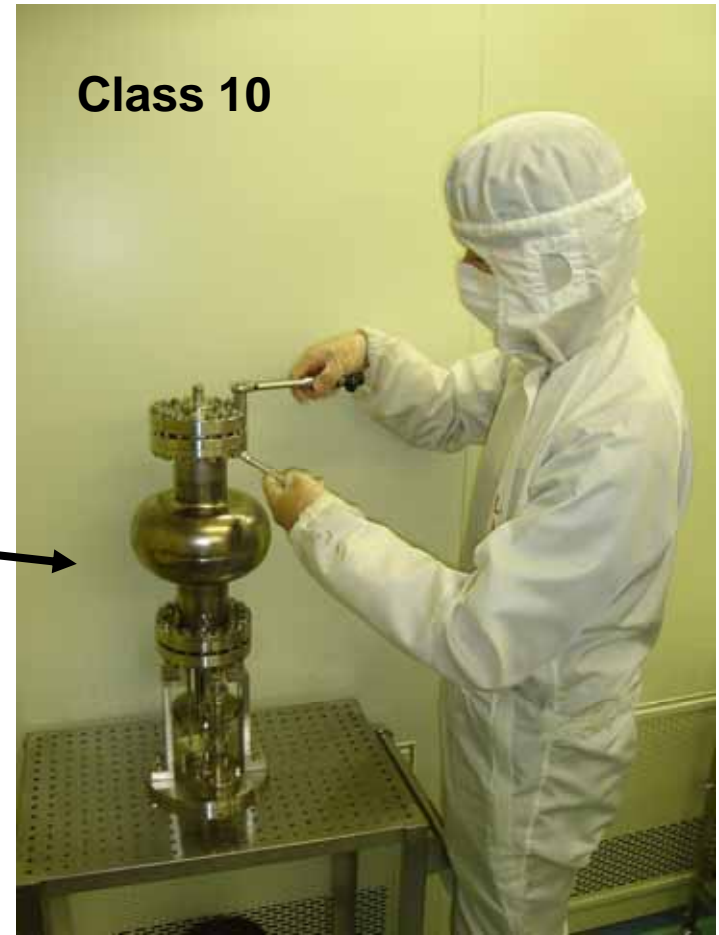
Clean-room at KEK

Assembly of cavity in clean-room at KEK

After HPR at Nomura (UPW),
KEK staff carries cavity to KEK
for assembly in clean-room.

HEPA filter (class 100)

ULPA filter (class 10)

- We cleaned up the clean-room at KEK (swept wall, floor, curtain...etc)
- Compared the cleanness of CR before/after the cleaning of CR by particle counter.
- It seems that cleaning CR does not affect so much in cavity performance.
- Operator's moving & acting calmly during assembly is most effective to avoid particle's going inside cavity.
- Also, cleaning CR-wear seems a bit effective.
