**NATIONAL TRANSPORTATION SAFETY BOARD**

**OPERATIONS GROUP FACTUAL REPORT**

**DCA 08 FM 002**

On Saturday, November 3, 2007 at approximately 0143 (EDT) the 819-foot, 62929 gross ton Bahamas-registered tank ship *Axel Spirit*, carrying a cargo of 441,000 barrels of Maya crude oil from the Petroleos Mexicanos (PeMex) marine oil complex in Cayo Arcas, Mexico to the Chevron facility in Perth Amboy, New Jersey, allided with Ambrose Light at the entrance to New York Harbor.

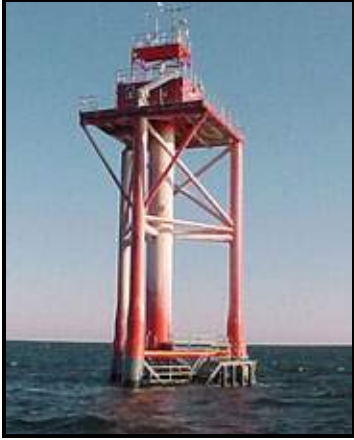
Fig 1. Ambrose Light (Prior to Allision)<sup>2</sup>

At 0143 the *Axel Spirit* struck Ambrose Light, causing extensive damage to the tower structure and the rotating beacon. The vessel incurred damage to its sideshell and internals above the waterline and at the turn of the bilge on the starboard side. Various accounts of the incident from each of the bridge team members described the close encounter with Ambrose Light. Some felt a vibration and others stated they saw a very bright light. Just prior to contact, the master gave a left rudder order to maneuver the vessel away and then, when Ambrose Light was close alongside amidships to starboard, he gave a right rudder order to swing the stern away.
