Investigation Report 474/06

Serious Marine Casualty

**Collision of CMV KLENODEN
with CMV HANJIN CAIRO
on 9 September 2006
in Hamburg**

15 July 2007

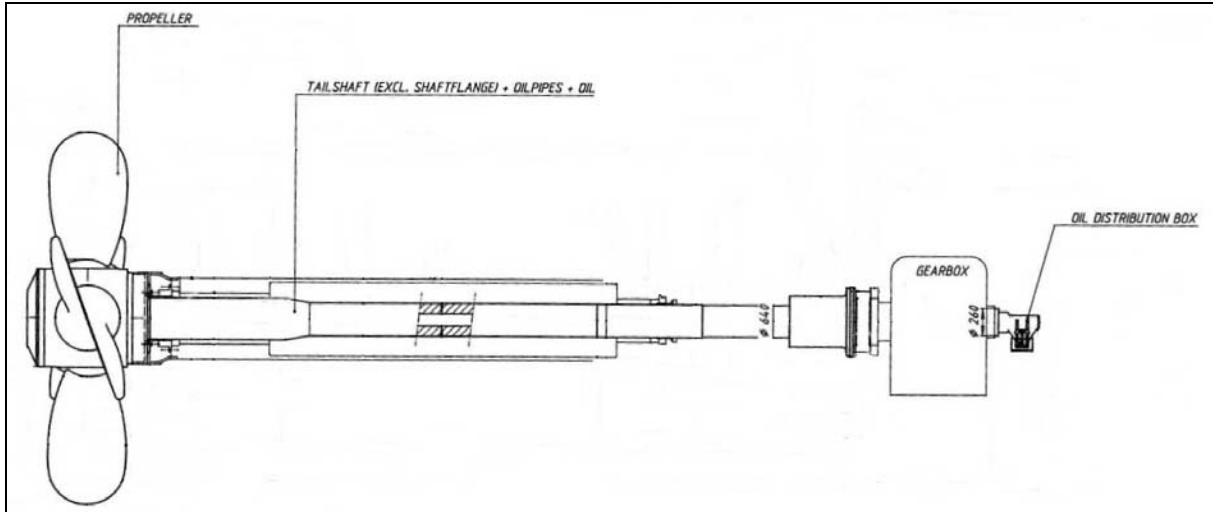
Figure 9: Schematic presentation of control system of the variable pitch propeller

The OD box of the pitch control system is located in the engine room on the outgoing power side of the main engine below the driving shaft (see fig. 9).

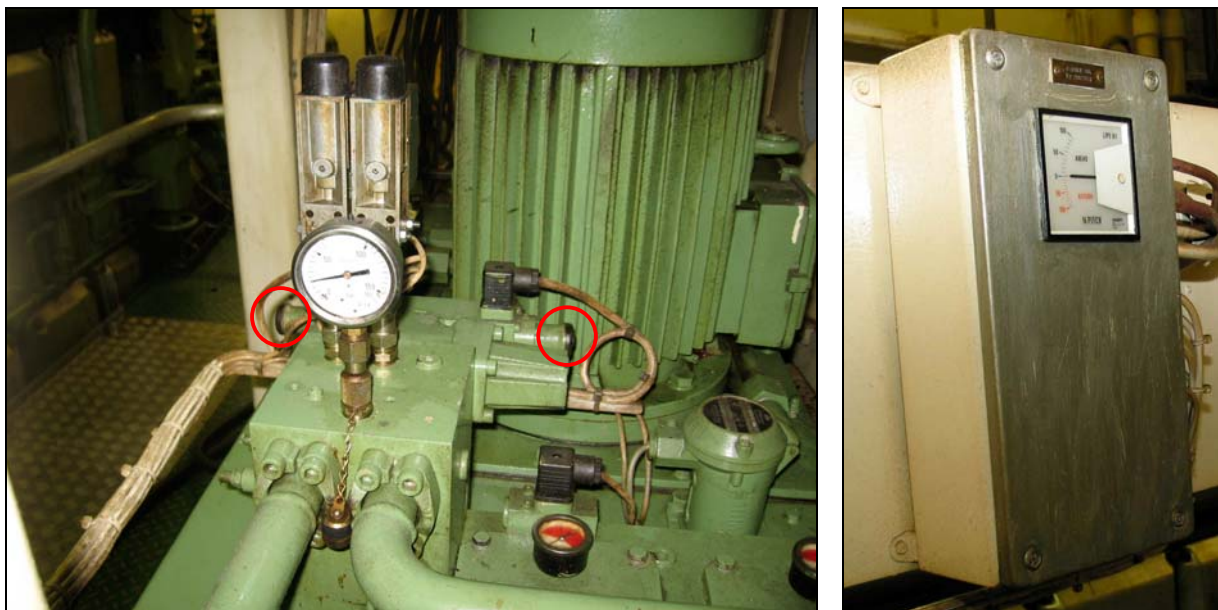
Figure 14: Pump station with pitch indicator placed above

The pitch of the propeller blades can be adjusted by operating the push buttons “Pitch Astern” and “Pitch Ahead” located below the remote indicators in the engine control room, on the bridge and in the wings of the bridge. The buttons are intended for emergency operation, as by their actuation the pitch limitation for the propeller blades is automatically suspended. In addition, there are buttons to push directly on the hydraulic pump station in the engine room intended for emergency operation. The pitch indication is mounted laterally above it (see fig. 14, push buttons marked by red circles).
