### III. Existing Conditions -- Truman Carriage House (HS-02)

#### Introduction and Description

HS - 2 TRUMAN GARAGE  
 HARVEY S. TRUMAN N. H. S.

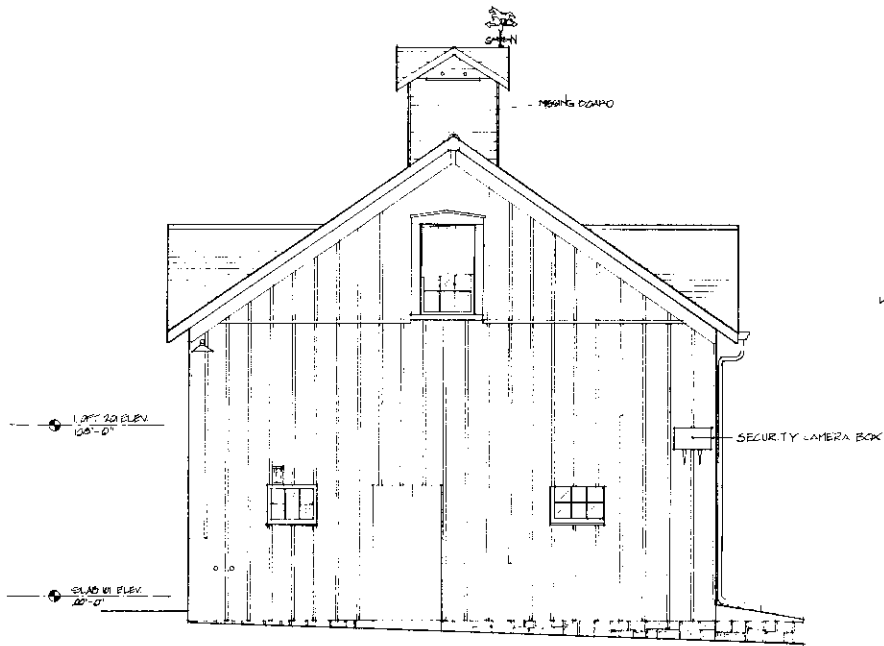
1 EXTERIOR ELEVATION EAST

The siding on the east elevation exhibits numerous open joints and missing or non-original battens. Relative to the west elevation, it is in poor condition. The edge is not in direct contact with the soil and is in sound condition.

The door at grade level on the east elevation consists of 3/4 x 5 inch tongue and groove wood boards fastened to a wood "Z" frame, and has two strap hinges secured to the siding boards at the south side of the opening. Like the windows, the doorway is devoid of casing and a finished frame. The top of the opening lacks any drip cap or flashing to protect the top edge of the door. Three siding boards adjacent to the door on the north side are loose and require refastening.

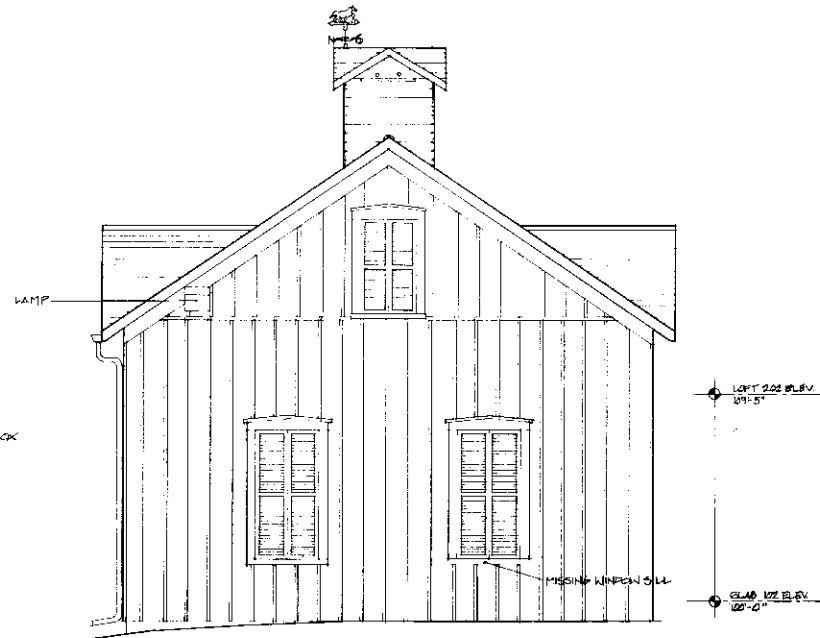
2 EXTERIOR ELEVATION WEST

The west elevation shares some of the same problems as the south elevation. The soil has been built-up 2 inches above the top of the foundation wall. Tall, thick bushes along the west elevation have compounded moisture problems by reducing ventilation and sun exposure. The only downspout on the building drains rain water at the northwest corner. Negative slope causes water to pond in this area.

Window casing at the jambs on the west elevation is plain wood  $1-1/8$  inches thick x  $4-1/2$  inches wide. The casing at the head is an unbroken pediment capped by a simple crown. The lower portion of the crown (cove

molding) is missing from the pediment of the north side of the north window.

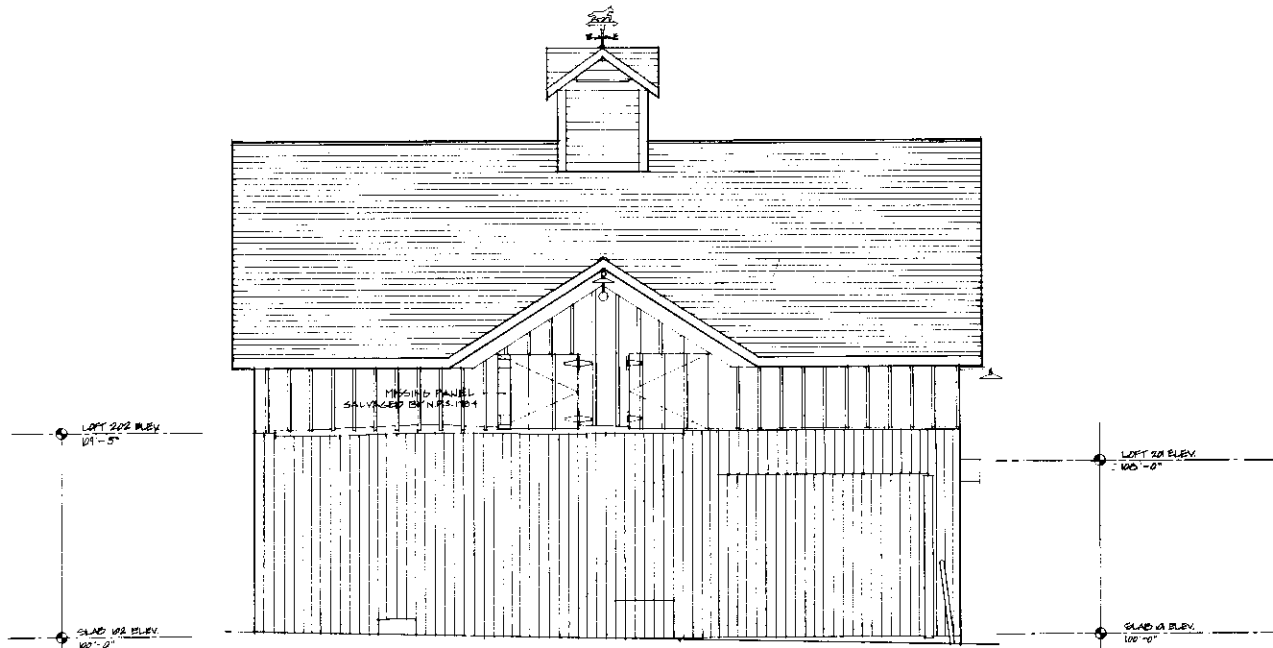
**EXTERIOR ELEVATION SOUTH**

Drainage around the structure is generally very poor. At the south elevation adjacent to the alley, soil and gravel has been built up to obtain positive drainage away from the Carriage house. Unfortunately, the exterior grade now rises above the interior grade of the concrete floor slab. This has led to severe deterioration of the siding, foundation sill and structural post bases. It appears that the exterior grade has been raised at least 20 inches along the south elevation with

layers of refuse waste, gravel and soil.

On the south elevation, two doors provide access to the loft. Both doors are board and batten and appear to be cut from the wall siding. The openings are without sills, casing, finished frame and drip cap or flashing at the head. The doors are secured with strap hinges and open toward each other. The west door is missing half of one board and one batten. The lower ends of the boards on both doors are split, checked, and require repair.

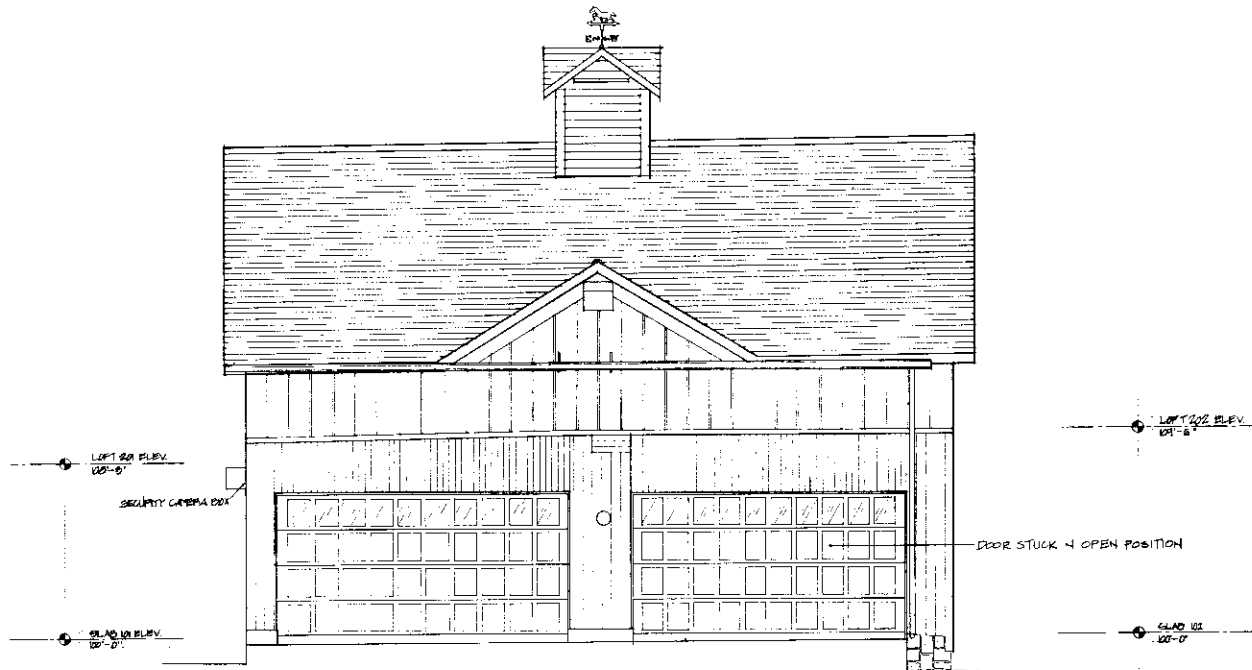
EXTERIOR ELEVATION NORTH

The sub-structure at the north elevation is completely encased in concrete slabs. There is good drainage from the structure here.

The two 7 foot x 13 foot 8 inch rolling overhead doors on the north elevation are in good condition except for the lower roller guides and pulleys which exhibit surface rust. The garage doors are paneled with the top panel glazed and are painted white. The doors are binding due to the shifting of the structure.
