Chapter 6:

Existing Conditions 2002

DRAWING 14: OVERALL EXISTING CONDITIONS PLAN

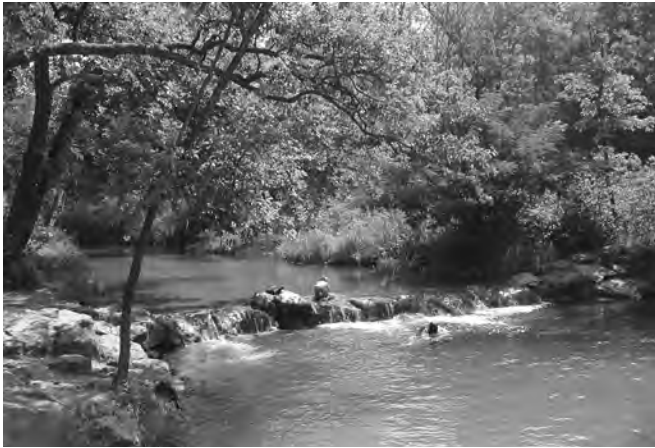
Figure 6-3. Upper dam at Bear Falls, 2002

Near Cold Springs Campground there are four boulder dams, two each at Bear Falls (Figure 6-3) and Garfield Falls (Figure 6-4). These four dams and their two swimming holes are some of the most heavily used in the park and their surrounds show significant compaction and bank erosion.

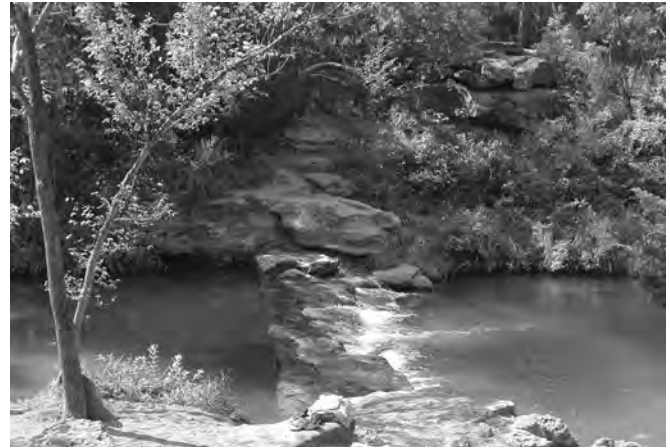
Figure 6-4. Lower dam at Garfield Falls, 2002.

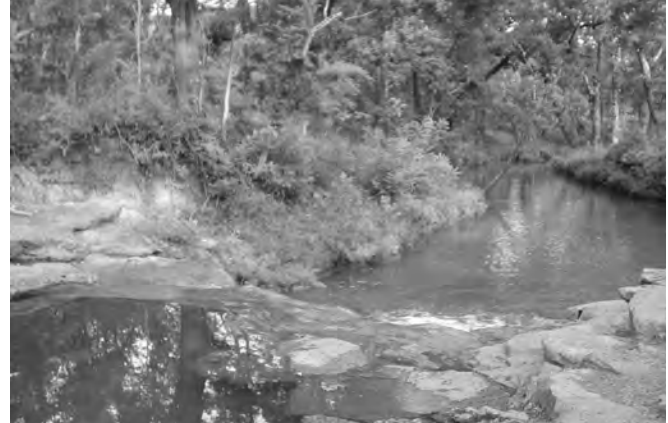
Adjacent to the east loop in Central Campground is the Central Campground dam (Figure 6-6). A shallow swimming hole is located above this dam. Though the

Figure 6-6. Central Campground dam and swimming hole, 2001.

approach down to this dam is heavily compacted, the area is less impacted from visitor use than are other swimming areas. A second falls is located downstream from the first; also used for swimming, this dam does not appear to have been constructed.

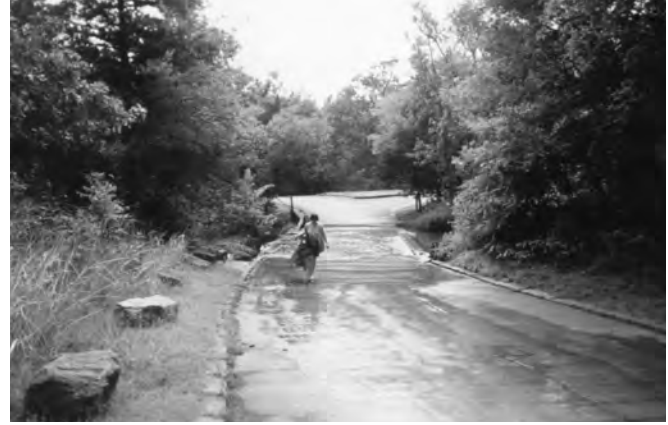
A one-way vehicular crossing occurs at Sycamore Falls, at the eastern edge of the component landscape (Figure 6-13). The crossing is a concrete dam topped by a flat concrete deck. A segmented stone curb lines the deck's downstream side and a continuous concrete curb lines the upstream side.

Figure 6-13. Sycamore Falls Crossing, 2001.

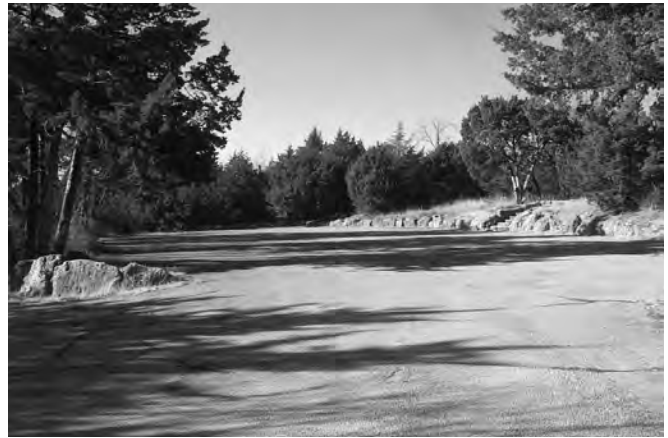
Figure 6-18. Bromide Hill Parking Area, 2004. Note historic stone walls.

Drawing 15. Vehicular access to Bromide Hill is provided by the perimeter road and a small oval parking area at the top of the hill (Figure 6-18).

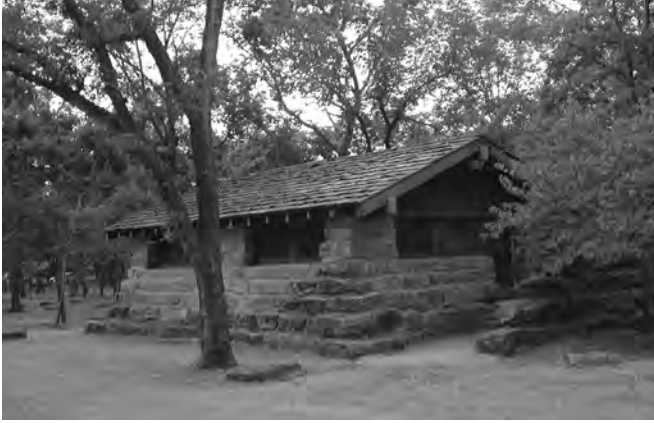
Figure 6-19. Bromide comfort station, 2001.

The Bromide Springs comfort station, located south of the 12th Street fountain, is in relatively good condition but its roof has been altered. Alterations include the conversion of the roof line to a simple gable (Figure 6-19).

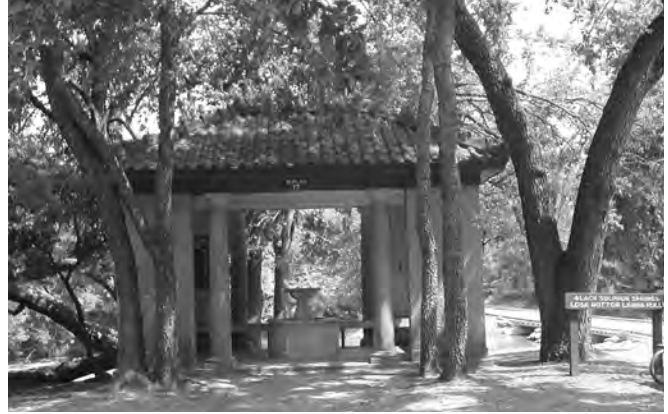
Figure 6-32. Black Sulphur Springs Pavilion and surrounding trees, 2001.

Black Sulphur Spring Pavilion (Figure 6-32) is the only historic structure in the area. The pavilion is in fair condition, as the building's stucco finish likely needs protection and lead abatement. The structure's metal tile roof has also deteriorated. The pavilion's central fountain has been filled with concrete and its water supply turned off.

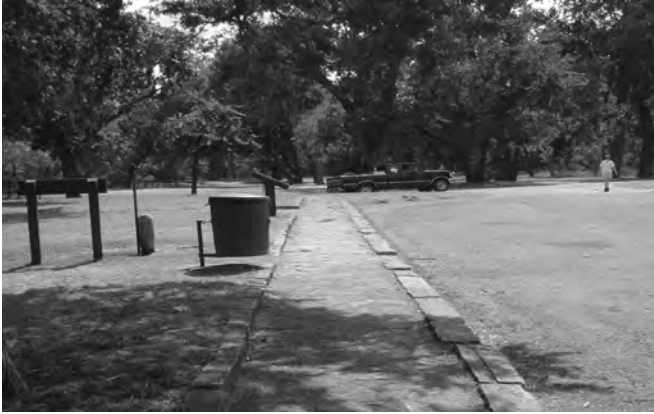
Figure 6-33. Black Sulphur Springs parking area, with stone curb, 2001.

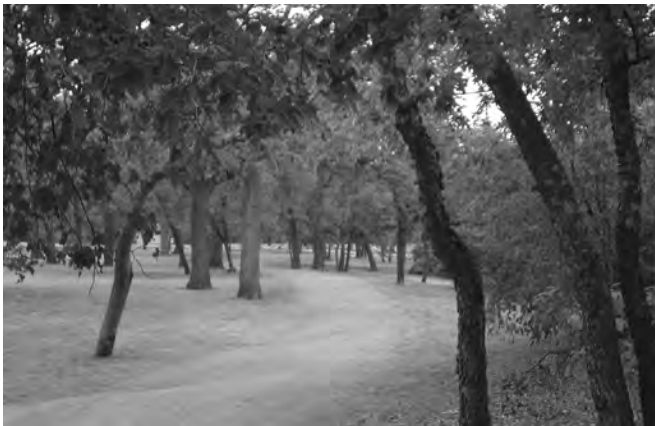
Figure 6-36. Compacted gravel path in western part of Flower Park, 2001.

The most important circulation system in Flower Park is the network of compacted gravel paths (Figure 6-36) that cover the entire site and shown on Drawing 17. The path system is accessed at the Vendome parking lot, Lincoln Bridge, and the main entrance at Broadway and Highway 177. Much of this network exists along the original alignments depicted in the 1936 survey of the

area. However, some sections have widened and/or shifted over the years, apparently a result of accommodating drainage pattern changes. This is noticeable, for example, at the base of the hill in the northeastern part of the park. In some areas concrete pads have been constructed over areas subject to path erosion during large storm events. In most areas, paths blend seamlessly into turf. However, in a few areas, original stone curb edging, spaced four feet apart, may be seen within an existing path cross section. While it is presumed much of this curbing has been lost, a good deal may remain *in situ*, having been buried over time. Two sets of stone steps traverse the hill behind the comfort station. These steps are in fair condition, their treads deteriorating due to erosion of their gravel surfaces. The steps both lead to a pathway which terminates at the Vendome parking lot, and stone edging is very apparent along this path segment. Only one original pathway in the whole park has been lost, replaced by a new pathway along the northern edge of the upper wading pool.

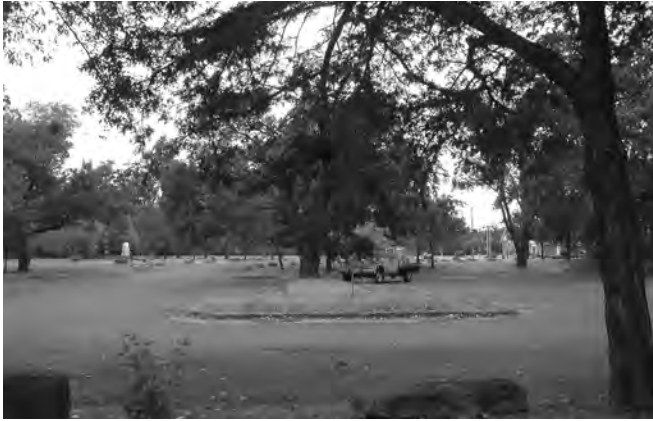
Figure 6-37. Vendome parking area, 2001.

Vehicular circulation in Flower Park is limited to the Vendome parking lot (Figure 6-37), which accommodates about 100 cars, which is more than adequate for regular visitors. However, the lot will be slightly redesigned as part of the new Visitor Center project and may provide less parking area. The parking lot is currently accessed from a boulder-lined entry off Broadway Avenue. The lot's asphalt surfacing is deteriorated and its stone curbing is failing in a few, though not many, locations.

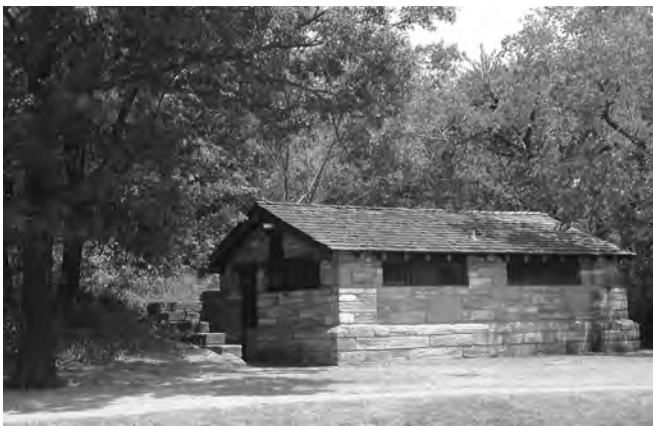
Figure 6-38. Flower Park comfort station, 2001. Photo was taken prior to 2004 pathway restoration.

Three historic structures are extant in Flower Park. The Flower Park comfort station (Figure 6-38) is located at the base of the southwest slope of the hillside in Flower Park. The building is in relatively good condition though the original hip-on-gable roofline has been altered to a simple gable. The Gothic-Revival style Lincoln Bridge (Figure 6-39) is still an elegant entry feature to Flower Park and is in good condition despite its age. The bridge retains four flagpoles installed in 1976, replacing those removed in the 1930s. The Main Entrance, in contrast, has seen more change. The gateway's original, semicircular stone walls and two large piers were damaged and removed in the 1970s. Today only a pair of low piers and walls flank both sides of Highway 177.

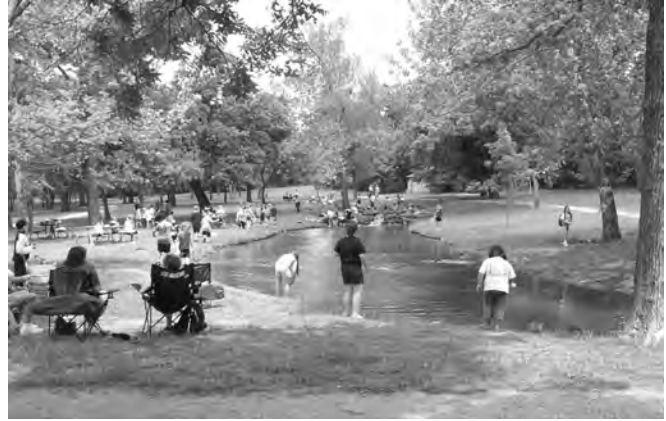
Figure 6-41. Lower pool and comfort station from Lincoln Bridge, 2003. Both lower and upper pools are narrower than in 1940.

The central feature of Flower Park is the Vendome stream, dams and wading pools. Created by the Vendome Well, the stream travels under the Vendome parking lot and emerges just east of the parking area to flow through Flower Park to cascade into Travertine Creek. Today the stream is in fair condition. Stream and pool edges are somewhat eroded due to foot traffic, water action, and the use of weed whackers along the banks. Some of the six dams along the stream are slowly being undermined. Algae bloom is something of an unattractive nuisance in the upper wading pool (Figure 6-40). Both pools are smaller than originally constructed, having been filled in (Figure 6-41).

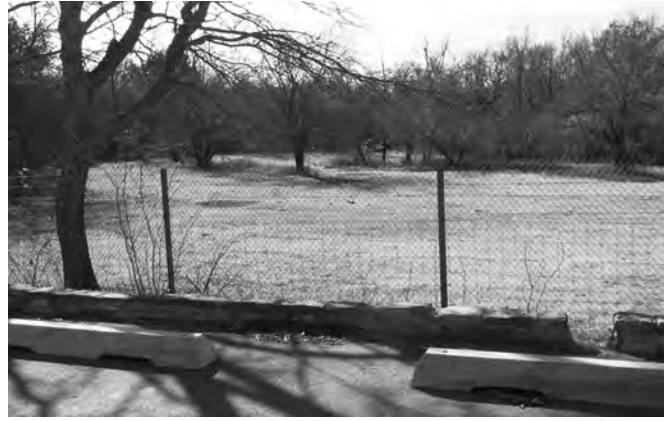
Figure 6-43. Stone wall at the Buffalo Pasture parking overlook, 2004.

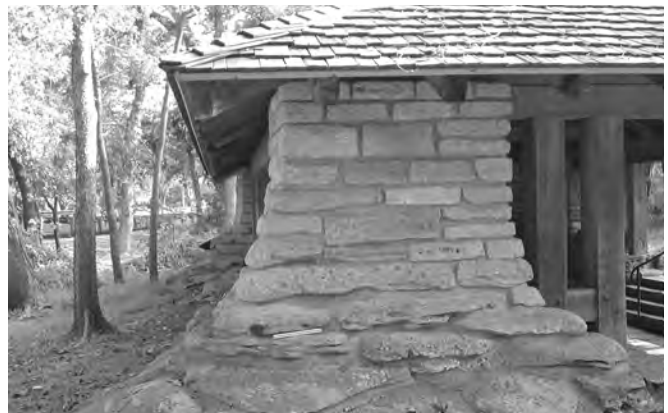
Figure 6-49. Construction detail, including buttressed wall and shake roof, 2001.

The Pavilion Springs Pavilion is roughly thirty by fifty feet with a sub-floor and wall footings constructed as monolithic slab of concrete. The Pavilion has a hipped roofed with the wood-shake shingles (Figure 6-49); this was done in December 2000. The focal point of the open pavilion is the large oval boulder from which water of the "Big Tom" spring flows into a small rectangular pool below. A low stone bench lines each interior wall.

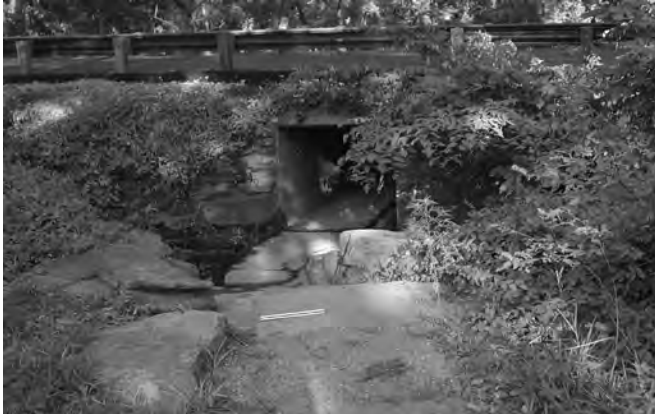
Figure 6-50. Highway 177 underpass at Pavilion Springs, 2001.

The Pavilion Springs underpass (Figure 6-50) is built of concrete and of limestone masonry and is in good condition, though there is some spring seepage through its walls. As noted above, it is part of the area's circulation features. It is also an expressive drainage feature. Water is drained from the basin below "Big Tom" and emerges outside the pavilion to mingle with small streams created by other springs in the hillside. These springs emanate from the line gaps in the stones surrounding the steps to the underpass. All drainage eventually collects and runs through the underpass in a runnel that merges into a small "tributary" running downslope toward Rock Creek. The runnel parallels the flagstone walkway and is in good condition.

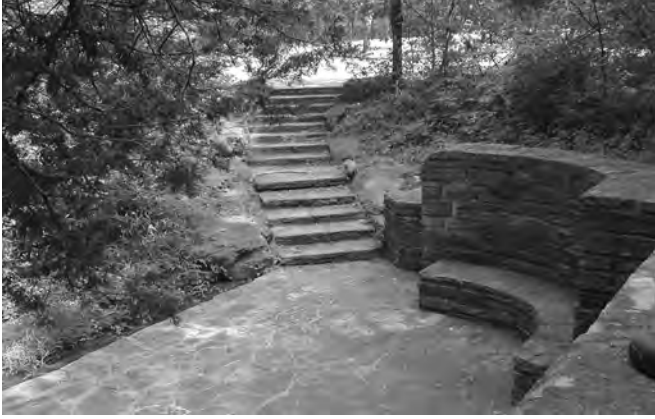
Figure 6-54. Stone steps leading to the Hillside Springs parking area, 2002.

Stone steps (Figure 6-54) lead from the parking area to the spring. These masonry steps are lined with boulders. A second flight of steps to the former Headquarters are much longer and combine masonry steps with longer treads with eroding gravel surfaces. These steps are also lined with boulders. Stone curb and granite fine walkways line the parking area and a stone retaining wall holds back the slope on the southern side of the parking area.

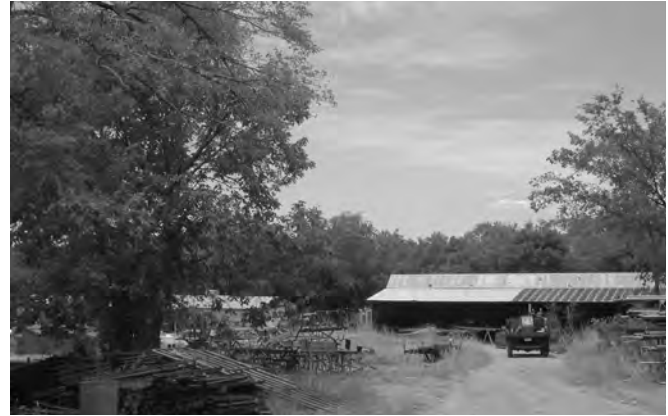
In the maintenance yard to the west are numerous storage buildings (Figure 6-62). Only one of these is historic: the earth-sheltered powder magazine. This concrete rubble masonry building was used as a storage building for explosives during the CCC era and later served as a chemical storage area. It is no longer in use. There are numerous other metal and wood buildings. These include 3 storage buildings and a tank fueling station just west of the warehouse. Further west is Building 128, housing a metal/welding shop and wood and mechanical supplies. Building 126 is a wood shop. Buildings 127 and 129 are storage buildings. On the south side of the maintenance area are horse stalls and a small hay shed; these are just west of the historic powder magazine and a second, non-historic underground storage area.

Figure 6-62. Shop yard with buildings and outside storage, 2001.

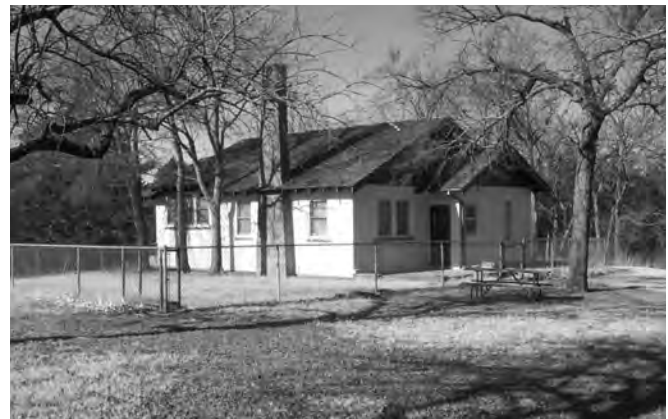
Figure 6-63. Residence 2, 2003.

Residence #2, one of two pre-CCC-era residences surviving today, is a gable-roofed, one-story residence thirty-two by thirty-five feet and is of wood frame construction. Remodeled by the CCC in 1935, today the building is finished with cream-painted stucco, a wood shingle roof and wood gable ends, stained traditional NPS brown.

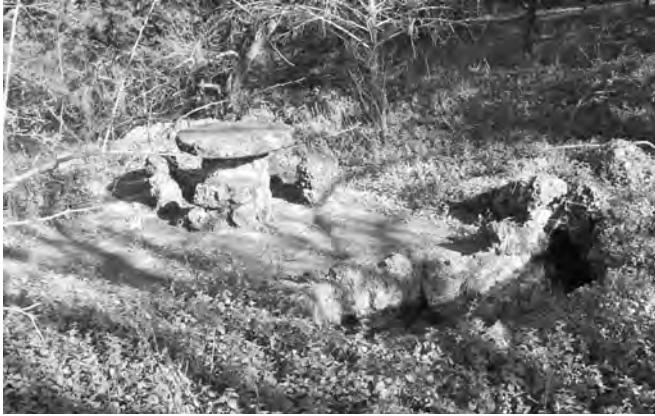
Figure 6-64. Stone table, benches and pond at the Employee Residence, 2003.

A small stone table, flagstone patio, benches and pond (Figure 6-64) are located about 100 hundred feet northeast of the house on the slope of the hill. The stone tabletop is five feet in diameter and has four curved benches; the pond is about five feet long and is filled with stagnant rainwater.

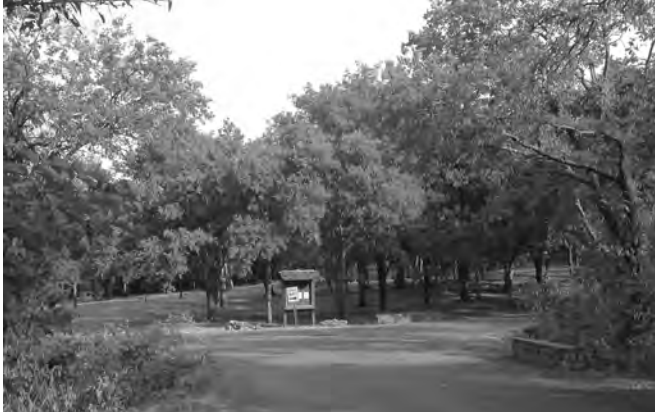
Figure 6-65. Eastern loop of Central Campground, 2001.

However, the trees in these camping areas are not in the best condition, having clearly been impacted by soil compaction over the years and storms of recent years. This is particularly evident in the west loop, where a lack of shade and numerous stumps attest to recent tree losses. Cedars along the north and east boundaries provide some buffer from the adjacent residential area, but in some places the road and houses beyond the campground are quite evident.

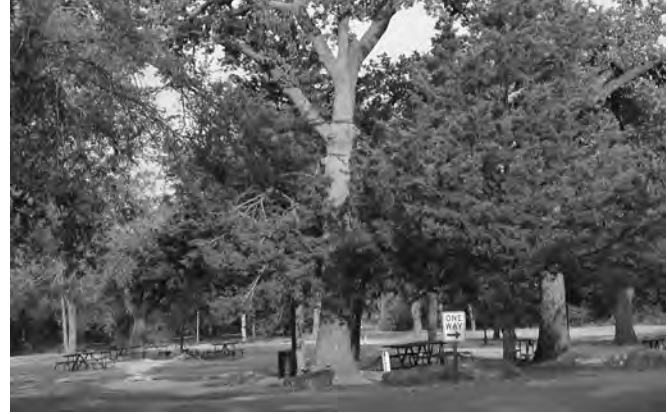
Figure 6-66. Western loop of Central Campground, 2001.

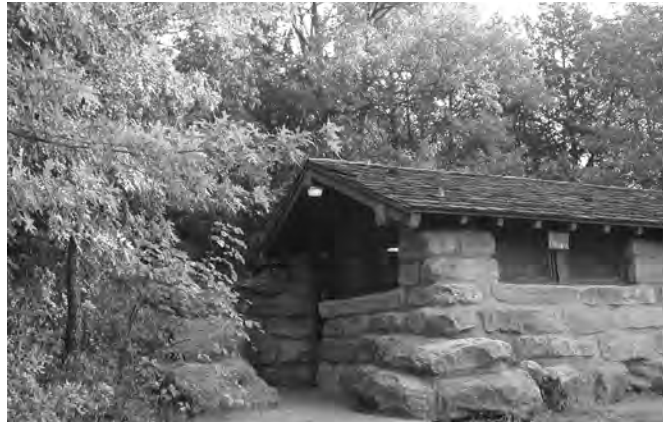
The only major structure in the component landscape is the Central Campground comfort station (Figure 6-67), which is similar to the comfort stations in Cold Springs campground and displays the same roof change as the other comfort stations in the district. Located at the northwest "corner" of the eastern loop, the structure is built into the slope behind it. The setting in front of the building is somewhat compromised, since asphalt paving meets the building edges. A "No Parking" sign is therefore prominently placed in front of the building.

Figure 6-67. Central Campground comfort station, 2001.

The building underwent lead abatement and received a new shingle roof in 2002-2003.

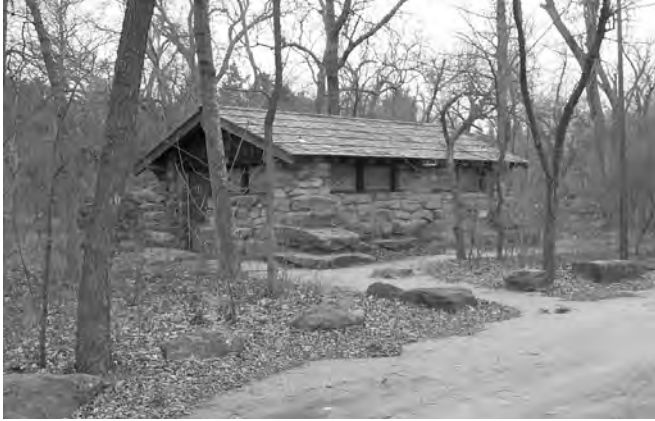
Figure 6-70. Typical Cold Springs comfort station, 2003.

The two comfort stations (#29, in the western half of the campground and #30, in the eastern half) are excellent examples of rustic NPS park architecture (Figure 6-70). Changes to their exteriors include a change from a hip-end gable to a simple gable roof.

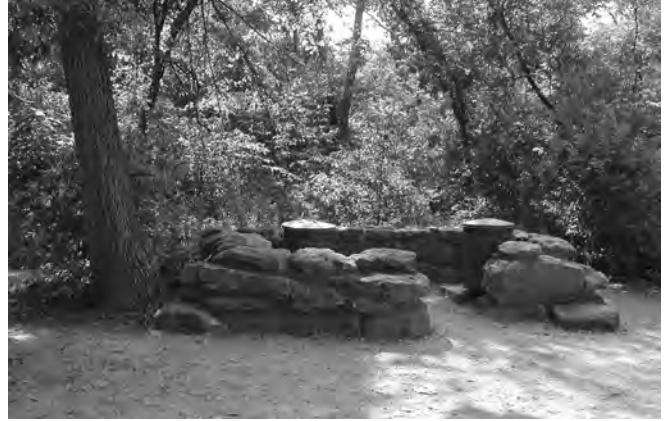
Figure 6-71. Historic wood and trash can holder typical at Cold Springs Campground, 2002.

Extant small scale historic features include nine stone-walled containers (Figure 6-71) that hold garbage cans. The enclosures are approximately three feet high, four-sided, square to rectangular in shape, with an opening in the wall facing the road. In the original design, a water faucet was attached to the front face of each enclosure; today only one of the structures has a functioning hydrant attached. Other hydrants are located throughout the camp to supply water for campers.

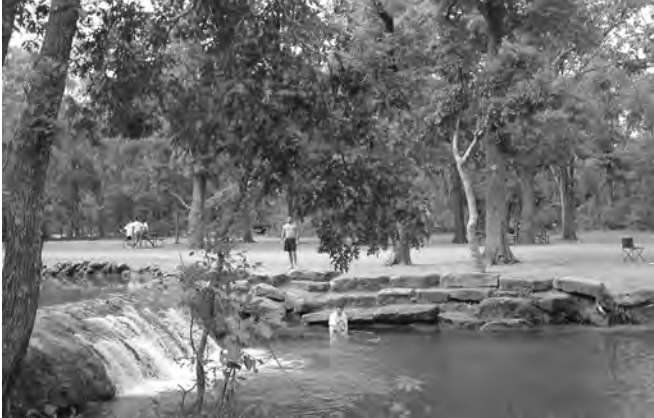
Figure 6-72. Upper dam and swimming pool at Little Niagara Falls, 2001.

Little Niagara Falls is composed of two dams which create a large and popular swimming area. Despite heavy use, the area is in relatively good condition, though the stream bank edges are highly compacted around the southern edge of the pool area.

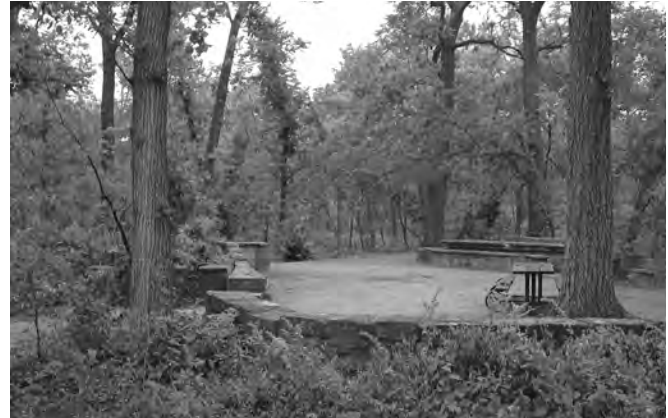
Figure 6-73. Large picnic area with stone tables on Travertine Island, 2001.

On the west side of Travertine Island there is also a stone-enclosed picnic area about forty-five by ninety feet. There is a stone seatwall embracing the area, two stone tables with stone benches and an adjacent "counter" or food preparation area. Garbage cans are located near the enclosure's entrance. In general, the masonry on all these features is in need of repair. Stones are spalling and mortar is cracking. Some elements are missing. For example the food preparation counter's storage area for

firewood has been filled in. Remnants of a third circular stone table and stools are extant but not complete. Stone and travertine steps leading from the enclosure down to the stream environment are badly deteriorated and overgrown with vegetation. Another circular stone bench is located on the end of Travertine Island near the lower Niagara Falls dam and across from the modern comfort station. This stone seat is also in poor condition, cracked and covered with underbrush.

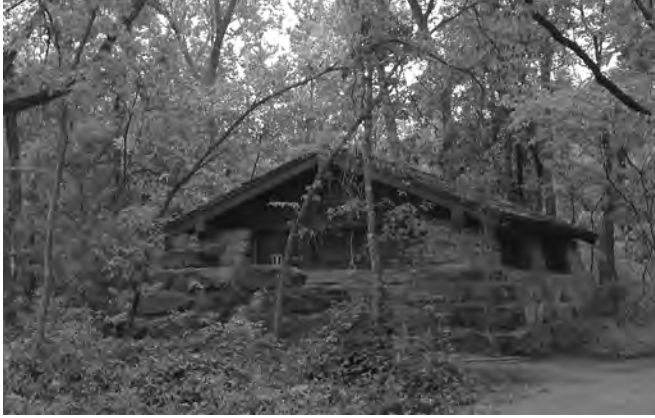
Figure 6-75. Historic Travertine Island comfort station, 2001.

the park's largest trees are located in the area, though far fewer than existed prior to the ice storm of 2000, when numerous large trees were lost. This is particularly true around the Travertine Island Comfort Station, which has lost its wooded setting and feels rather denuded, despite rapidly regenerating understory. Better quality understory and overstory vegetation is located around the northern parking area, which retains a more wooded feeling.

There are only two major buildings at Travertine Island and Little Niagara Falls. The first of these is the Travertine Island comfort station (Figure 6-75). This is an NPS Rustic comfort station similar to those at Cold Springs Campground and is in relatively good condition. It was re-roofed and lead abated in 2003. The second structure is the Mission 66 comfort station. Located close to

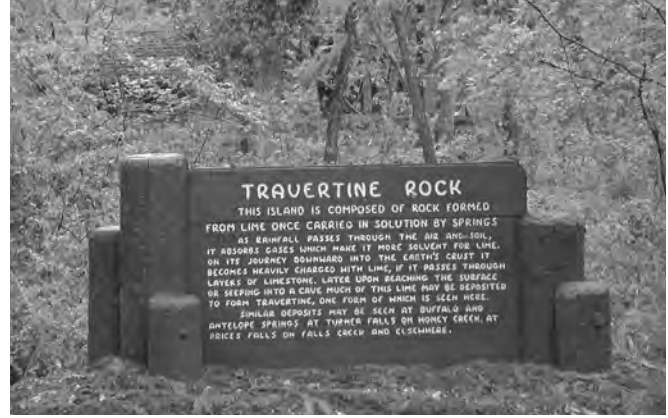
Figure 6-76. Original 1930s interpretive sign, 2001.

Across the path from the large stone picnic area is an extant interpretive sign describing travertine formations (Figure 6-76). The rectangular sign, roughly forty-six by seventy-six inches, is constructed of three-inch thick planks and twelve-inch diameter logs. The sign's text is incised lettering, painted white on the brown-painted sign. The sign is in poor condition

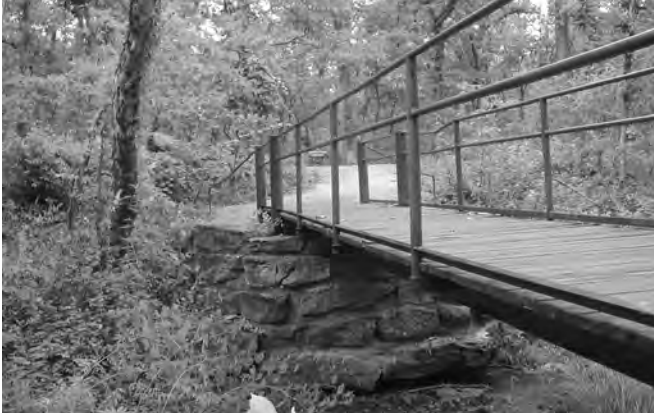
Figure 6-77. Wood plank and pipe railing bridge situated on revised historic abutments, where steps and stepping stones once existed, 2001.

There are sundry other small scale features. Two bridges constructed of metal tube railing and planks are located on Travertine Island, one crossing each of the two creeks. The one between the northern parking lot and the island sit on revised abutments of a former stair and stepping stone low water crossing (Figure 6-77). Picnic tables and standing grills are located in the three picnic areas. There

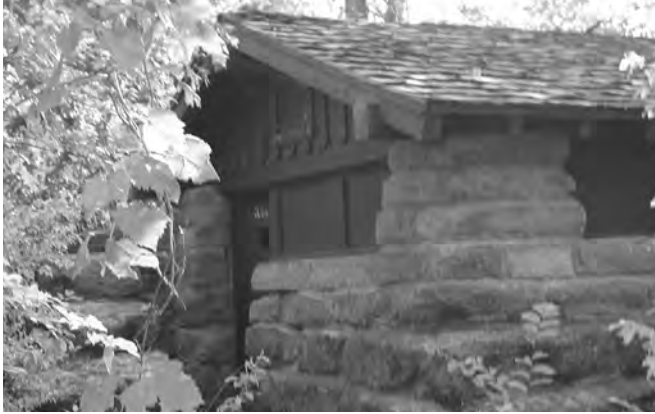
Figure 6-79. Rustic comfort station at Buffalo Spring, currently unused, 2001.

The Buffalo Springs Comfort Station (Figure 6-79) is the major NPS Rustic style structure in the area and is a replica of those built at Cold Springs Campground. The building is not currently used and is boarded up. Vegetation has grown up close to the building and could begin to impact the building’s condition. Lead abatement and re-roofing of the building was completed in 2003.

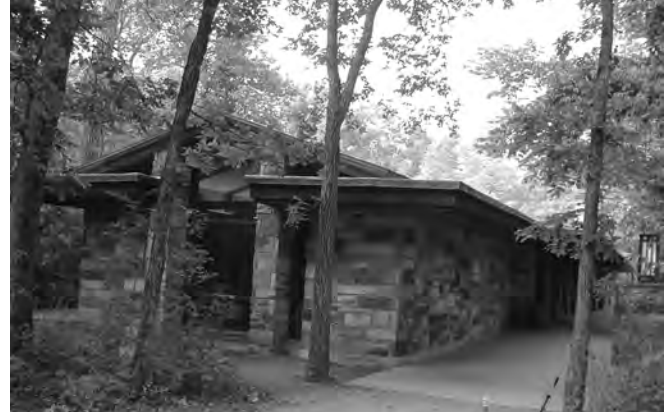
Figure 6-80. Travertine Nature Center, east facade, 2002.

The Travertine Nature Center (Figure 6-80) was completed in 1970, and was loosely based on design principles of Frank Lloyd Wright as is evident from its appearance. The building constructed over Travertine

Creek and contains a museum, auditorium, rest rooms, and staff offices. An integrated terrace, seatwall and bridge are part of the building's northwest façade. The building is in good condition.

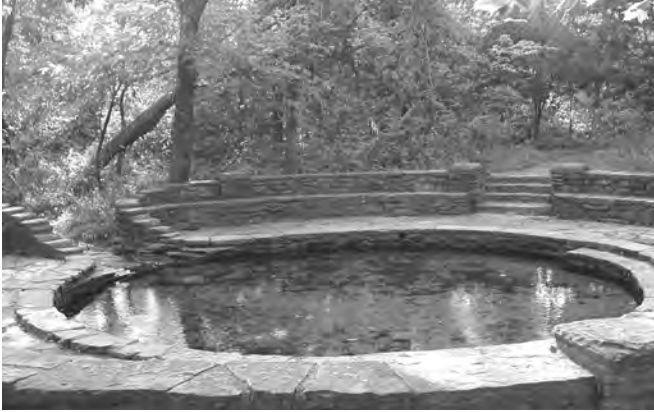
Figure 6-81. Buffalo Springs Enclosure, 2001 Note dense vegetation behind.

The Buffalo Spring Enclosure (Figure 6-81) is a circular feature of walls, seats, steps and paving enclosing the spring and releasing it through a spillway into Travertine Creek. Constructed of native stone, the structure is in good condition, though there is some minor masonry damage and evidence of water captured behind the walls.

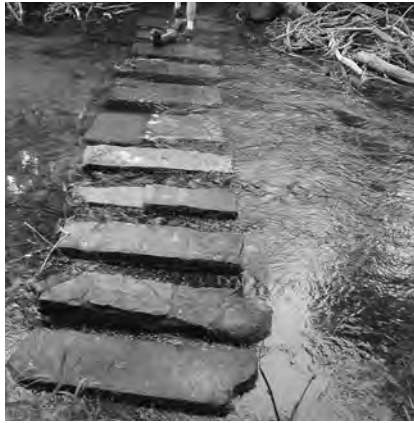
Figure 6-83. Typical stepping stones across Travertine Creek, 2001. Others are covered with plank bridges.

Three more sets of stepping stones (in addition to the one at Antelope Springs described above) crossing Travertine Creek are located in the area. Two have been covered with bridges while one is still extant without a bridge over it (Figure 6-83).

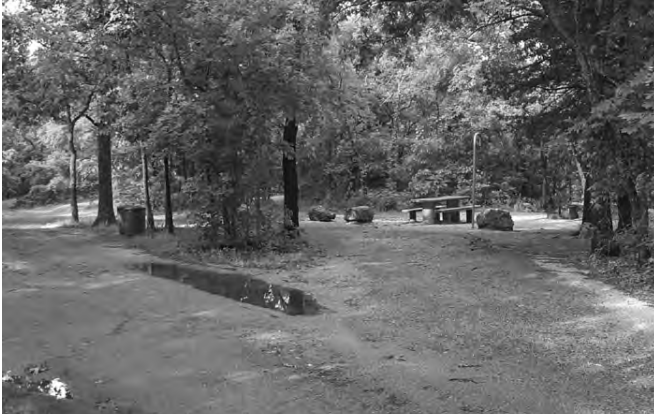
The campground is used for camping and the 106 campsites available on a first-come, first served basis. Pull-through sites in this campground are more appropriate for, and can accommodate small and medium-size RVs (Figure 6-84). Sites do not have water and electrical hookups.

Figure 6-84. Typical pull-through site at Rock Creek Campground is appropriate for recreational vehicles, 2004.

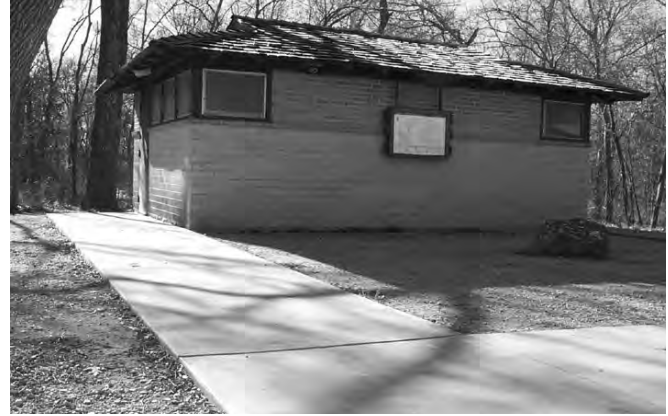
Figure 6-85. Mission 66 comfort station at Rock Creek, with new, white concrete walkway, 2004.

Two 1950s Comfort Stations are located in the center of the campground along the second and fifth rings of campsites. They are constructed of block and concrete masonry and are in good condition. One Mission 66 comfort station is located in the Chigger Hill area and is constructed of concrete block and wood, similar to others built at the same time. This comfort station is in good condition.

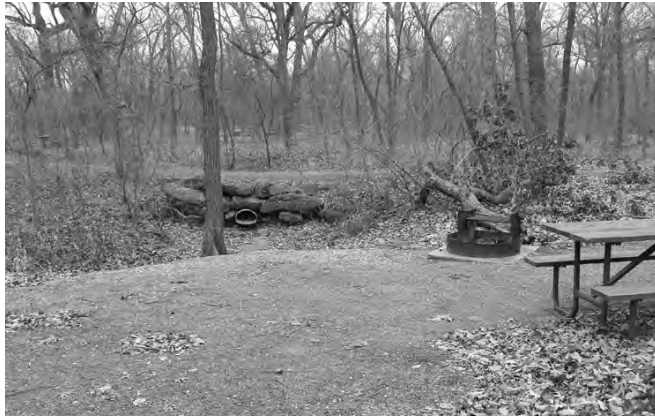
Culvert headwalls constructed of dry-laid natural limestone blocks (Figure 6-86) are found along the outlet areas close to Rock Creek. An open diversion ditch (Figure 6-87) is located along the eastern edge of the

Figure 6-86. Culvert headwall just north of Chigger Hill area of Rock Creek Campground, 2004.

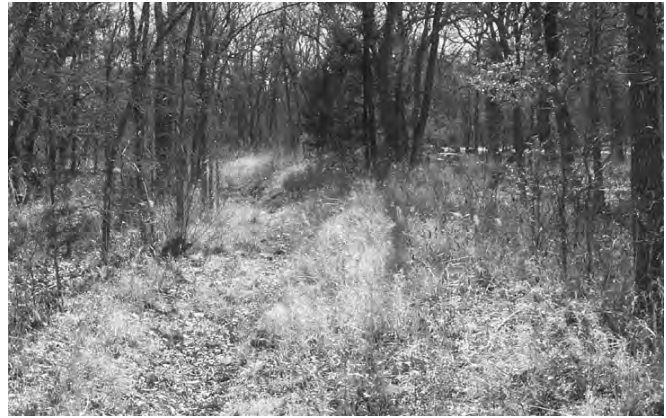
Figure 6-87. Drainage diversion along eastern side of the campground, 2004.
