# Five-Year Review Report

First Five-Year Review Report  
For  
Riverbank Army Ammunition Plant  
City of Riverbank  
Stanislaus County, California

February 2001

PREPARED BY:  
Department of the Army  
Riverbank Army Ammunition Plant

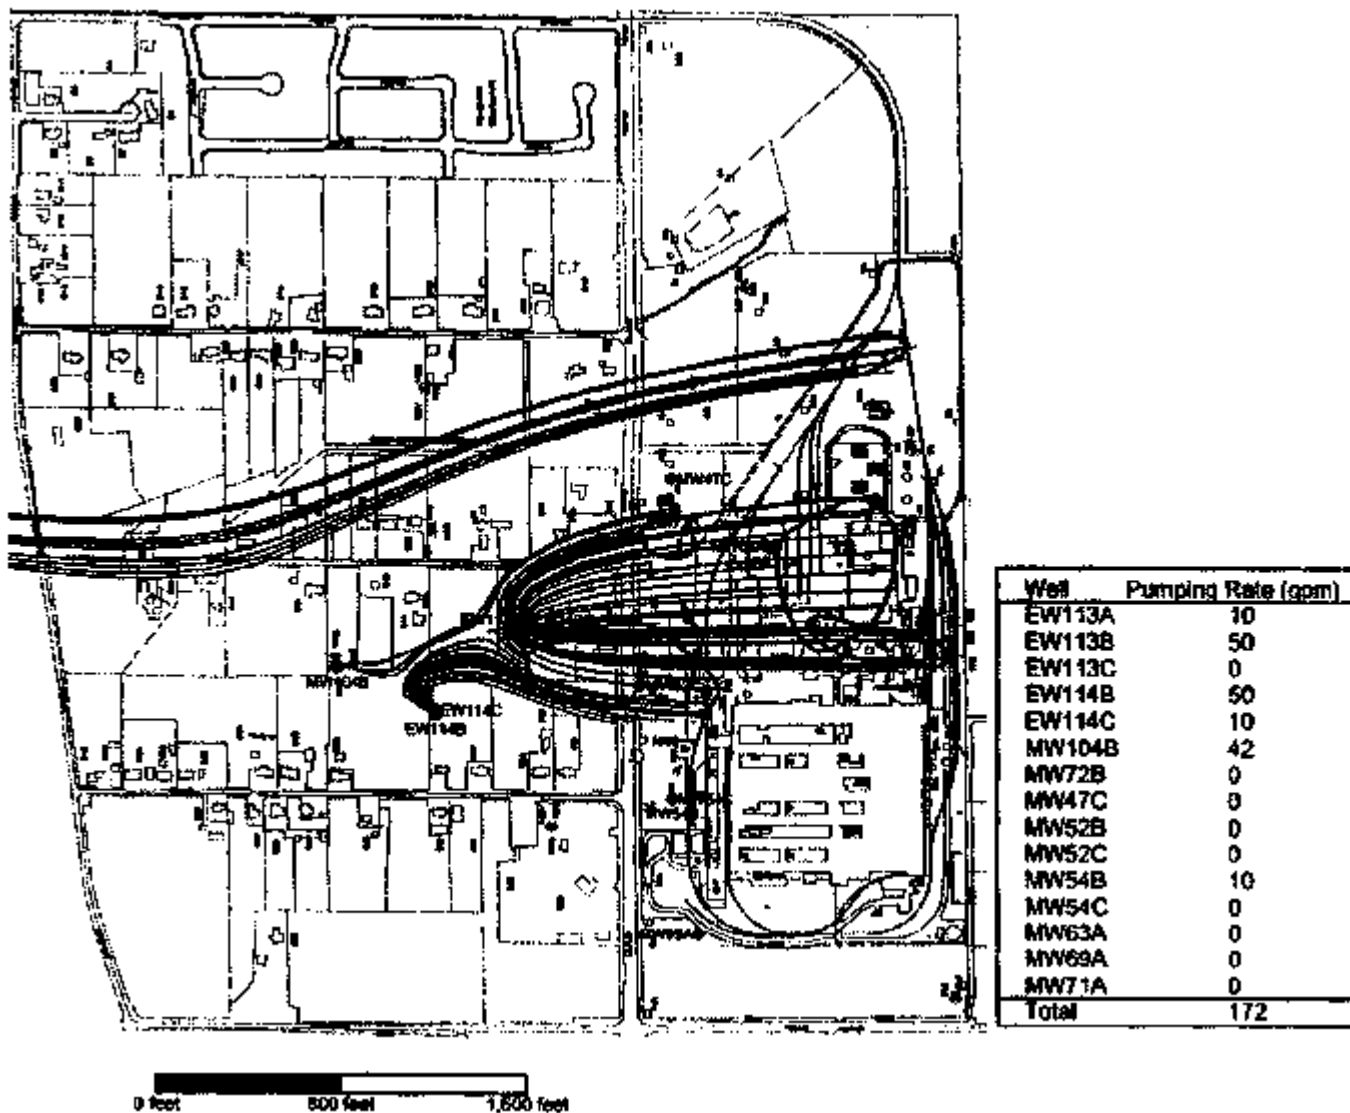
Figure 2  
 Flowlines Starting at the Edge of the  
 A Zone Target Areas  
 172 gpm Scenario  
 First Quarter 2000

The modeling simulations conducted to confirm that the 172 gpm target extraction rate is adequate to capture the groundwater contamination at RBAAP are presented in the Quarterly Groundwater Monitoring Report, RBAAP Groundwater Monitoring Program, 2000 - First Quarter (CH2M HILL, 2000b). Simulation results taken from the quarterly report are presented herein on Figures 2, 3, and 4 for the A/A', B, and C zones, respectively. These figures show groundwater flowlines emanating from the boundaries of the contaminated areas at RBAAP. There is just one small area of contamination that would not be captured under the 172 gpm scenario. This is a small area of chromium contamination located adjacent to the landfill. The Quarterly Groundwater Monitoring Report (CH2M HILL, 2000b) states that all of the A/A' zone wells downgradient of the small area of contamination are non-detect for chromium at this time, indicating that the chromium contamination has not migrated a significant distance away from the landfill. The Quarterly Report recommends continued monitoring of this area to detect any migration of the chromium contamination. As described above, if downgradient concentrations begin to increase, monitoring well MW45A' can be converted into an extraction well.

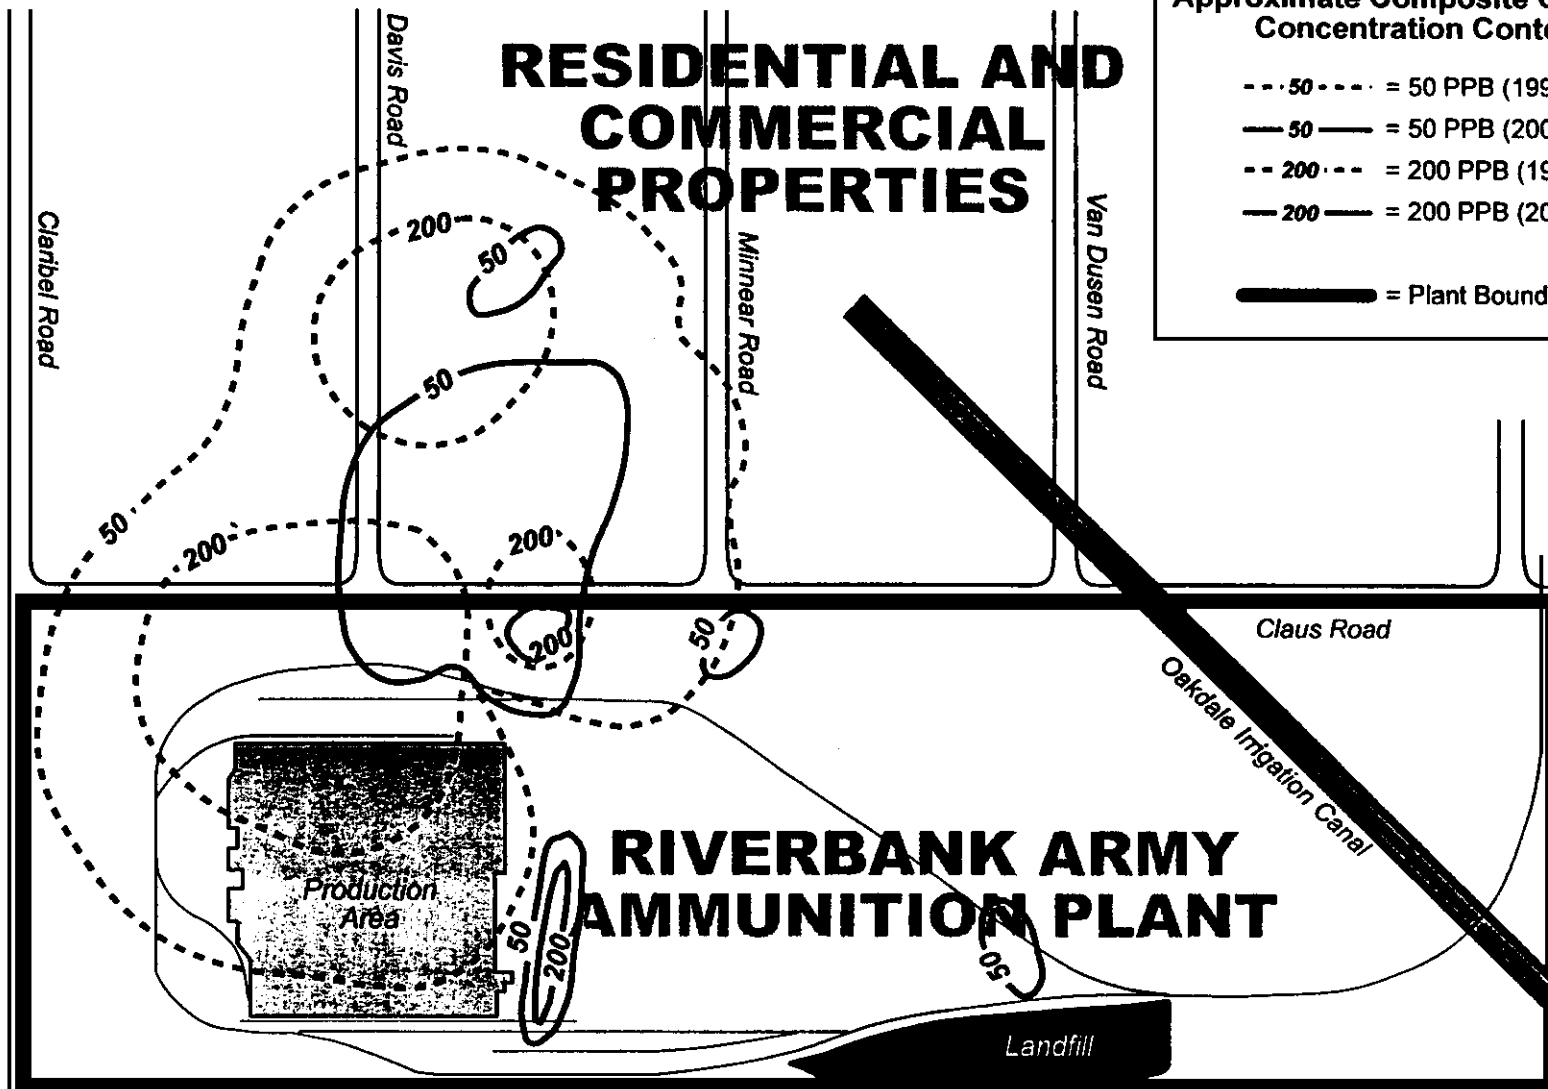
**Figure 5**  
**Groundwater Cleanup at Riverbank Army Ammunition Plant**  
 Riverbank, California  
 (1993-2000)

In general, contaminant levels have not declined significantly in the shallow A zone. A-zone contaminant levels have actually increased since they were last measured in the early 1990s. The increase may be attributable to the fact that the A zone was unsaturated for a number of years before beginning to recharge over the last two years. During this initial recharge period, higher flux of contaminants from the soil to groundwater can be expected. The Army is currently evaluating options to enhance remediation of the A zone. These options include increasing the amount of groundwater extraction from the A/A' zone onsite and in-situ remediation of the chromium and cyanide within the source areas. The ROD includes provisions for the recharge of the A zone that require the Army to investigate and, if necessary, remediate the groundwater in the A zone in accordance with the remediation goals (i.e., MCLs).

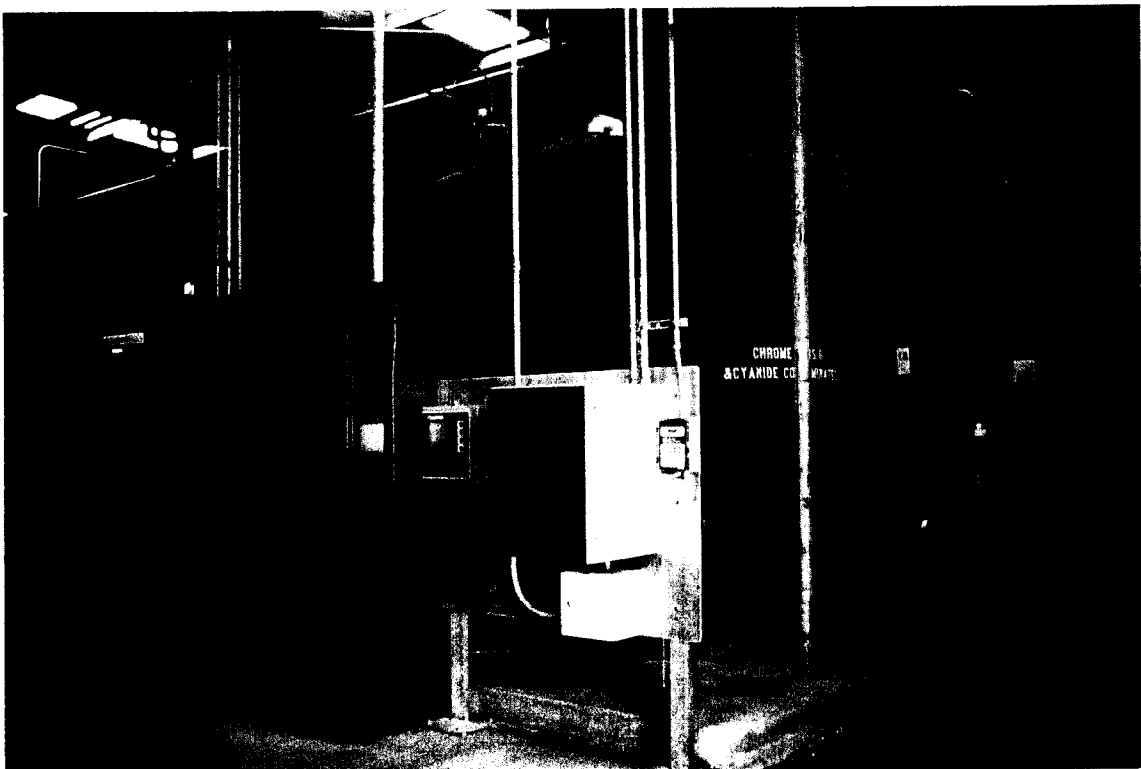
The groundwater treatment plant (consisting of the GWTS and the IGWTS) was found to be operating and functioning properly. No operational problems were observed. The current operating mode, which uses ion exchange only, results in very straightforward operation procedures. The primary operator activity is to regenerate the resin in the ion exchange columns when it is spent. Currently, each ion exchange column is regenerated approximately every two weeks. The as-built drawings and O&M manual have not yet

**Photo 1: Groundwater Treatment Plant Building**

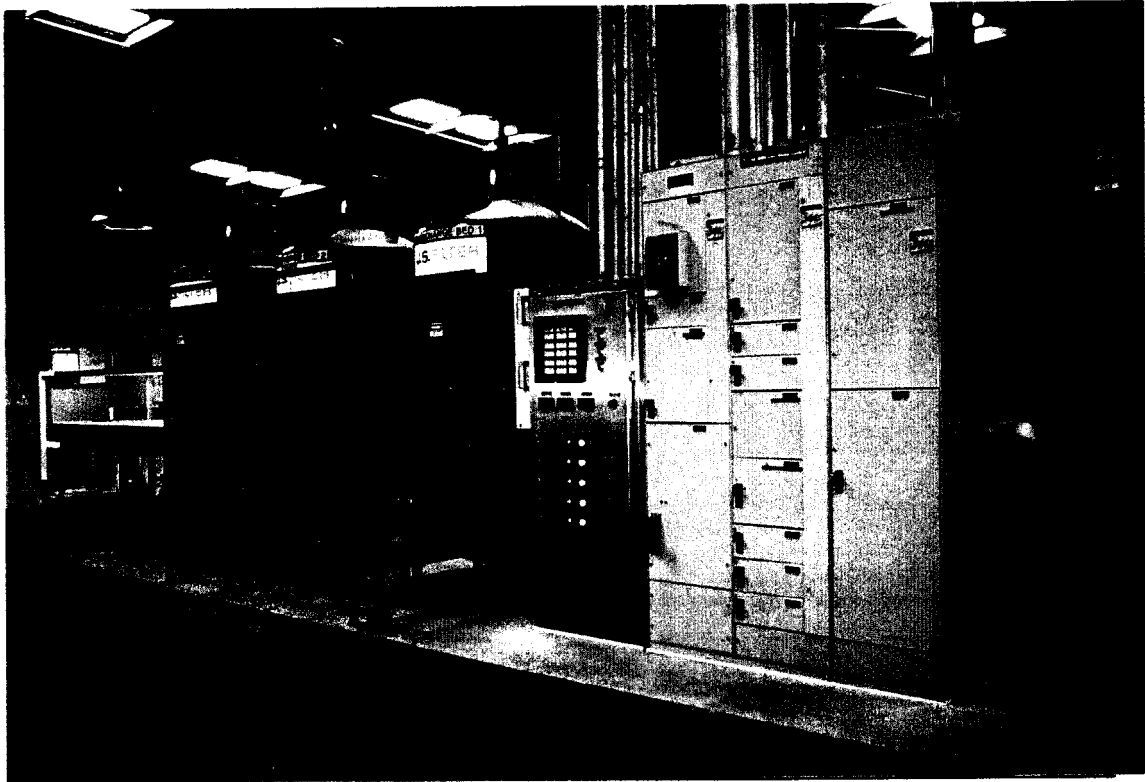
**Photo 2: Influent Tank and Control System**

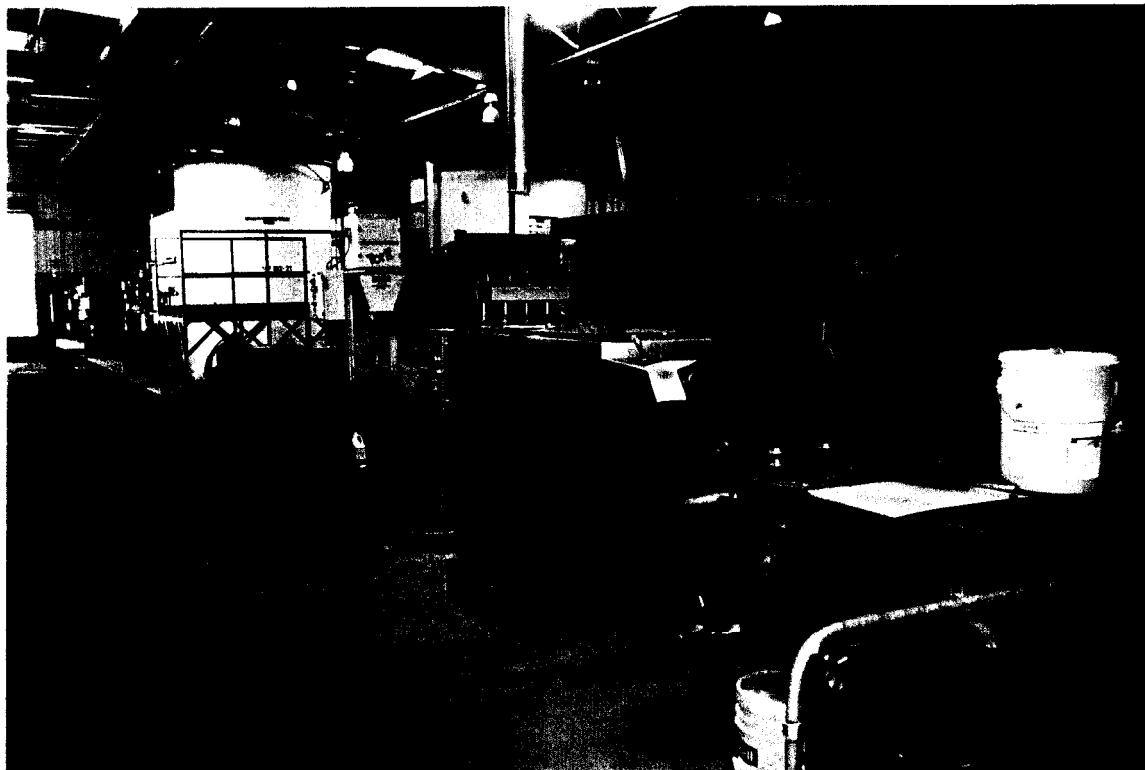
**Photo 3: GWTS Ion Exchange Vessels and Control System**

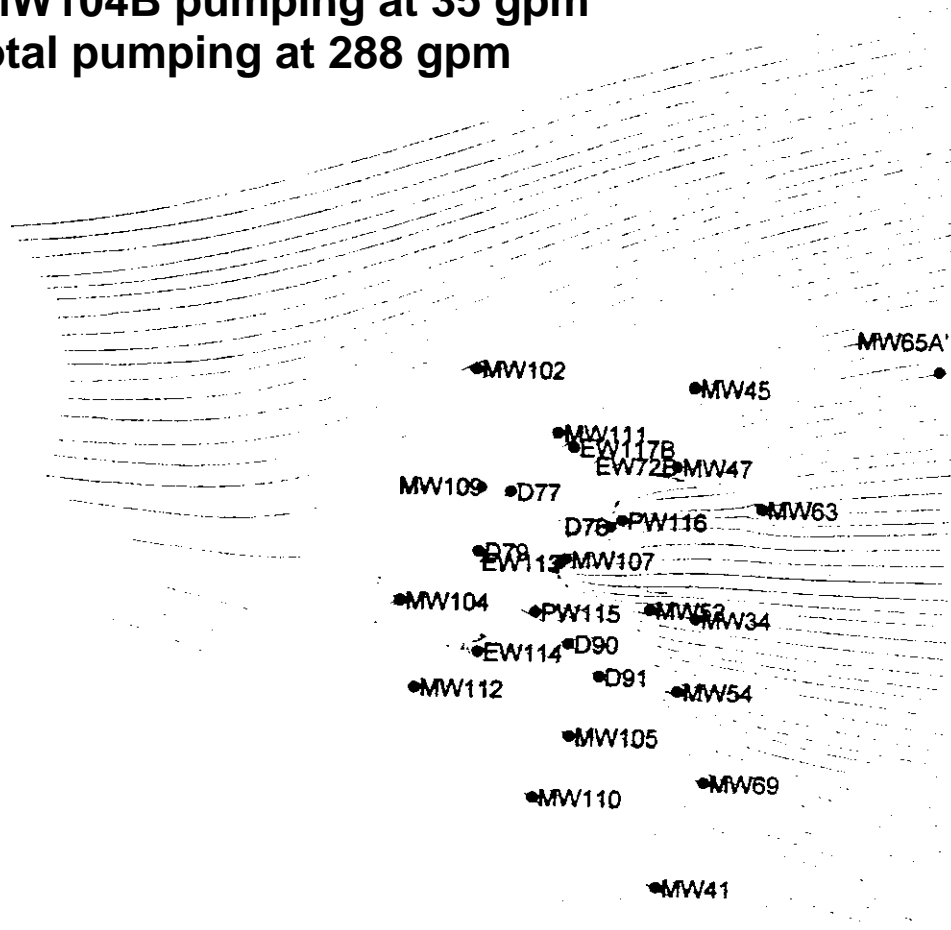
**Figure 1**

- Chromium concentrations in MW65A' are currently below the MCL.
- Based on the available monitoring data, it does not appear that there is sufficient mass of chromium in the MW65A' area to create a plume of >50 :g/L contamination that could reach the facility boundary. Further, chromium is currently non-detect in all cross-gradient and downgradient monitoring wells.
- The contamination does not represent any threat to human health as there is no pathway for exposure to the on-site A'-Zone contamination.
- Based on the groundwater flow conditions in the area and the distribution of extraction wells, the extraction rate could be increased 5 to 10 years from now and the contamination would still be captured by the extraction system in essentially the same manner that it would be captured if the extraction rate were increased now.

## Flowlines starting in the upgradient A/A' aquifer with MW104B pumping at 35 gpm and total pumping at 288 gpm
