Official Accident Report Index Page

Report Number	NTSB-AAR-82-5
Access Number	PB82-910405
Report Title	Eastern Airlines Flight 935, Lockheed L-1011-385, N309EA, Near Colts Neck, New Jersey, September 22, 1981.
Report Date	June 1, 1982
Organization Name	National Transportation Safety Board Bureau of Accident Investigation Washington, D.C. 20594
WUN	3529
Sponsor Name	NATIONAL TRANSPORTATION SAFETY BOARD Washington, D. C. 20594
Report Type	Aircraft Accident Report September 22, 1981
Distribution Status	This document is available to the public through the National Technical Information Service, Springfield, Virginia 22161
Report Class	UNCLASSIFIED
Pg Class	UNCLASSIFIED
Pages	40
Keywords	Rolls-Royce RB-211 engine; inadequate lubricating oil supply; low pressure location bearing; oil leaks; coupling seal displacement; oil spray; fire; fan shaft overheat; fan shaft failure; fail-safe shaft failure.
Abstract	<p>About 1140 e.d.t. on September 22, 1981, the No. 2 engine, a Rolls-Royce RB-211-22B, failed as Eastern Airlines Flight 935, a Lockheed L-1011-385 (N309EA), was climbing through 10,000 feet after departing Newark International Airport, Newark, New Jersey, for San Juan, Puerto Rieo.

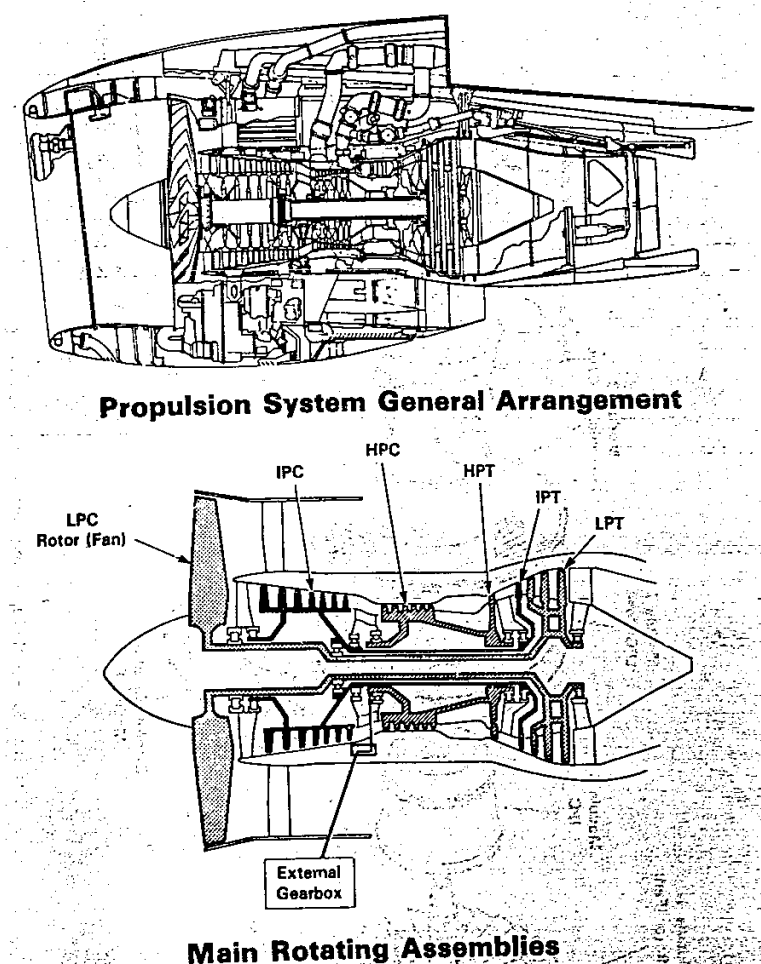
Figure 2. -- Propulsion System General Arrangement and Main Rotating Assemblies.

The engine has six rotating assemblies: the low-pressure compressor (LPC) rotor or fan, the intermediate-pressure compressor (IPC), the high-pressure compressor (HPC), the high-pressure turbine (HPT), the intermediate-pressure turbine (IPT), and the low-pressure turbine (LPT). ([See figure 2.](#))

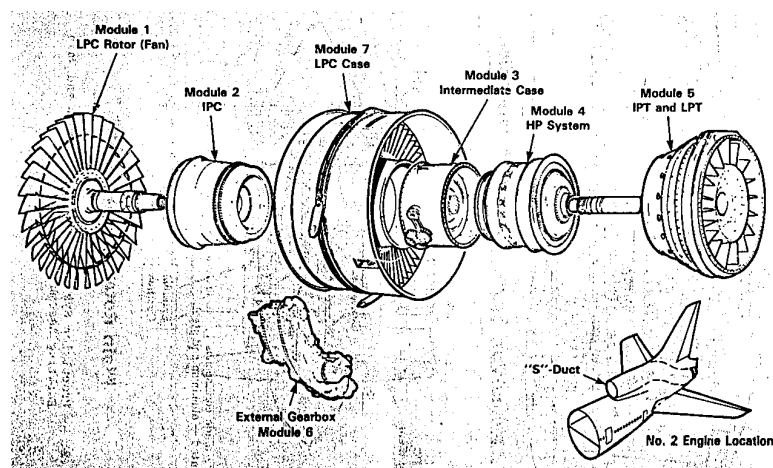
Figure 3. -- Module Breakdown of Engine.

Engine Modules--The engine has been designed to break down into seven major modules. These are: ([See figure 3.](#))

Engine Component	Module No.
LPC rotor (Fan)	01
IPC	02
Intermediate Module	03
High Pressure System	04
IPT & LPT Assemblies	05
External Gear Box	06
LPC Case	07

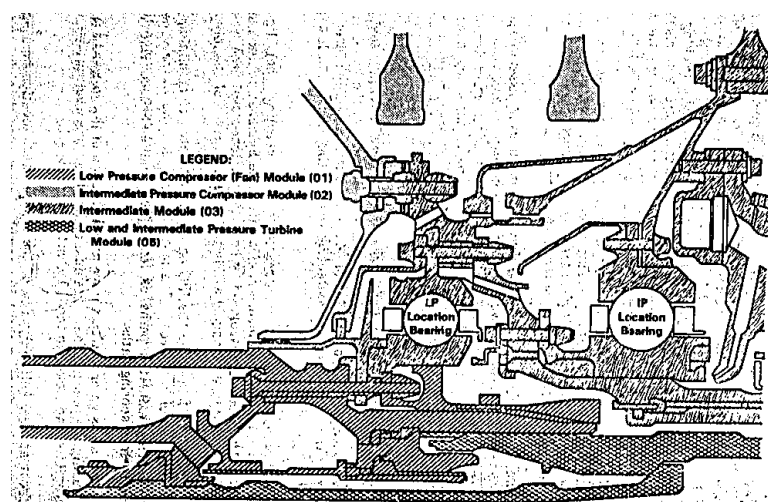
Figure 4. -- RB-211-22B Module Arrangement.

The compressor rotor shaft has five titanium discs in the forward section and two steel discs forming the rear section. Titanium rotor blades are used throughout. The rear stub shaft is splined and locked to the IPT shaft. [\(See figure 4.\)](#)

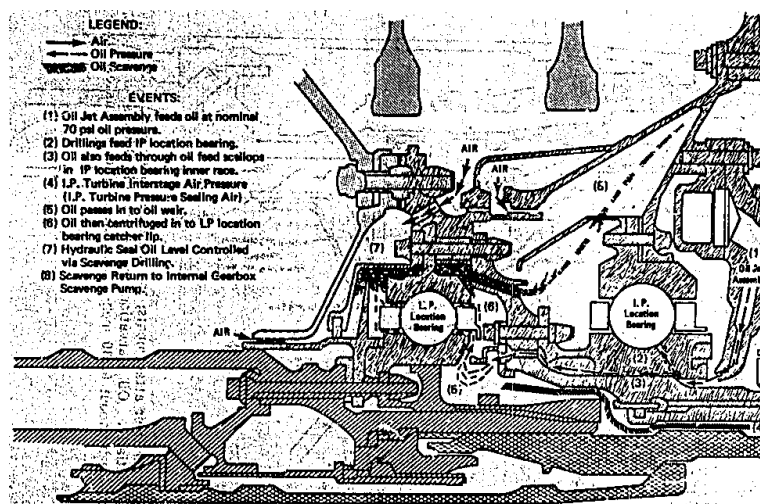
Figure 6. -- LPLB Normal Oil Supply and Scavenge.

Nominal total lubrication system capacity is 38.7 quarts of oil, including 23.7 quarts in the tank; consumption is 0.95 quarts/hour. A single-gear pump in the external gearbox supplies pressurized oil to the engine via a pressure filter. If the filter becomes blocked, the element is bypassed automatically and the engine oil filter pressure warning light illuminates on the flight deck. Low-pressure and intermediate-pressure location bearings are supplied by a single oil jet. [\(See figure 6\)](#) This jet sprays oil toward an annular slot formed between the IPC stubshaft and the IPLB inner race; typical catch efficiency is 60 percent for the RB-211 engine. Under centrifugal forces, part of the oil entering the slot passes outward through a passage in the IPLB inner race to supply the bearing; the remaining oil passes forward and outward to a weir through holes in the IPC stubshaft and in the weir flange. The oil supply must cross the two flanged joints between the IPLB inner race and the rear IPC stubshaft and between the stubshaft and the oil weir to reach the weir. A lip on the aft side of the LPLB cage catches oil being thrown outward after spilling over the weir lip for LPLB lubrication. Cage passages distribute oil within the bearing.
