**EMPO-561**  
**Rev. 0**

**Oak Ridge Reservation**  
**Public Warning Siren System**  
**Annual Test Report**

October 2000

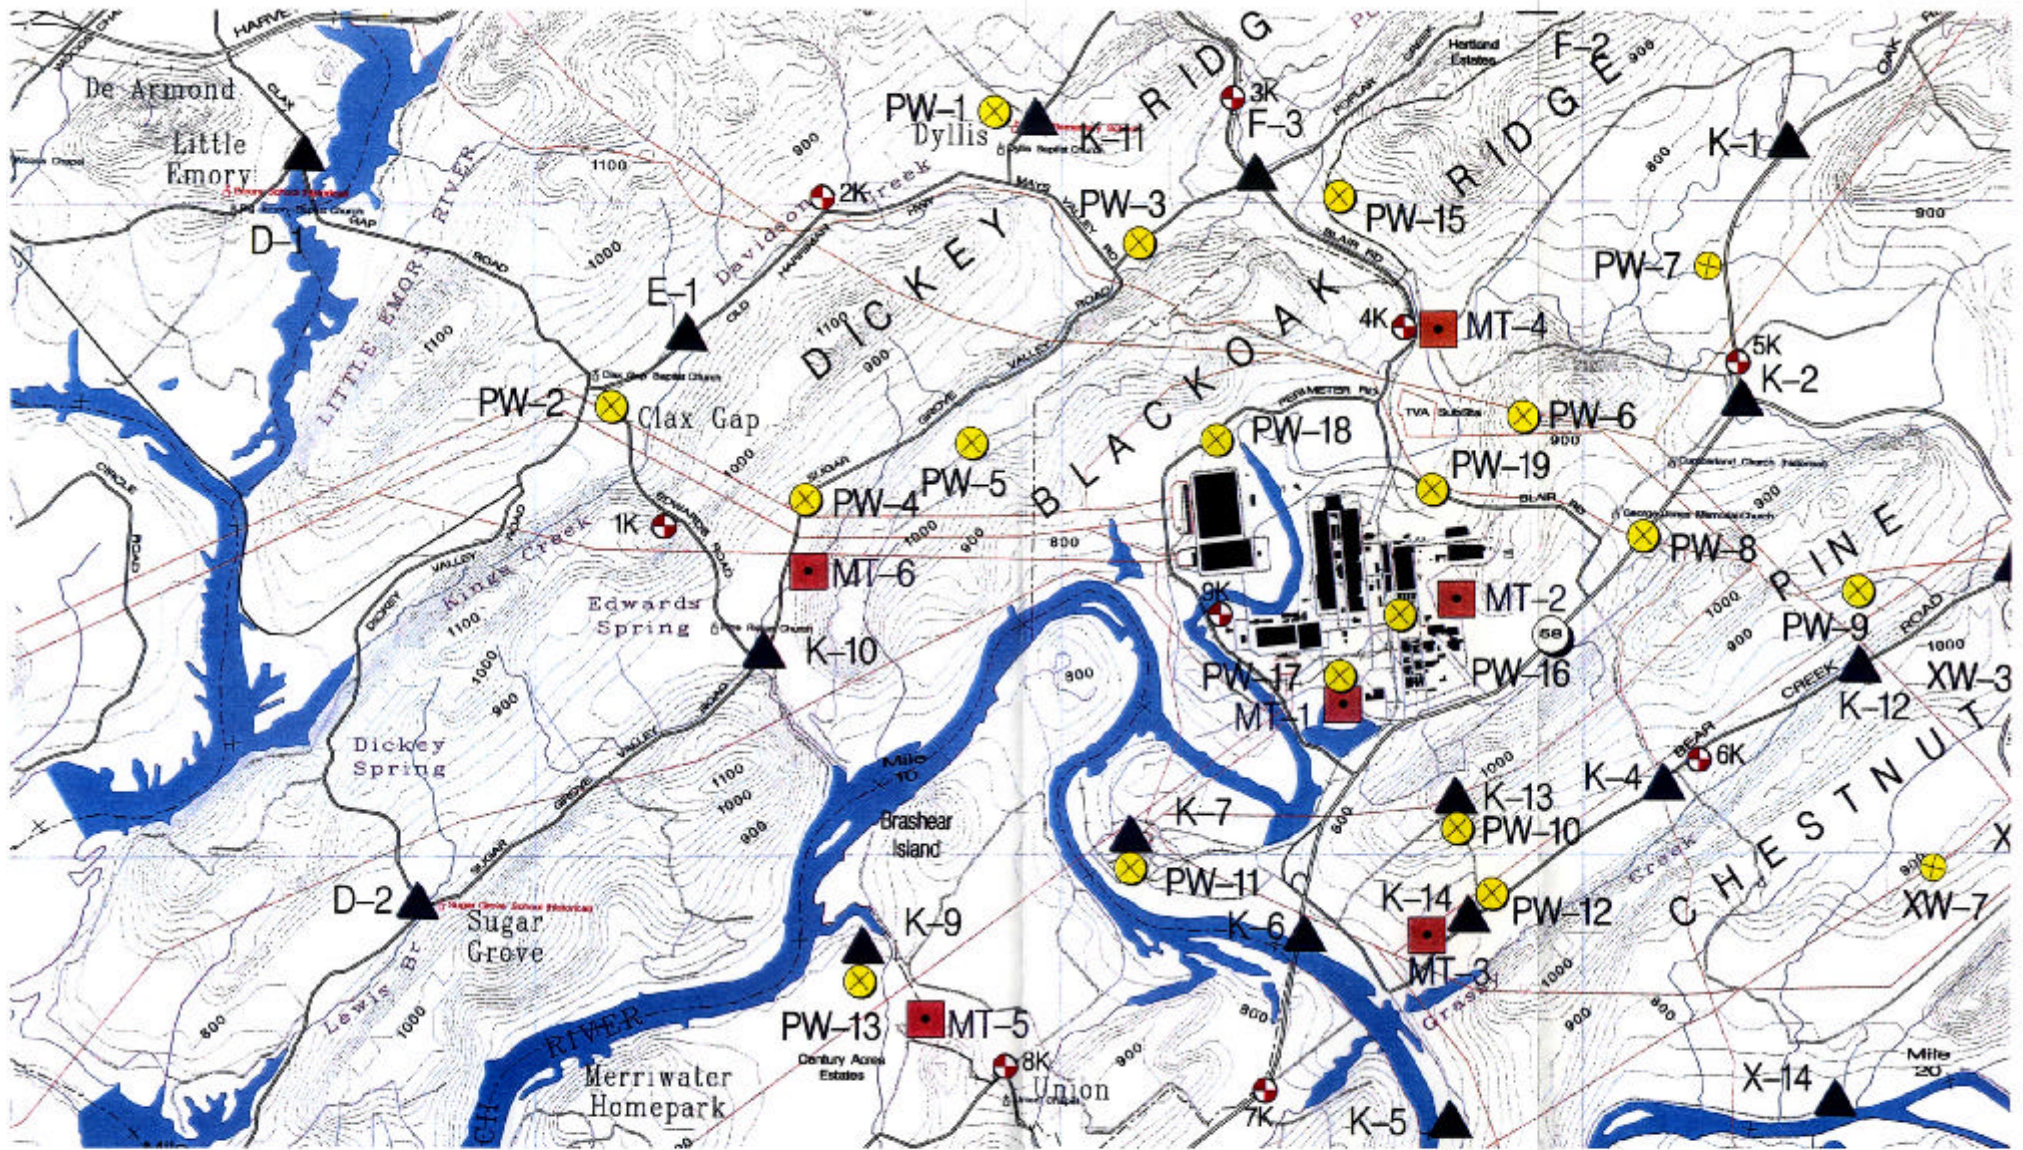
Fig. 1. ETPP measurement locations.

The siren system status report indicated Siren Run - Partial for two sirens, KCA 006 and KFA 016. This condition was reported to the system maintenance contractor.

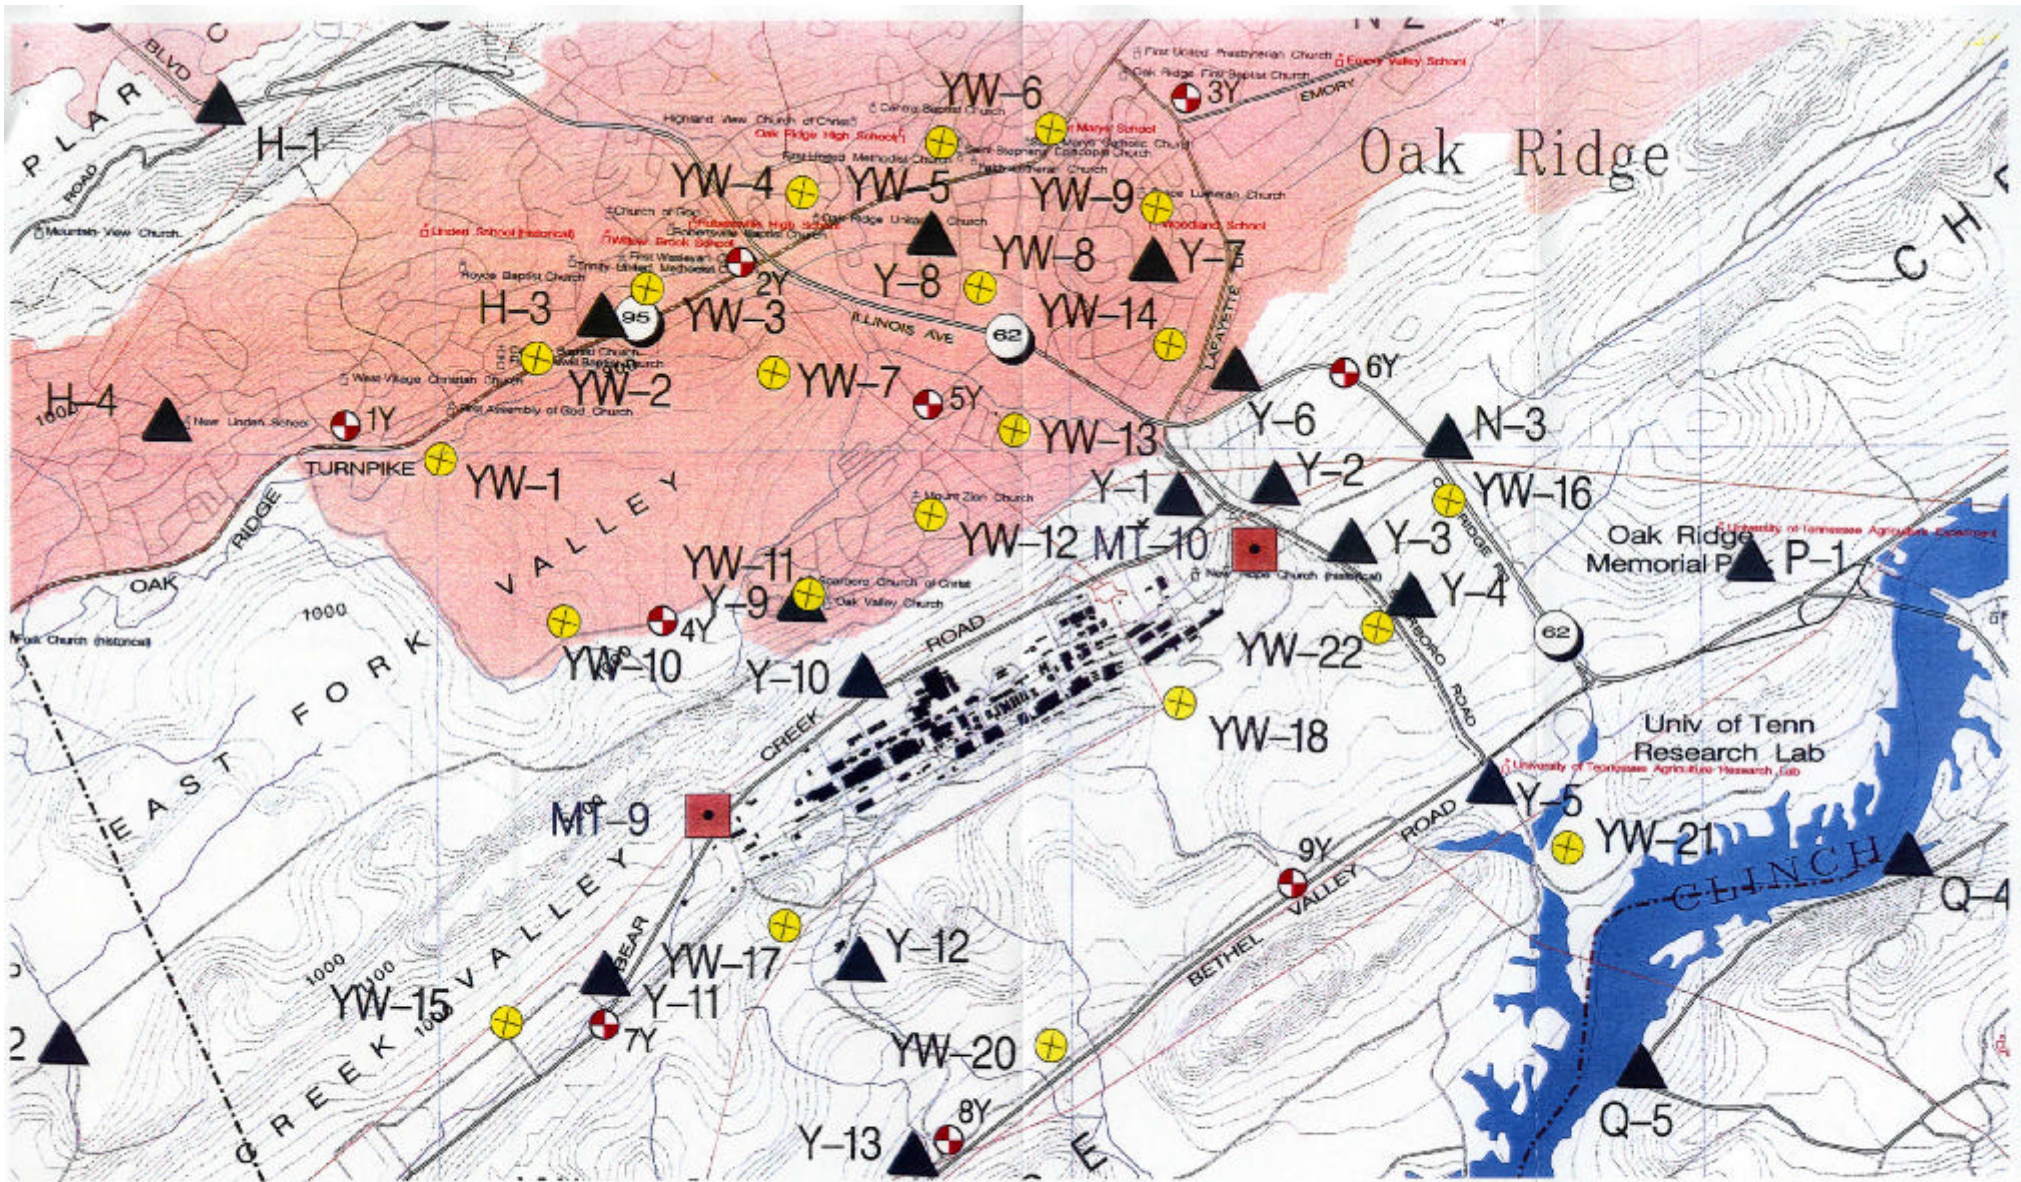
Fig. 2. Y-12 measurement locations.

The siren system status report indicated Siren Run - Partial for three sirens (ACC 012, ABB 014, ADG 021), Siren Overrun for three sirens (ABA 009, ADB 016, ADG 021), and Low Battery for one siren (ADA 015). These conditions were reported to the system maintenance contractor.
