U.S. CHEMICAL SAFETY AND HAZARD INVESTIGATION BOARD

INVESTIGATION REPORT

CONFINED VAPOR CLOUD EXPLOSION

CAI, INC. AND ARNEL COMPANY, INC.

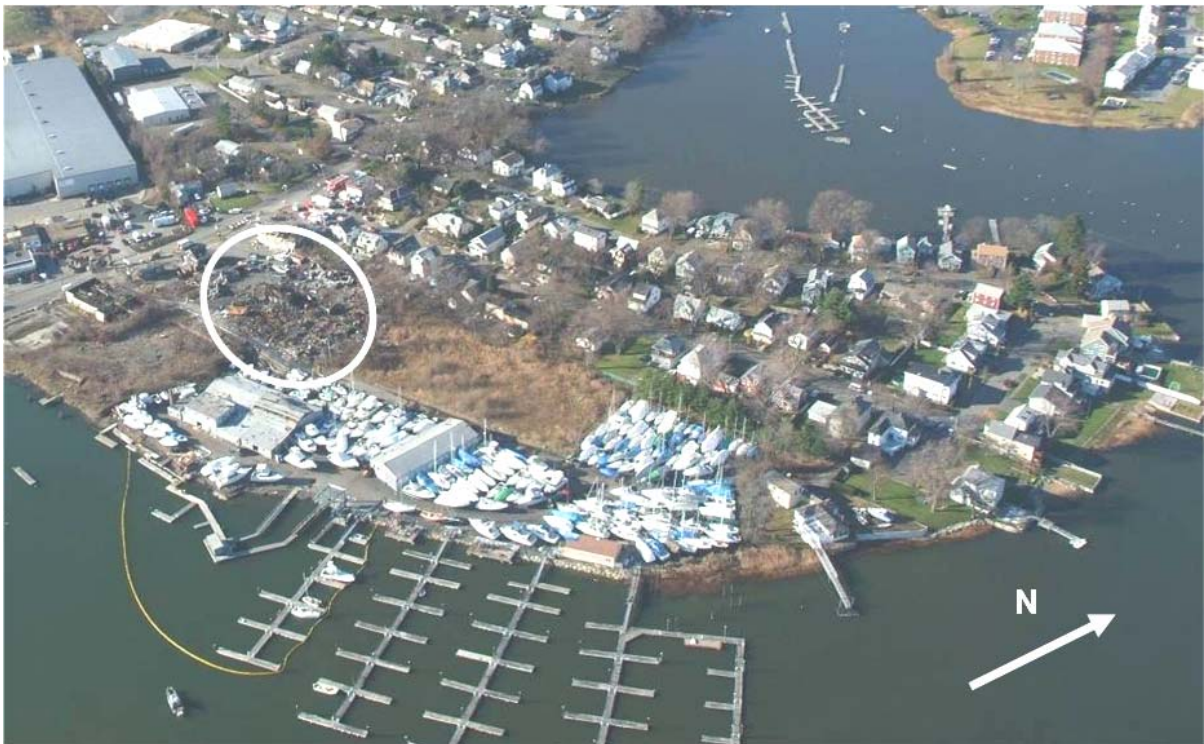
Figure 1. Danversport peninsula. CAI/Arnel facility explosion site circled (ATF photo).

The explosion heavily damaged dozens of nearby homes and businesses and shattered windows as far away as two miles. At least 10 residents required hospital treatment for cuts and bruises. Twenty-four homes and six businesses were damaged beyond repair, and dozens of boats at a nearby marina were heavily damaged by the blast wave and debris strikes.

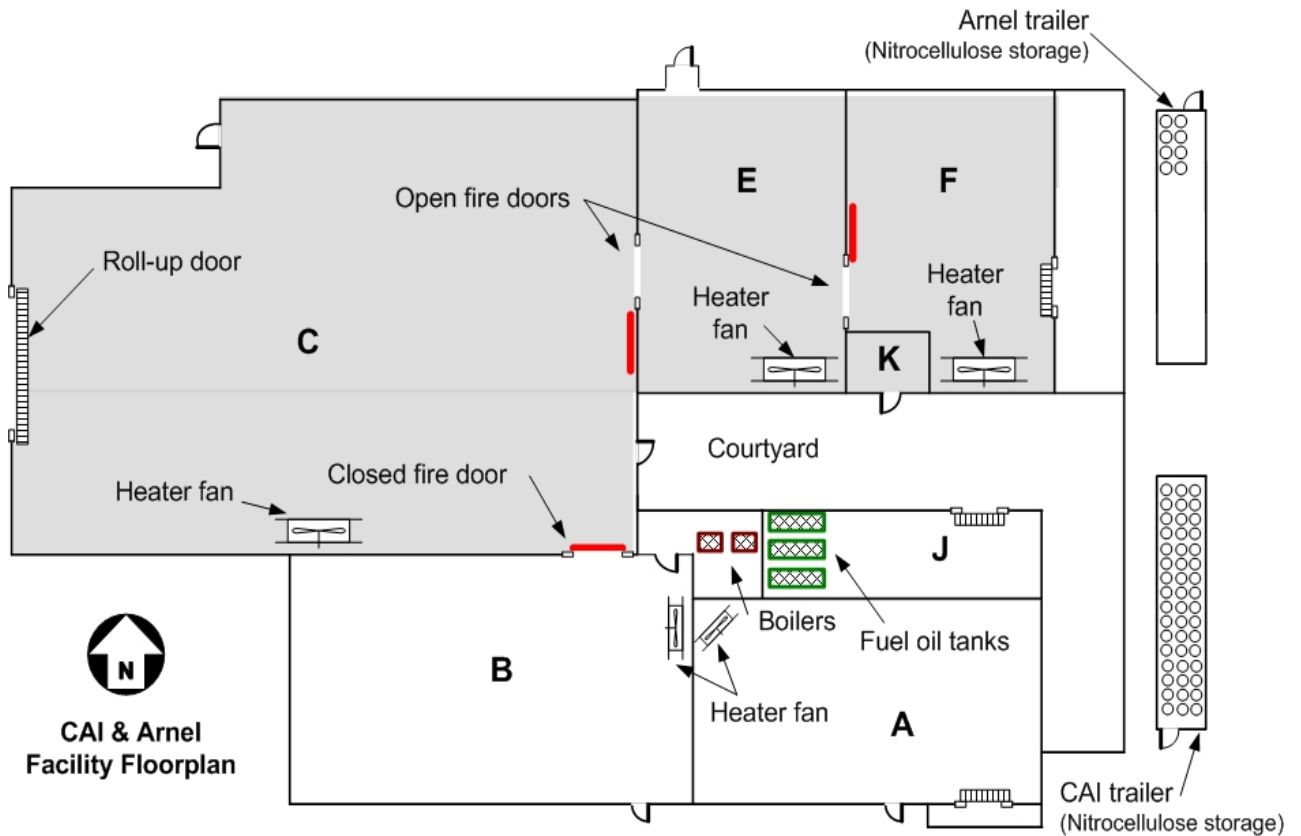
Figure 3. CAI/Arnel building layout. Production areas are highlighted.

Areas C, E, and F housed the production equipment, raw materials, and product storage for both companies. The electrical equipment in the production areas was required to be rated for use in a flammable environment because of the potential for a flammable atmosphere to be present.^{4,5} The CSB investigation team noted that the permanent lighting fixtures, mixer motors, electrical conduit, and other electrical equipment in the production area debris after the explosion appeared to be appropriately rated.⁶ The CSB team also recovered a few non-rated electrical devices from the debris,

The damage to the CAI/Arnel building and the open or closed status of the fire doors as reported by employees, suggest that flammable vapor most likely accumulated only in areas C, E, and F, the production areas (Report, Figure 3). From layout drawings provided by CAI, the CSB estimated that the available air volume in these zones of the building was 110,000 cubic feet.

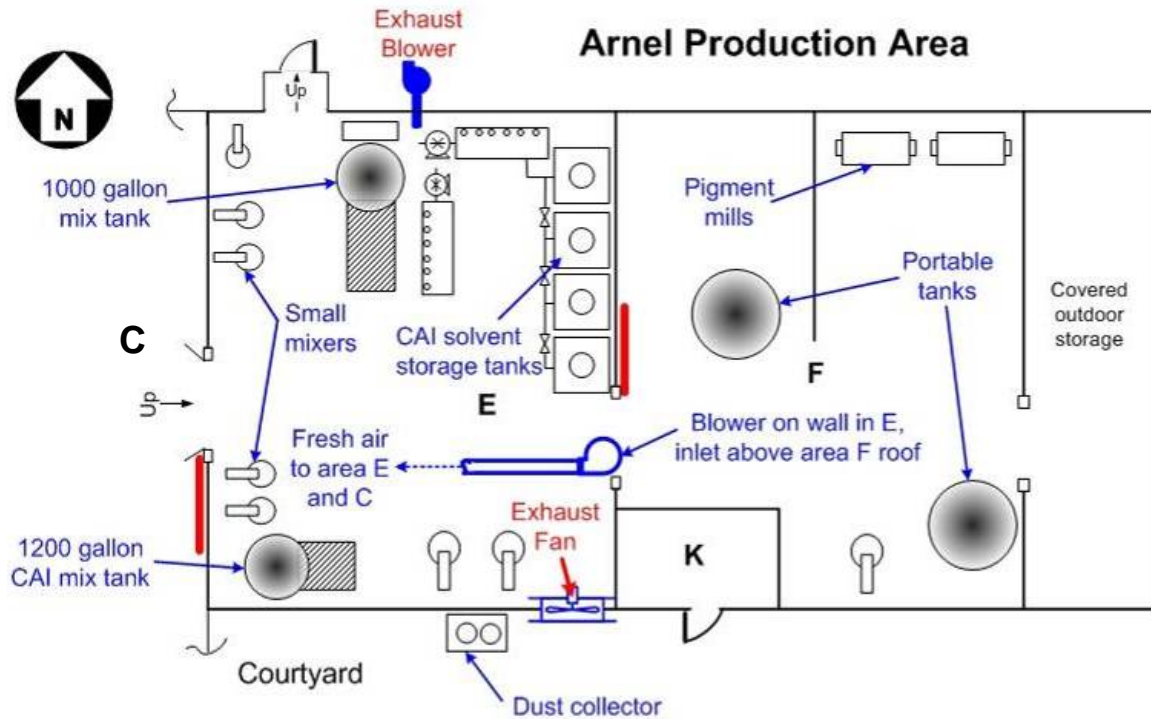
Figure 5. Arnel production area equipment and ventilation systems, areas E and F. CAI solvent storage and one mix tank also located in area E.

CAI management reported that CAI employees turned off the ventilation system at night to allay nearby residents' complaints about excessive noise and to reduce heat loss from the building.

Flammable liquids were stored in containers permanently connected to a distribution manifold using elastomeric hoses and compression clamps. In addition, open-top mix tanks routinely contained flammable liquids, sometimes with agitators energized, even during the unoccupied overnight hours when the ventilation system was not operating. Four mix tanks had heaters connected to the continuously operating steam system. If a leak occurred from a storage container, pipe manifold, or mix tank, or if a tank heater malfunctioned, flammable vapor could accumulate to dangerous concentrations within the building. However, CAI management did not recognize the increased risk of fire or explosion due to flammable vapor accumulation in the unventilated and unoccupied building.

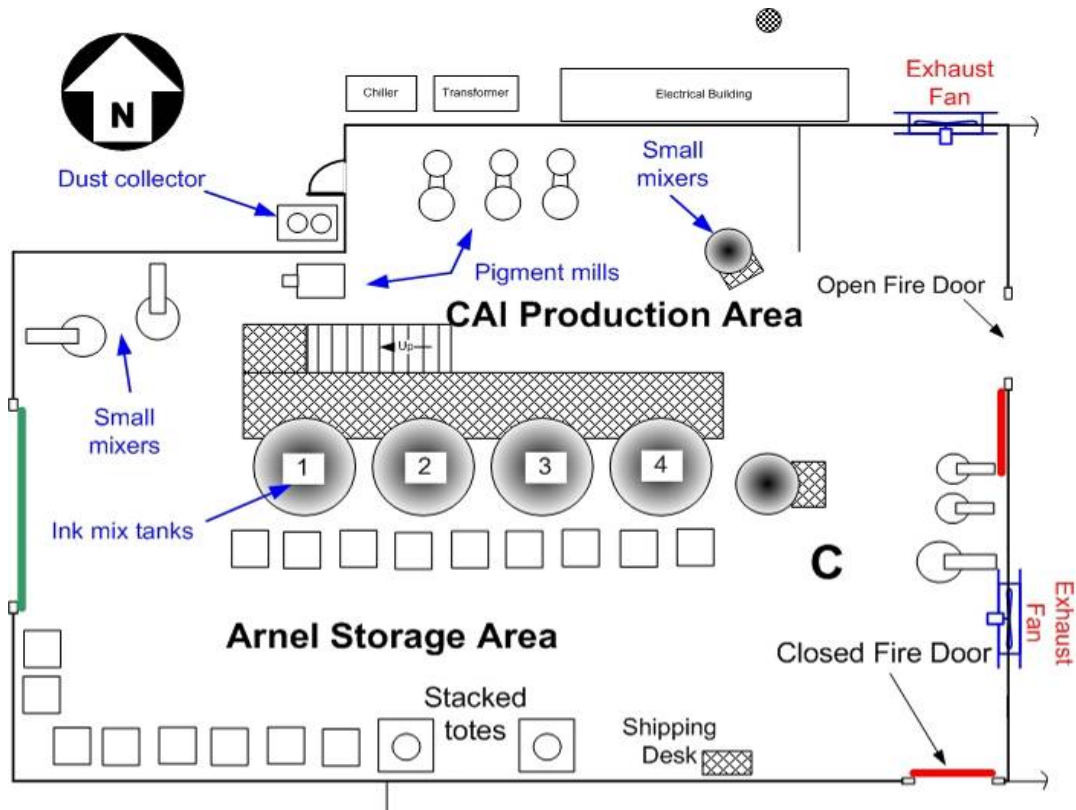
Figure 6. CAI production and Arnel materials storage, area C.

The largest CAI production equipment, four ink vehicle¹⁵ mix tanks, each approximately 3000 gallons in capacity, was located in area C (see Figure 6). Each tank was about 10 feet tall and eight feet in diameter and had a top-mounted mixer. Mix tanks 1 and 2 were fully open on top, while tanks 3 and 4 were each equipped with a top dome containing a 12-inch diameter access hatch (Figure 8). A hatch cover on each kept debris from falling into the tanks, but did not prevent air or vapor from passing through the opening. Each tank was equipped with a steam heating jacket connected to the steam boiler. Mix tank 3 was insulated on the bottom and sides. The operator controlled the mixture (ink vehicle) temperature by opening and closing a ¼-turn ball valve on the steam pipe connected to the tank jacket.

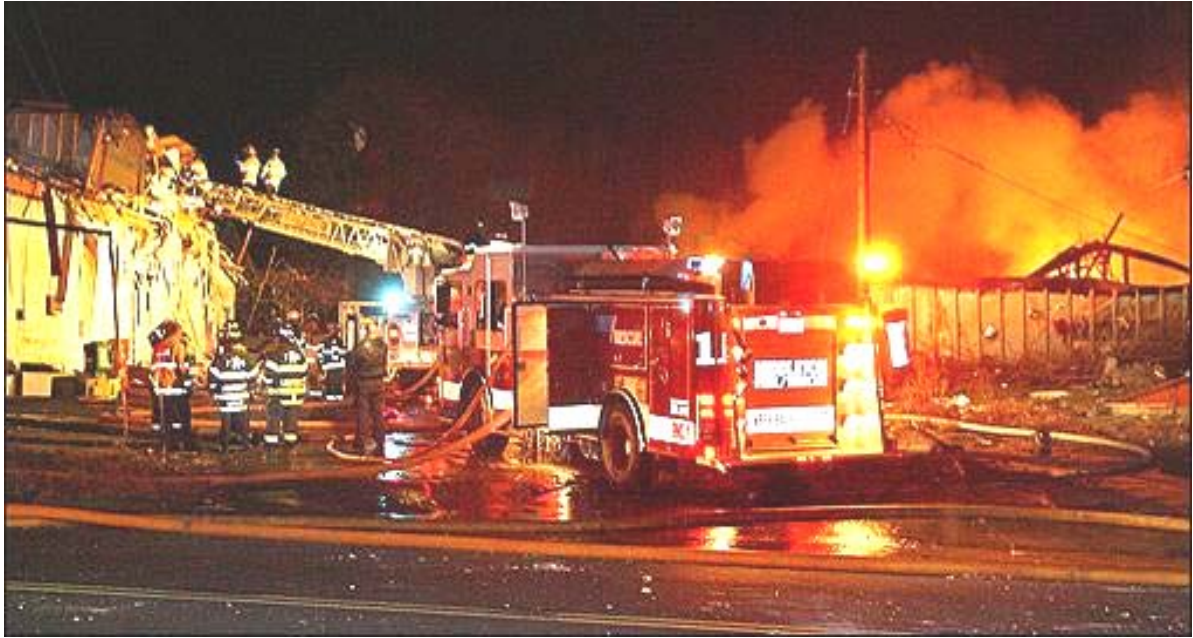
Figure 9. Search and rescue activities after CAI/Arnel building explosion (Boston Globe photo).

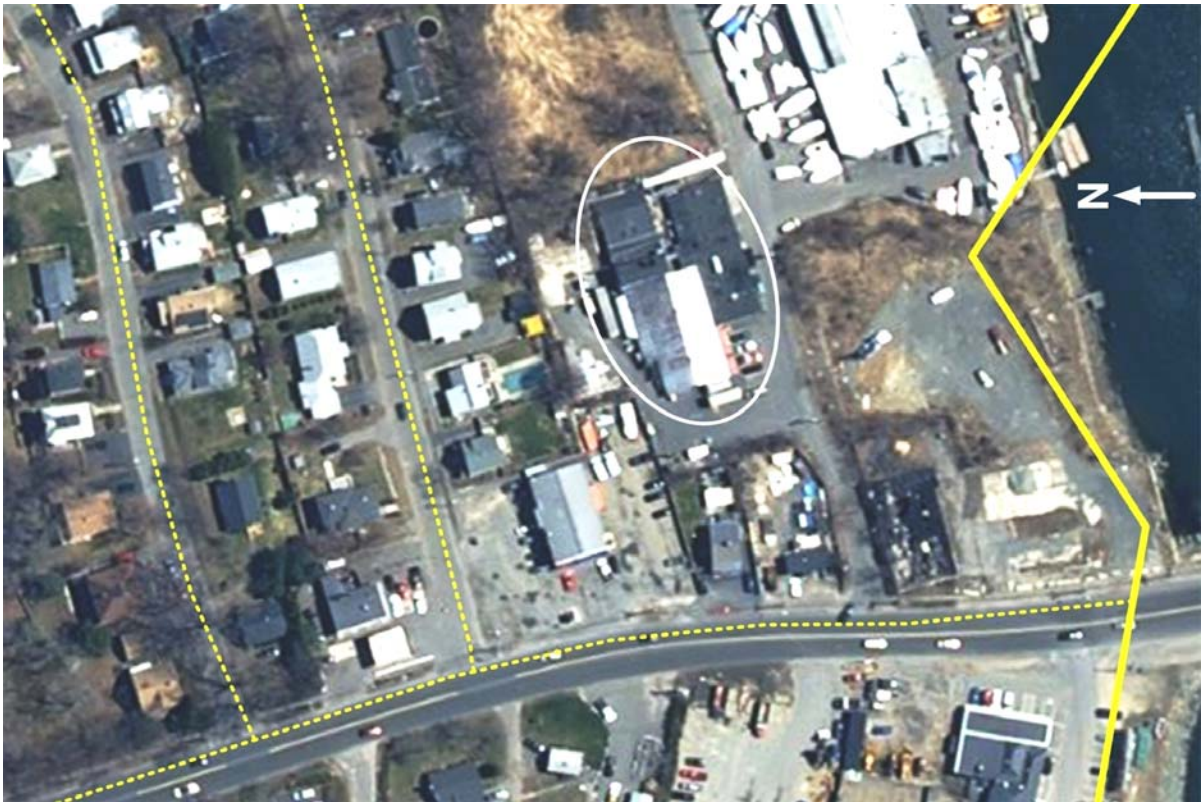
The Maritimes and Northeast pipeline is 215 feet south of the facility and operates at a maximum pressure of about 1400 psig. The pipeline is 30 inches in diameter and has 0.618-inch wall thickness. The pipeline is all-welded steel and has been in operation less than four years.

Figure 18. Buried natural gas lines near the CAI/Arnel property (circled).
Solid line – Maritimes and Northeast pipeline.
Dashed line – KeySpan utility pipeline.

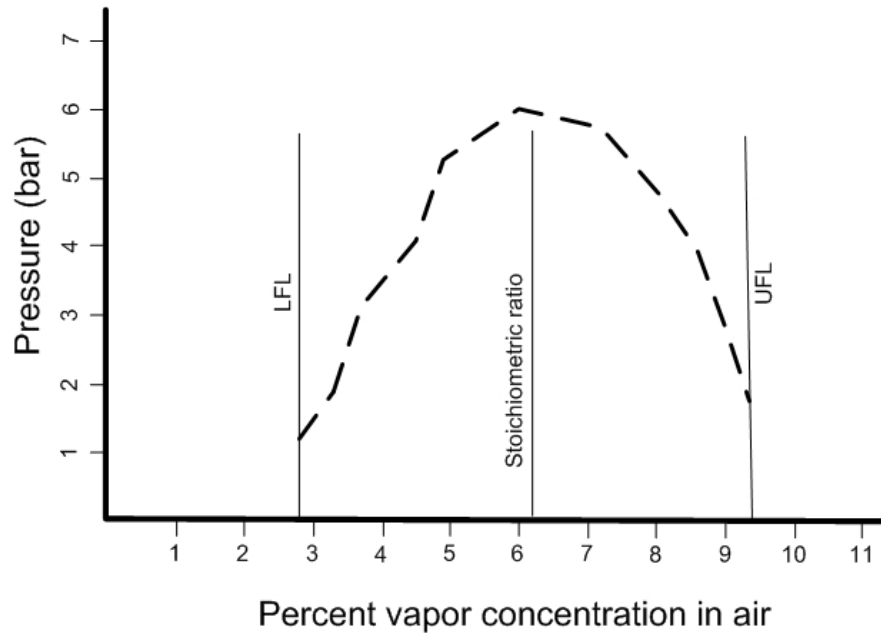
interior walls within the confined volume imposed considerable congestion. These factors combined to increase the severity of the explosion and the resulting overpressure and impulse.

Figure 21. Example of maximum pressure vs. flammable vapor volume concentration in air in a standard test apparatus.
