Coal Mine Fatal Accident 2003-24

| Operator: | RAG Coal West, Inc. |
| Mine: | Belle Ayr Mine |
| Accident Date: | September 9, 2003 |

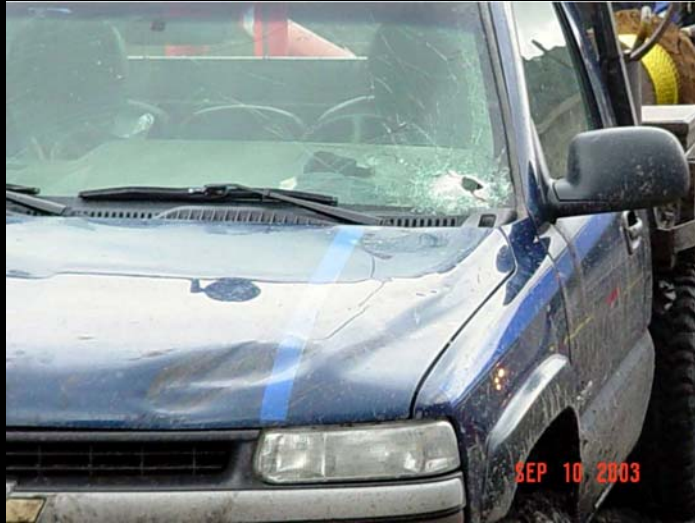
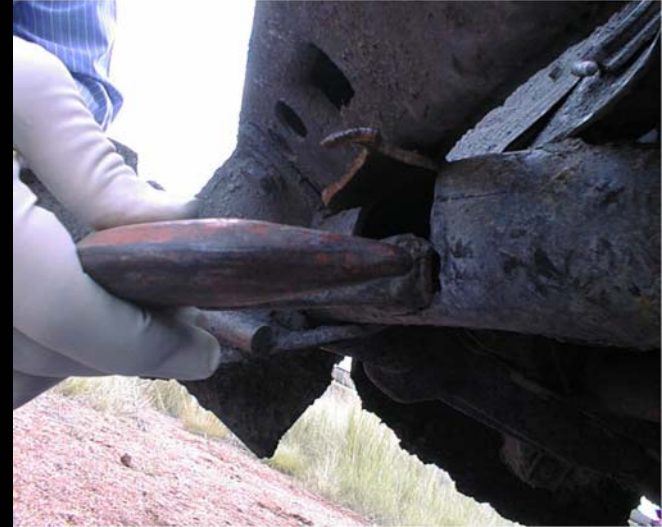
- Two metal hooks had been welded to the tubular steel hitch receiver on Madsen's truck (towing truck).
- These hooks were mainly used to attach the ropes from the cable horns when moving trailing cable.
- The hook on the left side had broken off previously, but the area where it was welded was clearly visible.
- Madsen attached the tow rope to the hook on the right side when hooking up to Beavers' truck before the accident.
- He placed the eye with the clevis on the hook.
- Examination of the hook found no markings from the steel clevis, indicating only the rope eye had been placed over the hook.
- The tubing of the receiver frame failed, allowing the hook to dislodge from the receiver frame.

- This hook broke off during the attempt to pull Beavers' truck and projected back causing the injuries to Beavers.
- Visual observations indicated the welds remained intact but the tube wall failed around the welds on the sides adjacent to the hook base.

The use of a hook, welded on the hitch receiver of the towing truck, as the attachment point for the tow rope between the two trucks, created an unsafe operating condition that resulted in the hook fracturing the receiver steel and projecting back towards the truck being towed, causing the accident. The physical orientation of the hook on the receiver frame combined with the direction of the rope's pulling force induced a load that exceeded the structural capabilities of the receiver frame in the area in which the fracture started. The fracture appeared to have initiated in the heat affected zone of the welded area of the receiver frame. The use of a nylon tow rope as the towing device contributed to the cause of the accident as the elongation characteristics of the nylon rope allowed greater energy storage than that which would occur in other types of towing devices.

- **Use only tested and approved mechanisms for pulling or towing.**
- **Obtain approval of manufacturer for modifications to original towing equipment.**
- **Ensure employees are properly instructed on proper towing practices.**
- **Ensure vehicles have sufficient traction for surface conditions.**
- **Conduct audits (observations) of specific tasks to ensure proper techniques are employed and tools/materials are maintained.**
- **Never exceed the rated capacity of a tow vehicle or towing equipment.**
- **Use hands-on training specific to the individual task.**
- **Communicate & prepare pre-task check of materials and techniques for every application.**
