**Internal Review of MSHA's Actions at the
Aracoma Alma Mine #1
Aracoma Coal Company, Inc.
Stollings, Logan County, West Virginia**

U.S. Department of Labor
Mine Safety and Health Administration
Program Evaluation and Information Resources

June 28, 2007

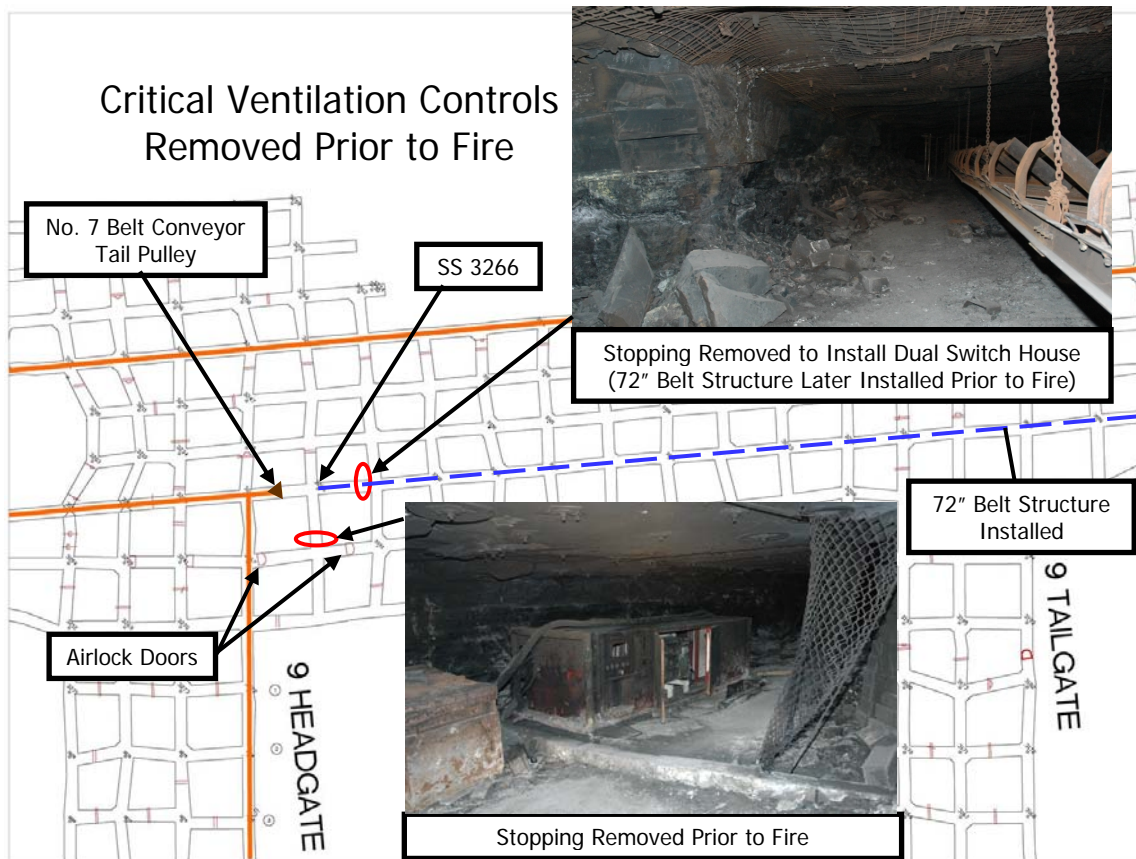
The removal of the stopping located immediately adjacent to the North East Mains roadway South of SS 3266, in the crosscut where the Panel No. 9 Longwall Belt electrical installations were located, made the electrical installations common with the 2 Section escapeway and adjacent to the daily travel route. There was also a second stopping removed inby in the same entry as the No. 7 belt conveyor which is discussed further in the *Enforcement of 30 CFR 75.380(g)* section of this report. The most recent documentation of the inspection of these electrical installations was September 26, 2005. These installations were not documented as being inspected during the regular inspection conducted from October through December 2005.

The mine records of Weekly Electrical Examinations were documented as being inspected on December 19, 2005. At that time, the operator's last documented weekly examination for the electrical installations associated with the 9 Headgate Longwall Belt was November 25, 2005. The MSHA inspector did not issue a citation for this violation or investigate further to check the area in question. The mine operator's next examination of these electrical installations was documented on December 20, 2005.
