Docket No. SA-522

Exhibit No. 15-C

NATIONAL TRANSPORTATION SAFETY BOARD

Materials Specialists' Submission
Selected Photographs of the Fractographic
Examination of the Vertical Stabilizer

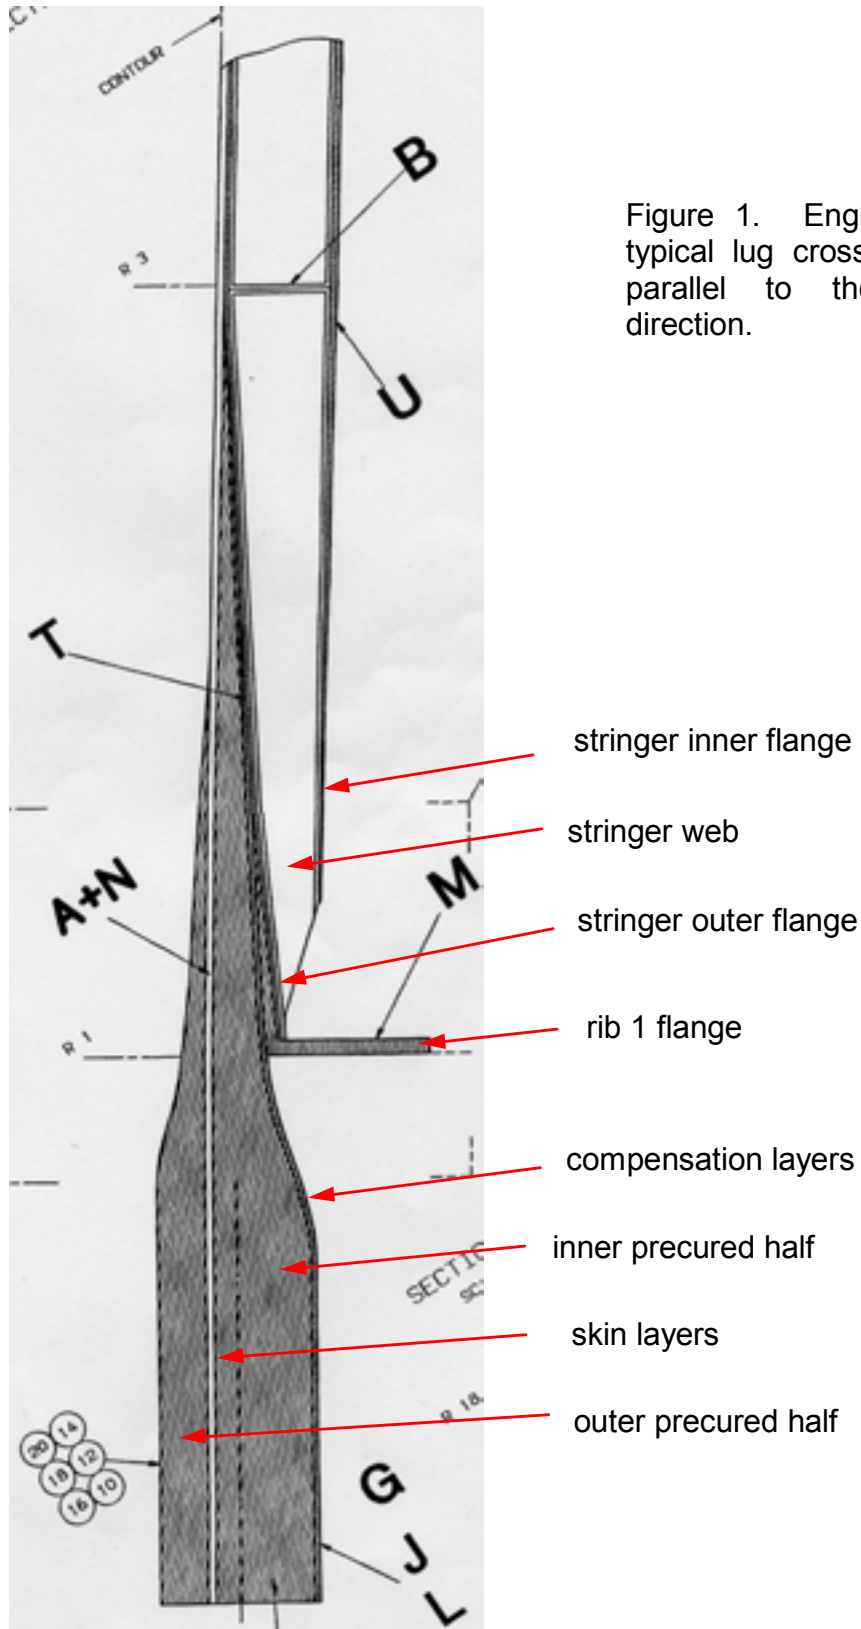
Figure 1. Engineering drawing of a typical lug cross section in the plane parallel to the zero-degree fiber direction.

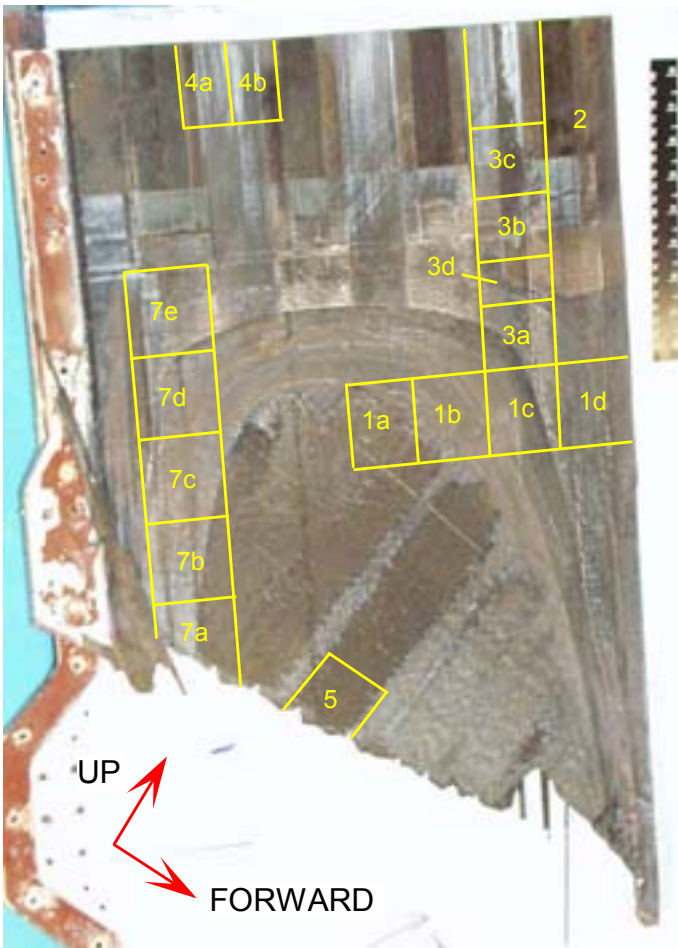
ImageNo:210A0003, Project No:A00415

Figure 29. Specimens cut from the left aft skin section for examination using SEM.

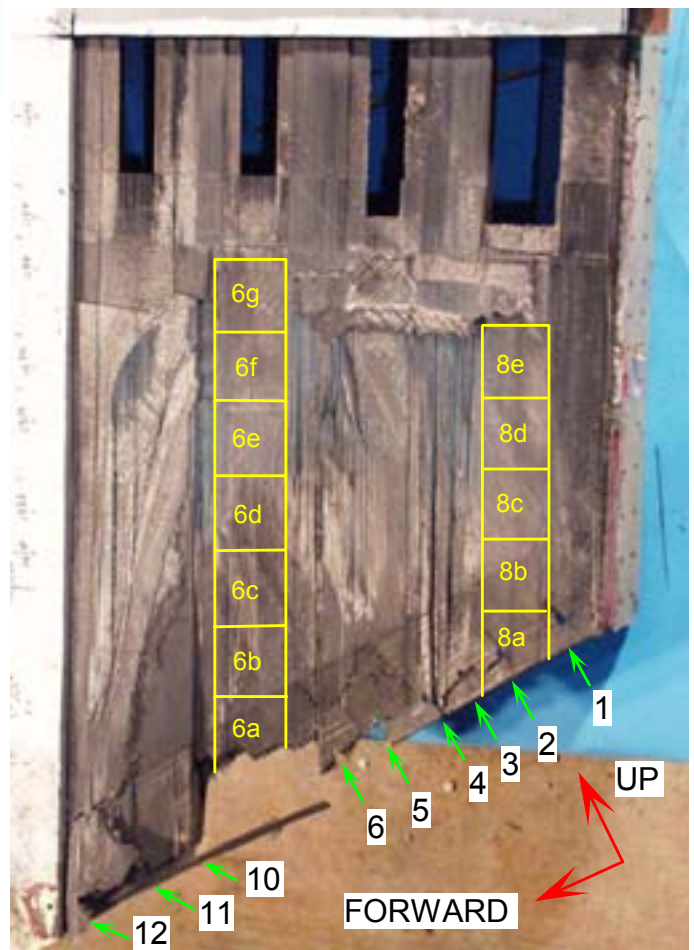
ImageNo: 210A0004, Project No:A00415

Figure 30. Specimens cut from the lower end of the left aft upper skin panel piece for examination using SEM. Rib 1 fastener holes are numbered at the bottom of the part.

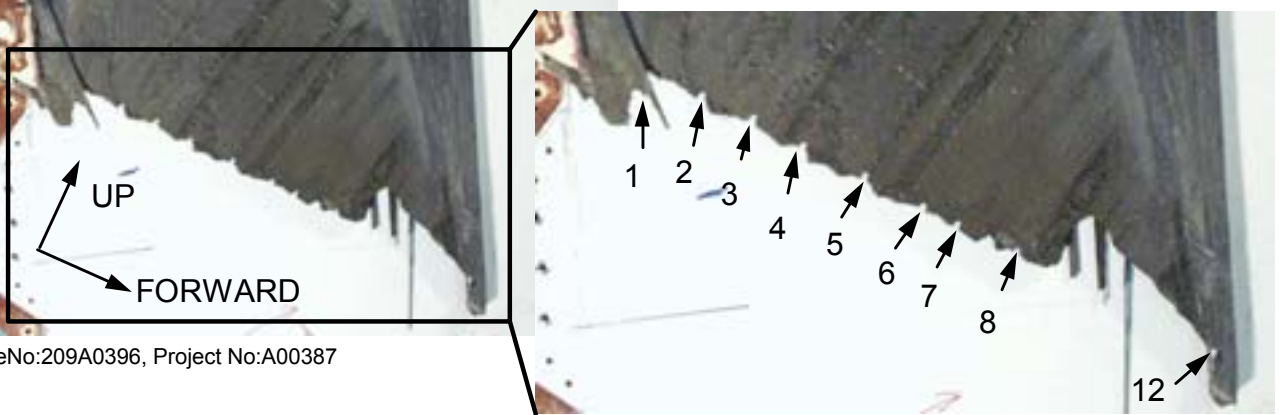
ImageNo:209A0403, Project No:A00387

Figure 32. Vertical stabilizer skin fracture at a rib 1 fastener hole in the vicinity of the left aft lug, viewed looking upward.

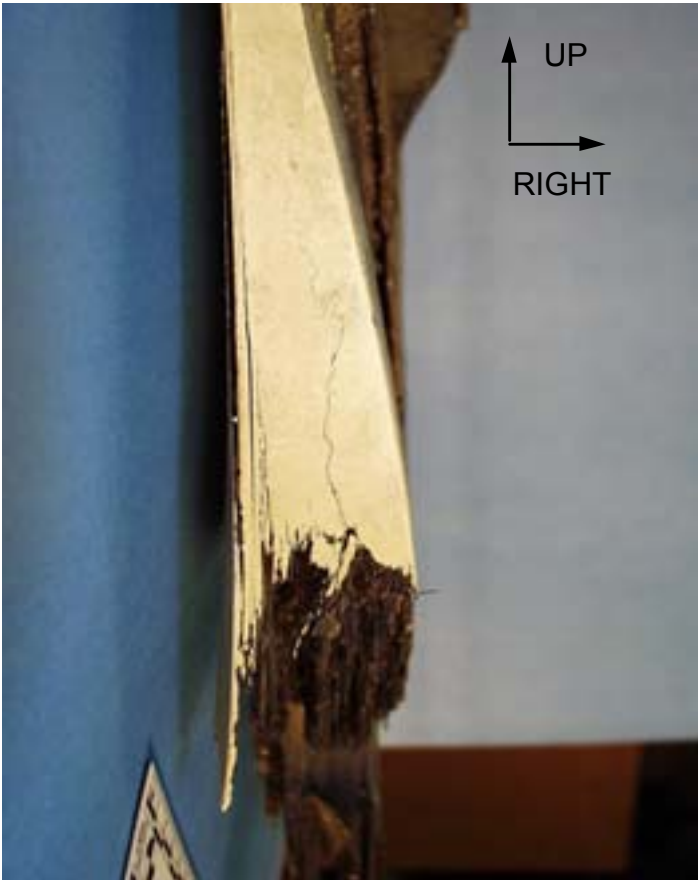
ImageNo:210A0045, Project No:A00387

Figure 48. View of the aft surface of the left forward lug.

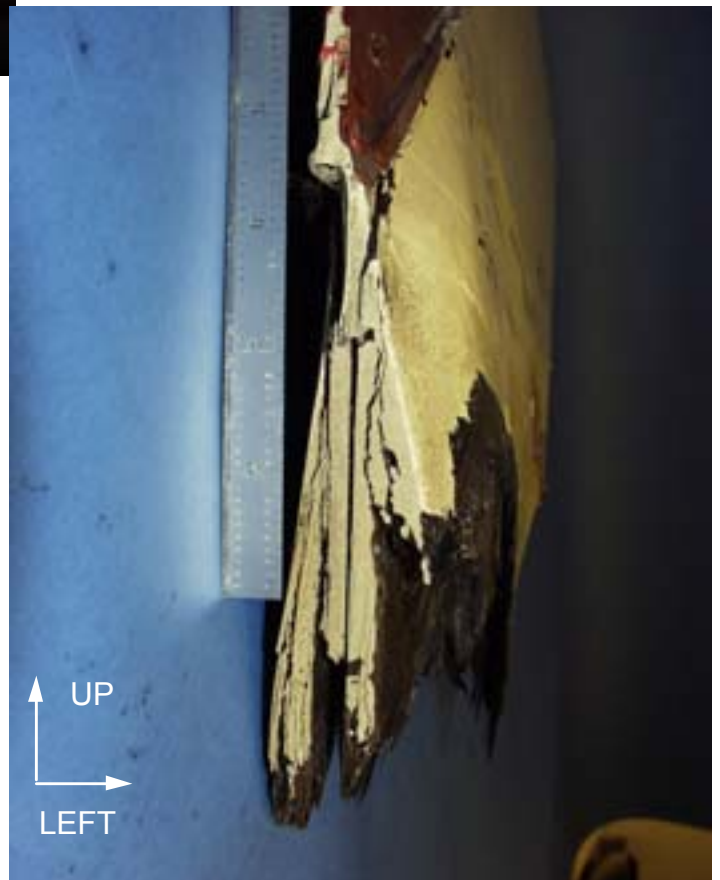
ImageNo: 210A0043, Project No:A00387

Figure 48. View of the forward surface of the left forward lug.

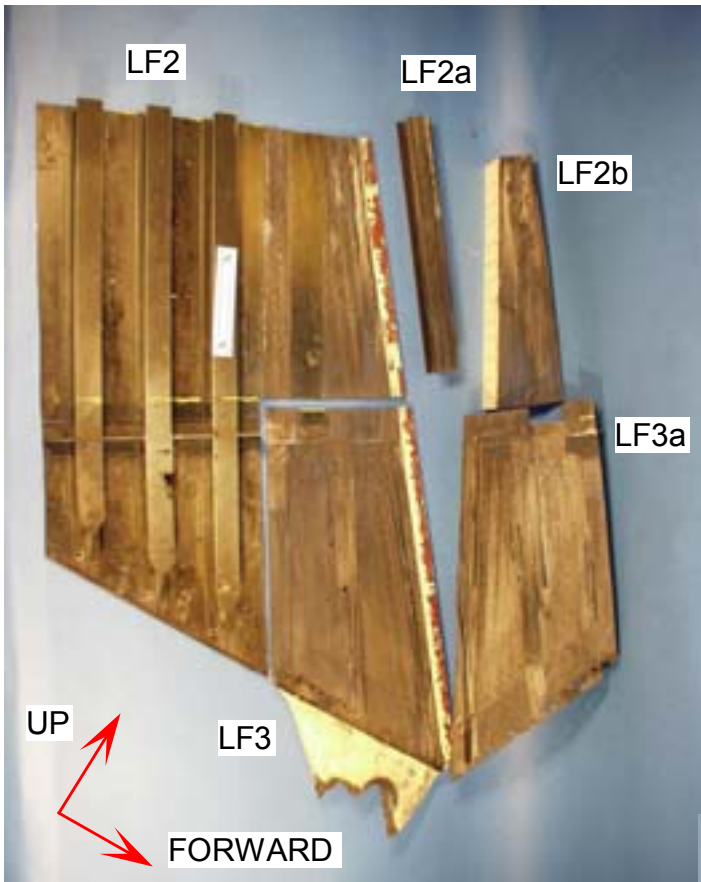
ImageNo:210A0031, Project No:A00424

Figure 54. Mating pieces after cutting to expose the interlaminar fracture above the left front lug. Arrows indicate UP and FORWARD for the main pieces LF2 and LF3.

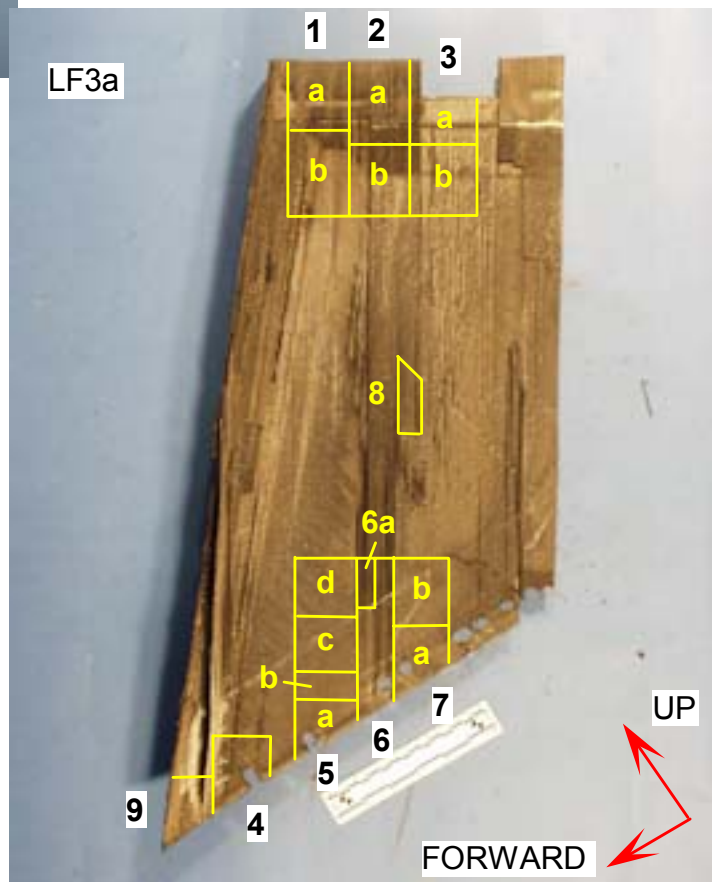
ImageNo: 210A0032, Project No:A00424

Figure 55. Specimens cut from section LF3a for examination in the SEM.
