High-Frequency Response Functions for Composite Plate Monitoring with Ultrasonic Validation

Engineering Sciences & Applications
Los Alamos National Laboratory
Los Alamos, NM 87545

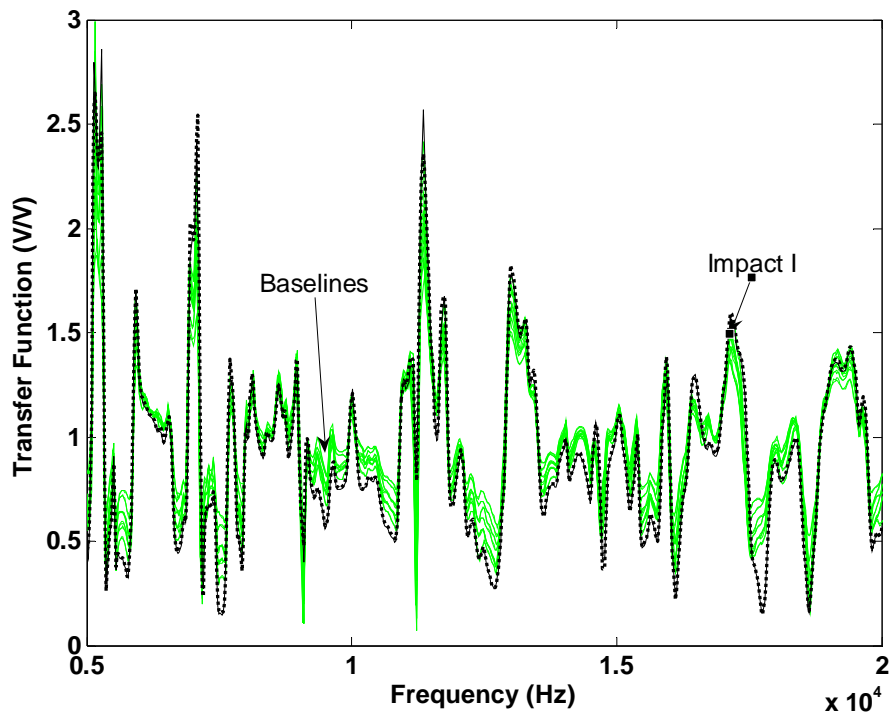
Figure 10: Baselines and after Impact 1 (dotted line)

For the normalized FRF, the measurements are quite repeatable. The essential pattern of the FRF signatures remains the same over the 3 week test period when damage was not induced. The normalization procedure is, therefore, applied to the subsequent measurements taken after the impacts. When Impact 1 (31.09 m/s) is introduced, no or minor changes in the response were observed, shown in Figure 10, indicating that no (or very small, if any) damage is introduced by Impact 1. Impact 2 (39.93 m/s) produces considerable changes in frequency response functions as shown in Figure 11. This change could be considered an indicator of the severity of damage induced by the impact. This impact also causes visual damage to the plate, as shown in Figure 5. All the remaining impact shows the noticeable changes in FRF signature. Figure 12 and Figure 13 illustrate the response after Impact 3 and 4 and after Impact 4 and 5, respectively. Once again, it is easy to see that the signals are qualitatively different before and after the corresponding impact, which indicates the presence of damage in the plate.

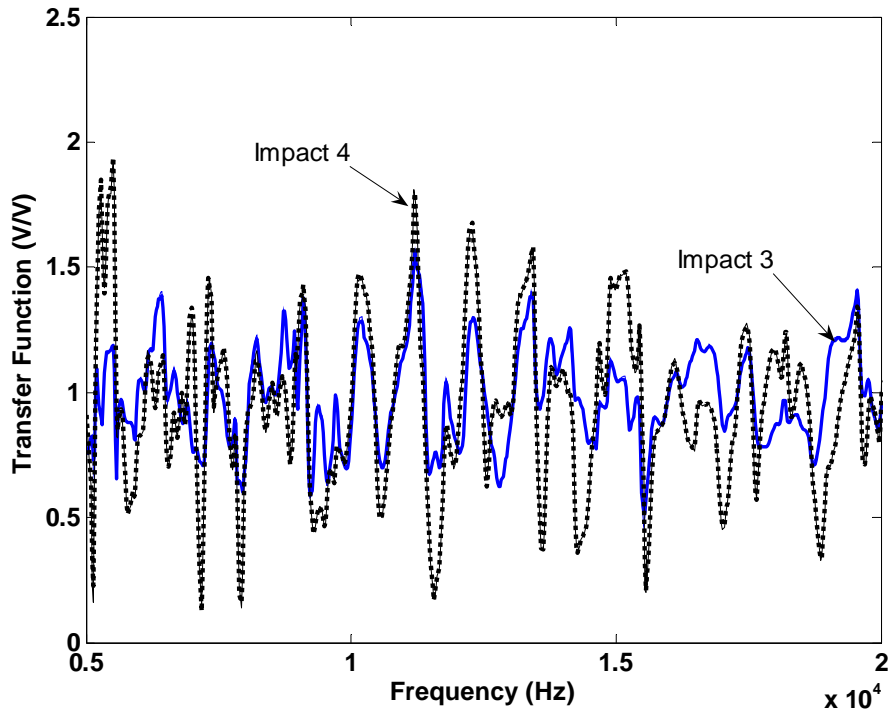
Figure 12: Responses after Impact 3 and Impact 4 (dotted line)

In Table 1, the largest variation of damage metric in the baselines is identified to be 0.0353. Therefore, any value higher than that is taken to represent changes in the structural condition or the presence of damage. After Impact 1, the maximum value for the damage metric is 0.0465. Although it is higher than the established threshold value, it is considered as a “suspicious” condition rather than definite “damaged” condition because of its minor increase. It is confirmed by the ultrasonic scan (described later) that Impact 1 did not produce any delamination in the plate. Rather, it is believed that Impact 1 causes fiber-split, or fiber-breakage, and these damaged conditions could not be identified through the ultrasonic scans. Impact 2 stands out as having the highest damage metric relative to other conditions. Impact 2 was the highest projectile velocity and caused the most visible damage to the plate. All other impacts cause relatively large increases in the damage metric, which indicates that the impact introduced invisible damage into the plate. The results in Table 1 also show that Impact 4 causes more significant changes in the plate compared to Impact 3, even though it has a lower impact velocity.
