Failure Analysis Associates, Inc.  
Engineering and Scientific Services  
149 Commonwealth Drive, P.O. Box 3015  
Menlo Park, California 94025  
(415) 326-9400 Fax (415) 326-8072  
Internet Site: www.fail.com

Faaa-SF-R-96-06-16

## Investigation of the Failure of an SCBA Cylinder

July 2, 1996

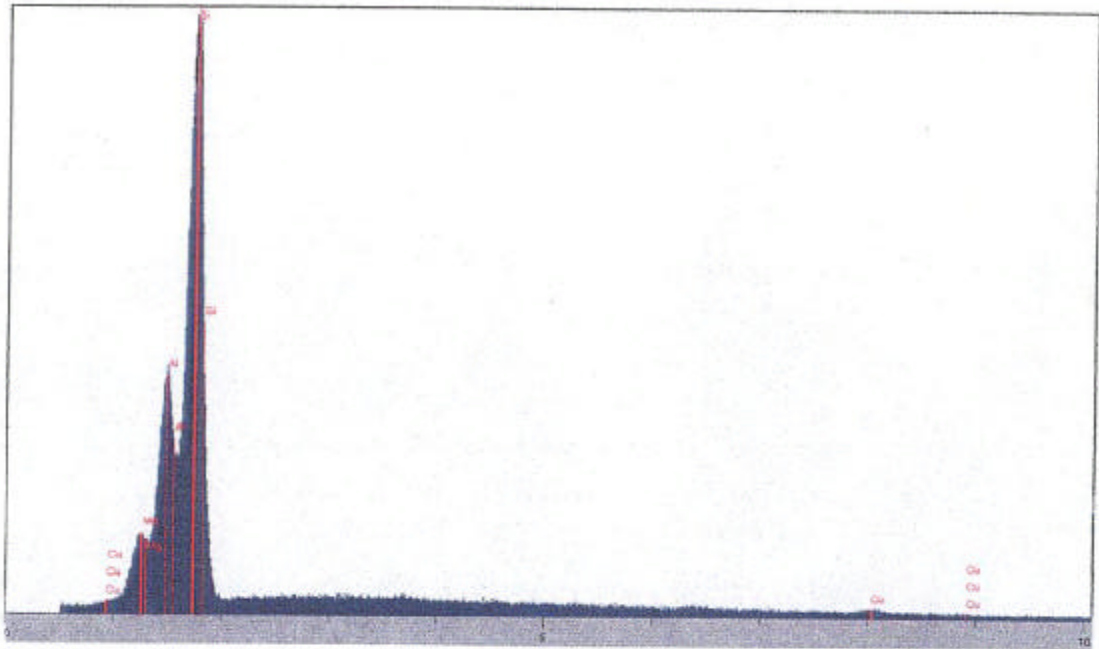
Figure 13. EDS Spectrum of Fiberglass Sample

Chemical analysis by EDS was performed on samples E, 4, 5 and 6. Our EDS analyses were only sensitive to elements with atomic numbers greater than 10, i.e. sodium and above on the Periodic Table. Therefore, any hydrocarbon compounds or oxides would not be detected using our EDS technique. No significant evidence of the presence of sulfur or phosphorus, from possible Alume™ mineral acid components, was observed. A typical EDS spectra is shown in Figure 13. The EDS spectra from sample 6, Figure 14, exhibited additional titanium spectral peaks which are associated with the yellow paint pigment.
