NIOSH
Fire Fighter Fatality Investigation
and Prevention Program

March 27, 2000

Floor Collapse Claims the Life of One Fire Fighter and Injures Two-California

Fatality Assessment and Control Evaluation Investigative Report #99F-03

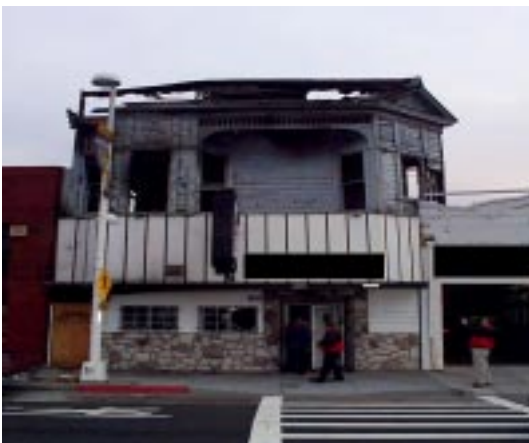
Incident Scene

At 1046 hours, Truck 2574 was the first to arrive on the scene and reported heavy smoke was emitting from a two-story building (see Photo). Dispatch also made a report that they had received calls stating that civilians were trapped on the second-floor of the burning structure. Truck 2574 established Command and requested a second alarm. Battalion Chief 2512 arrived on the scene and assumed command. He immediately struck a third alarm and shortly after struck a fourth alarm because there were buildings adjoining the burning structure and he wanted to control the fire from spreading (see Photo). Engines 2550 and 2545 arrived on the scene shortly after. Engine 2550 hooked up a 2 ½ -inch line to a nearby hydrant and proceeded to the burning structure as Engine 2545 hooked up a 5-inch supply line to the hydrant. Engine 2550 and Engine 2545 pulled two 1½-inch attack lines and took position at exposure A (see Diagram). Engine 2548 arrived on the scene and set up in the rear of the structure at exposure C and side D, while Truck 2574 placed their aerial ladder to exposure C. Engine 2548's original assignment was to act as the Rapid Intervention Team (RIT), but as they arrived at 1051 hours, they requested to set up in the rear due to the amount of apparatus already in the front. At 1052 hours, Battalion Chief-2514 arrived and was assigned to be in charge of Outside Operations. He immediately proceeded to side D and then to exposure A, to complete a size up of the structure.

The Captain from Engine 2545 and a fire fighter from Engine 2555 entered the secondary front door, which lead to the second-floor (see Photo). As the two proceeded up the steps with the Captain on the nozzle, the steps collapsed, and the Captain and fire fighter retreated and exited the structure. The Captain reported to the IC that there was heavy fire near the stairs and that they could not access the second-floor. The Captain ordered a fire fighter from Engine 2545 to retrieve an axe and break loose the steps so they could proceed under them to the rear of the structure. After the steps were knocked out, the Captain and two fire fighters from Engine 2545 and a fire fighter from Engine 2555 entered the area applying water and proceeded toward the rear of the structure approximately 35-feet where they encountered a gas furnace. The furnace was blocking the fire fighters path to the rear of the structure, so they decided to remove the furnace and drag it to
