Thermal Cycling of Mir Cooperative Solar Array (MCSA) Test Panels

David J. Hoffman
Lewis Research Center
Cleveland, Ohio

National Aeronautics and
Space Administration

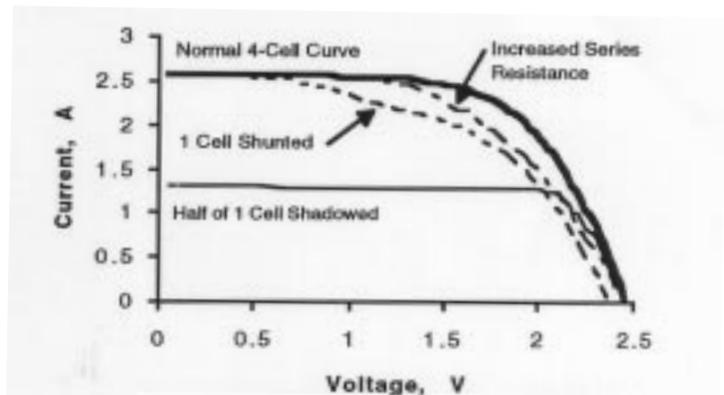
FIGURE 5. DEGRADATION IN 4 SERIES-CONNECTED CELLS

In order to illustrate these various effects, damage to an array of four MCSA-type solar cells connected in series was simulated. First, one cell was shunted while the other three cells were left untouched. Second, series resistance was added to the 4-cell string to show the effect of losing contact weld pads. Last, half of one cell was covered, or shadowed to simulate a loss of area within the cell. Figure 5 shows the results as compared to a normal 4-cell I-V curve.

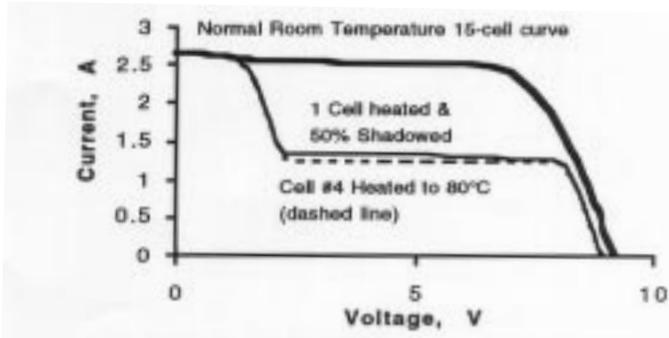
FIGURE 6. DEGRADATION IN 15-CELL TEST ARTICLE (RUSA-2)

A normal IV curve for the 15-cell series-connected RUSA-2 thermal cycle test article is shown in Figure 6.

The slight hump in the I-V curve near I_{sc} is due to the bypass diode. The bypass diode is across 10 cells, which includes 5 cut cells shortened to 7.5 x 8 cm instead of the normal full 8 x 8 cm. The cut cells limit the maximum current through most of the I-V curve. Once the bias voltage drops below the voltage of the final row of cells, the bypass diode operates, eliminating 10 cells form the circuit, and the current is only supplied by the remaining 5 uncut cells and rises up to the full area value.

The dashed line labeled "Cell #4 Heated to 80 °C" shows the I-V curve shape which resulted after heating the bad cell (cell 4) in RUSA-2. Notice the current is limited to nearly 50% of the baseline. This curve is nearly identical to the result obtained after one-half of one cell was covered, or shadowed, so that it only produced half of its full area current capability, labeled "1 Cell Heated & 50% Shadowed". The very obvious similarity in these two I-V curves indicates that a loss of area in cell #4 is one possible explanation of the current drop seen at elevated temperatures. Note the I-V curve shape reveals no shunting or increased series resistance characteristics, which would seem to rule out explanations using those phenomenon by themselves.
