Hybrid 7z77 Traveler

June 27, 2000

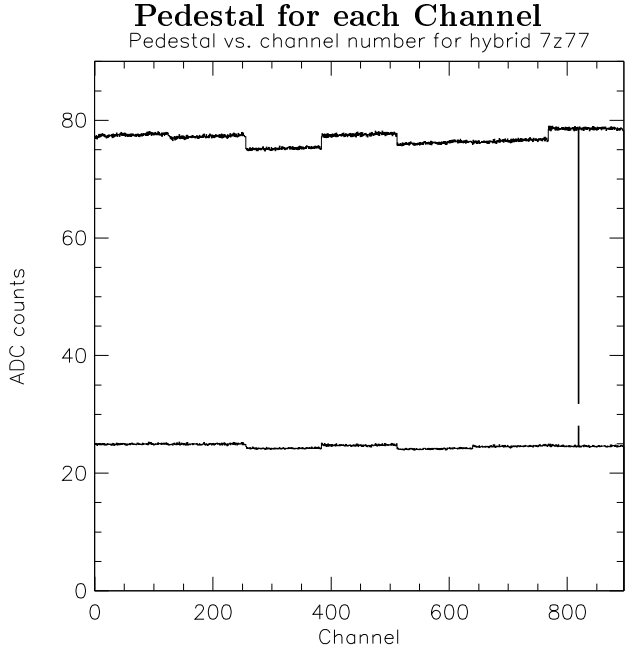
Pedestal for each Channel

The following plot shows the pedestals vs. channel number with and without charge injection:

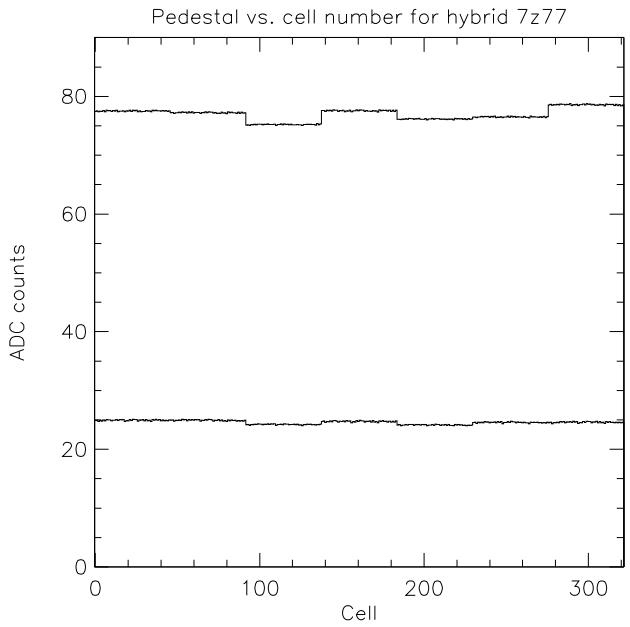
Pedestal vs. Pipeline Cell ID

The following plot shows the average pedestal vs. pipeline cell ID with and without charge injection. The x-axis is cell ID offset by 46 for each chip. Thus cell ID 5 for chip 1 is at x=5, chip 2 at x=51, chip 3 at x=97, etc.

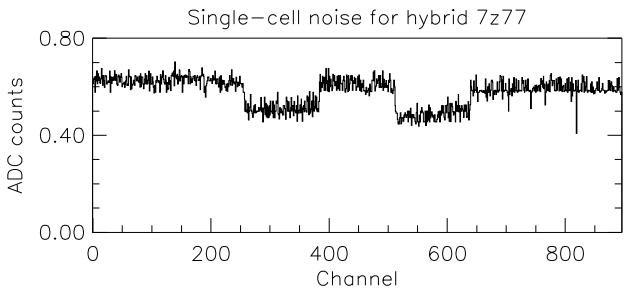
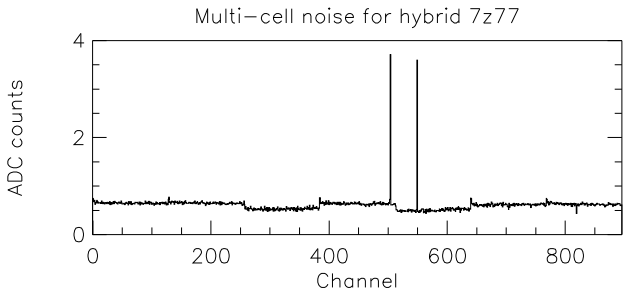
RMS Noise

The following plots show the single-cell and multi-cell RMS noise:

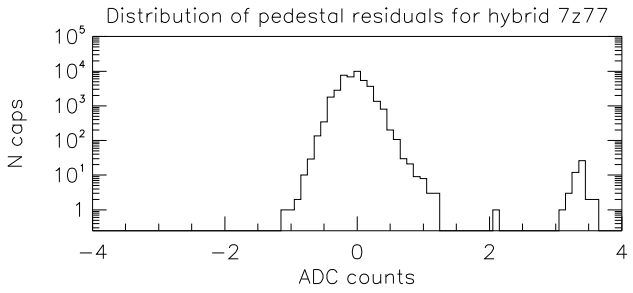
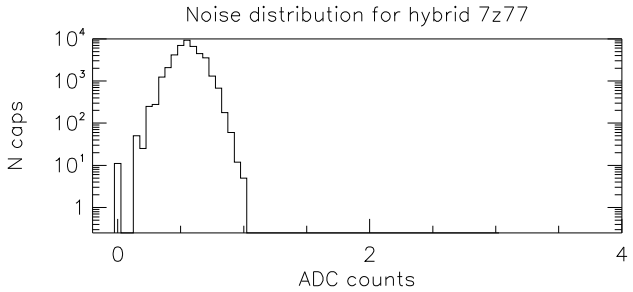
Distribution of Pedestals and Noise

The following are histograms of the pedestal of each pipeline capacitor relative to the chip average (top); and the RMS noise of each capacitor (bottom):

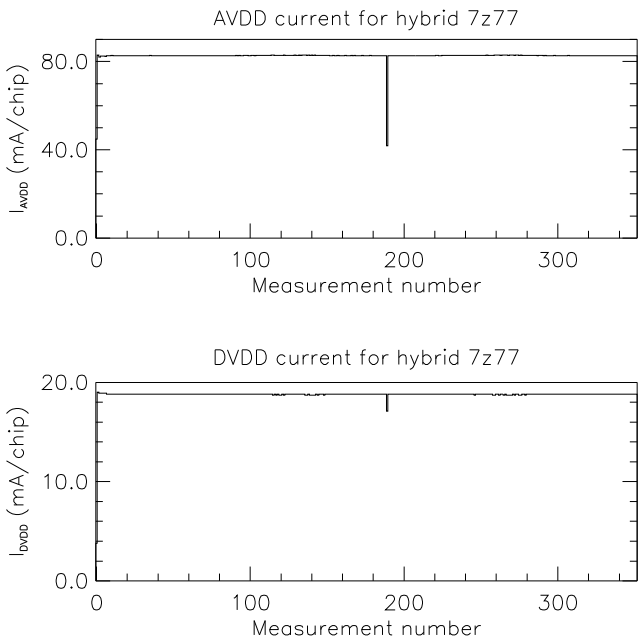
Supply Currents During Burn-in

The following plots show the supply currents per chip as a function of measurment number. Currents are measured approximately every 10 minutes:
