## Unreviewed Safety Question Activity Report

2005-4

Office of Facility Safety (EH-2)

October – December 2005

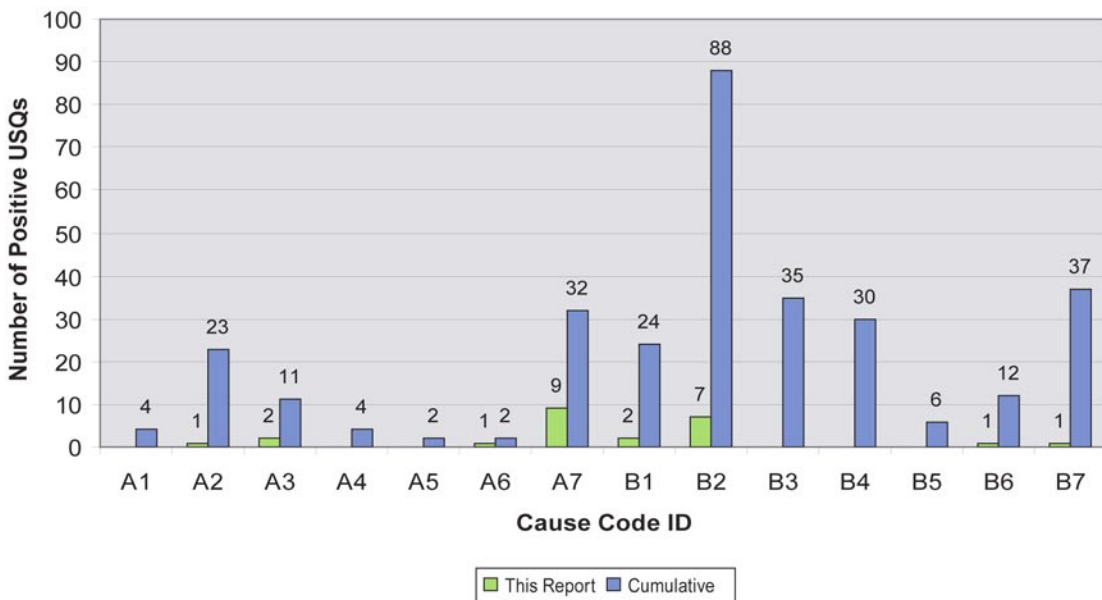
**Figure 2**  
**Grouping of USQDs by Cause Code**

From October through December 2005, there were 24 positive USQDs across the DOE Complex. The results of the team’s review of the USQDs are discussed below. Specific details for each USQ (in tabular form) are provided in Appendix A. Figure 2 shows USQs reported for this period and the cumulative period from March 2001 through December 2005, grouped by the cause codes defined in Table 1 (page 8). Figure 3a shows the percentages of USQs by cause code for the period of October through December 2005, and Figure 3b shows the percentages of USQs by cause code for the cumulative period of March 2001 through December 2005.

Note: For the Cause Code definitions, see Table 1 on page 8.  
 \* For the period from March 2001 – December 2005  
 The cumulative number of USQs equals 310.

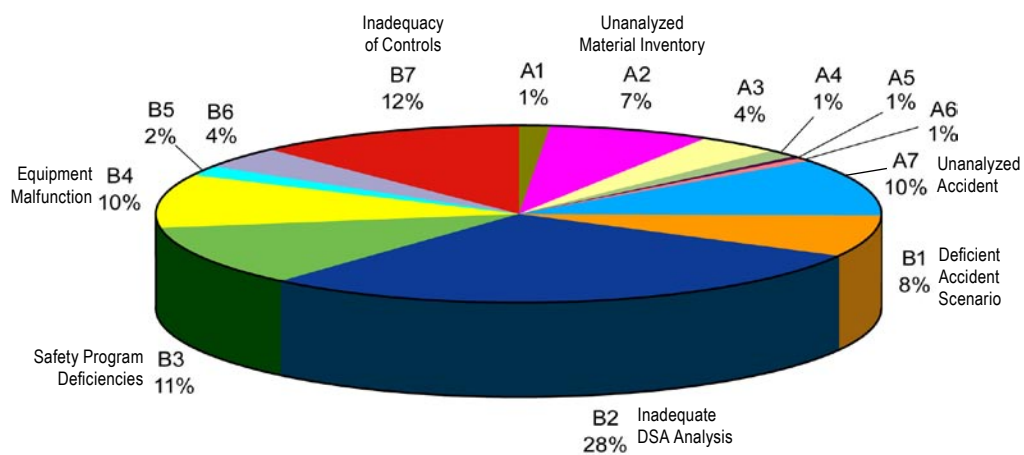
**Figure 3b**  
**Percentages of USQs by Cause Code**  
 (Cumulative\*)

Note: For the Cause Code definitions, see Table 1 on page 8.  
 \* For the period from March 2001 – December 2005
