PRESERVATION TREATMENTS

Protection and Stabilization (Mothballing)

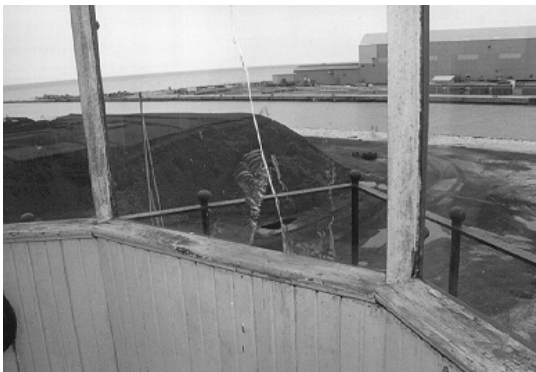
Figure 7. Lantern glass with holes and/or cracks should be replaced as soon as possible to minimize water infiltration. If immediate replacement is not feasible, the glass can be temporarily patched.

- **Lantern glass:** Lantern glass, frames, and roofs must be weathertight before mothballing. Refer to the **Lantern** section of this handbook for more information concerning weatherproofing lantern components.

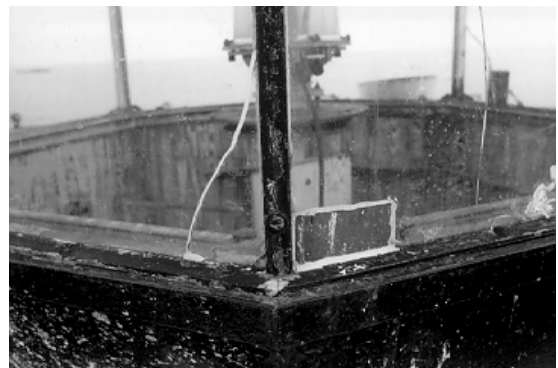
Figure 8. Detail of an acceptable temporary repair to a lantern glass using a piece of painted sheet metal that has been adhered to the glass with a high quality, exterior grade caulk. This type of temporary repair will prevent water from entering the lantern and therefore help avoid further damage. This fix should be considered only as an interim treatment until replacement of the lantern glass.

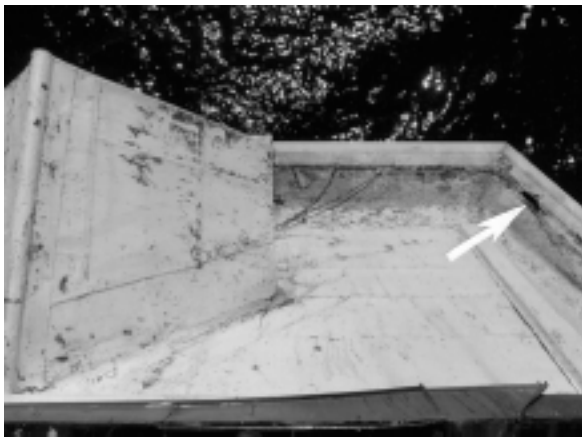
Figure 9. View of built-in gutter system on a mansard-style roof; the arrow indicates where a fist-size hole exists. This hole allows water to enter the interior of the lighthouse.

- **Built-in gutter systems:** All rainwater gutter systems (lantern roofs, or other tower roof forms) should be cleaned and checked for holes. All holes and non-functioning gutter system components should be repaired. For more information refer to the discussion on roofing in the **Lantern** section of the handbook.

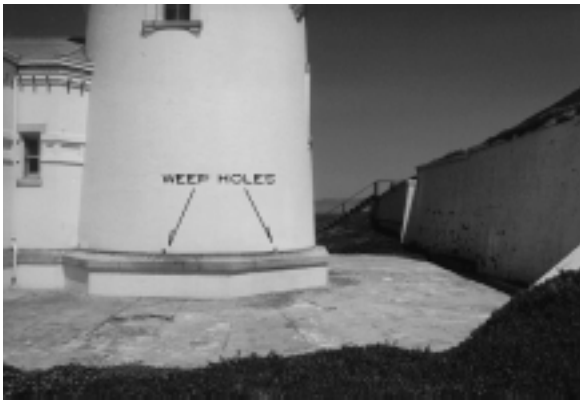
Figure 12. Typical masonry lighthouse weep hole locations. Each weep hole provides drainage for each individual cavity within the masonry wall.

- **Weep and vent holes:** If the walls have cavities between the interior and exterior walls, weep holes may exist at or near the base of these walls. Weep holes typically range in size from small slits to large brick headers. These holes allow any moisture that has entered the cavity between the walls to drain out. These openings must be kept clear in order to provide sufficient drainage of the cavity. In some instances the walls may have vent holes (larger than weep holes) that allow the movement of air through the cavities or voids. Typically vent holes open into the interior. These openings must be kept clear in order to provide sufficient ventilation (see Figure 12).
- **Protective coatings:** Lighthouses were often painted as a protective measure and for identification as a daymark. As part of a

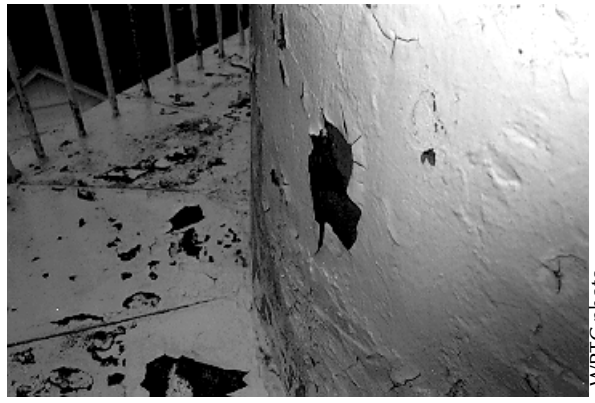
Figure 14. Detail of failing paint, a problem which should be addressed during stabilization and protection. In this particular case, spot painting may be all that is required to maintain a weatherproof protective coating.

mothballing treatment, the exterior coating should be checked for loose and flaking paint. Any deteriorating areas should be scraped and repainted to match the existing color. Ultimately, as part of a mothballing treatment the entire lighthouse should have all loose and flaking paint removed and a new coating applied according to the manufacturers specifications. If the overall condition of the coating system is sound and there are only a few bare spots, however, the lighthouse can be spot painted to provide a weatherproof coating. Either of these actions will result in a coating

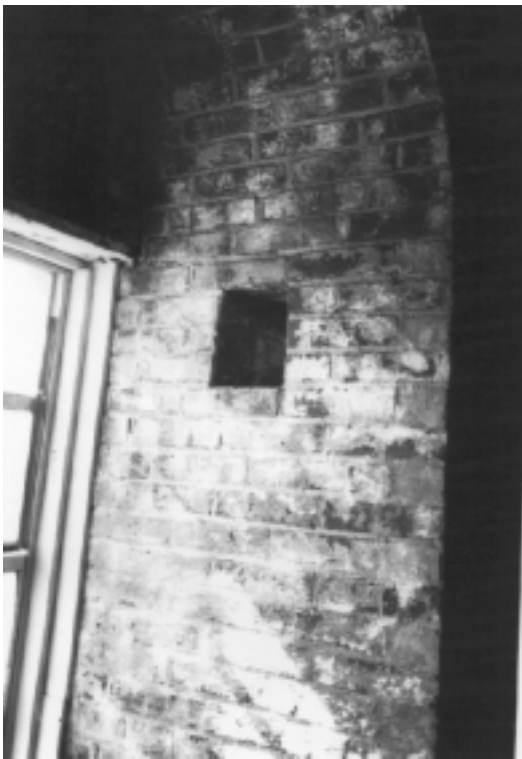
Figure 13. Vent hole located in the window well of a brick lighthouse.

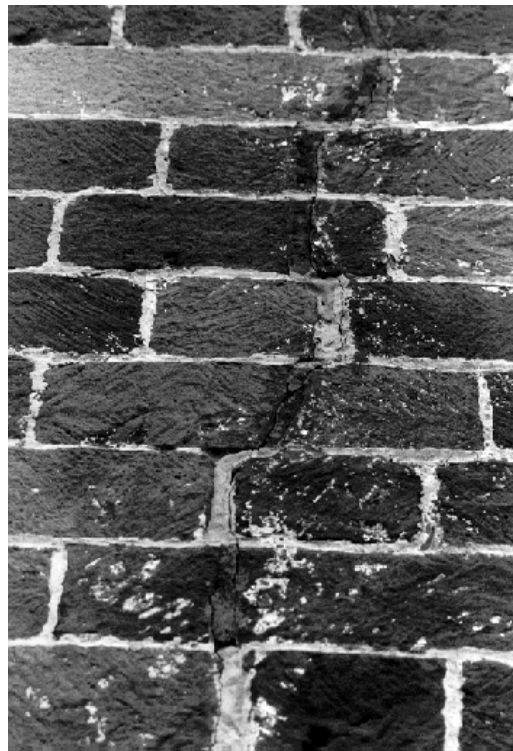
Figure 15. Cracks such as these in a sandstone lighthouse should be monitored for movement prior to treatment.

- **Open cracks in walls:** Cracks in exterior masonry walls indicate that movement has occurred, either caused by shrinkage (in the case of stucco) or by settlement or mechanical impact. Cracks should be monitored to determine if movement is still occurring and

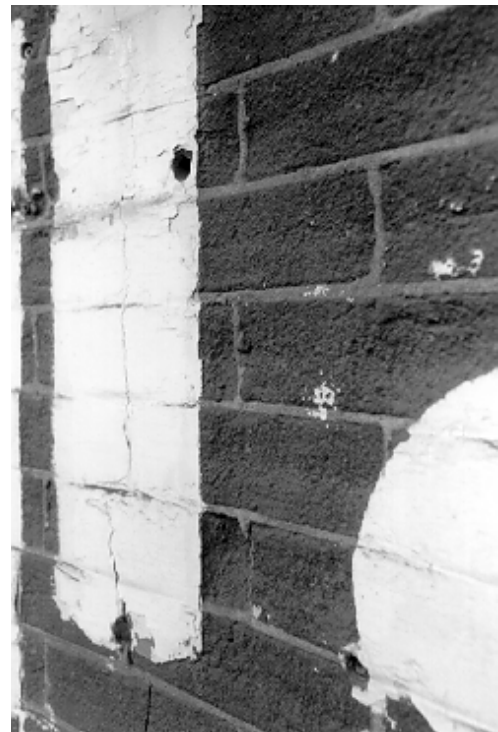
Figure 17. Deeply eroded brick as a result of sandblasting. The white areas are where electrical components were attached to the wall at the time of sandblasting.

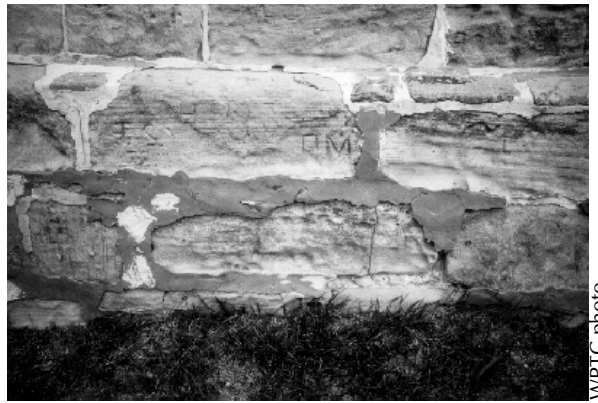
Figure 19. The use of hard portland cement mortar and sloppy pointing technique have aided in the deterioration of this soft sandstone wall.

Modern portland cement has a higher compressive strength than the lime-based mortars. This quality makes the portland-based cements less flexible than the lime-based mortars; therefore, the pointing tends to resist the expansion and contraction of the softer historic bricks. This resistance will ultimately cause the faces of the bricks to fracture and spall off the body of the brick. In some cases the exterior wythes of brick may shear from the inner core of the wall, resulting in the failure of the outer sections of the wall.

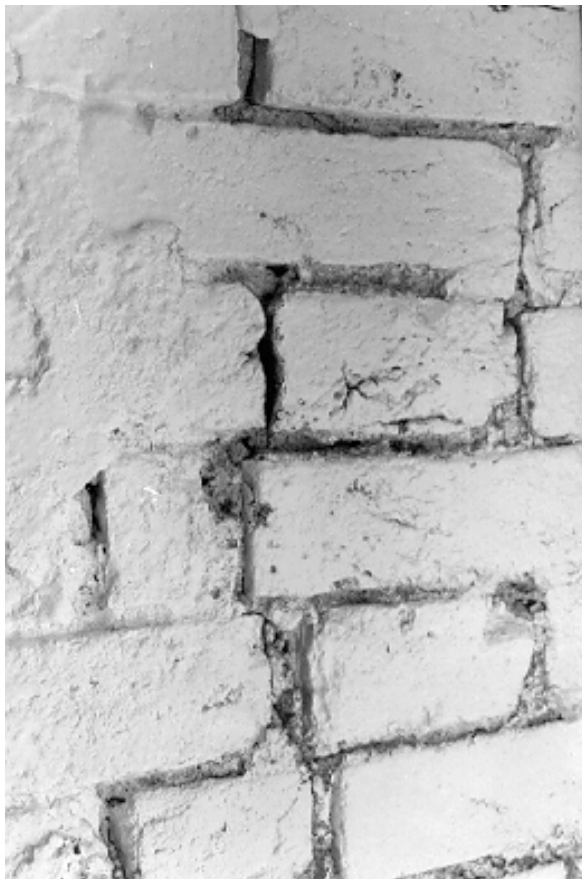
Figure 21. Detail of eroded pointing.

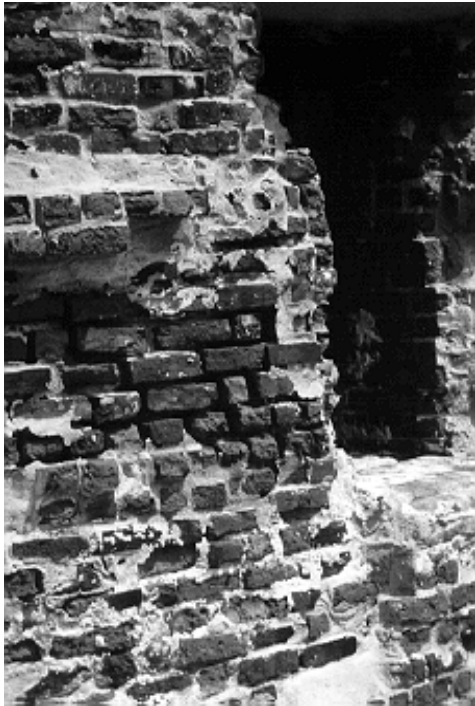
Figure 25. View of the lower portion of the tower showing the more severe deterioration. Note that a large percentage of the first brick wythe is missing or has been removed. The white areas are remains of a portland-cement-based parging applied in the late 1960s in an effort to protect the deteriorating bricks.

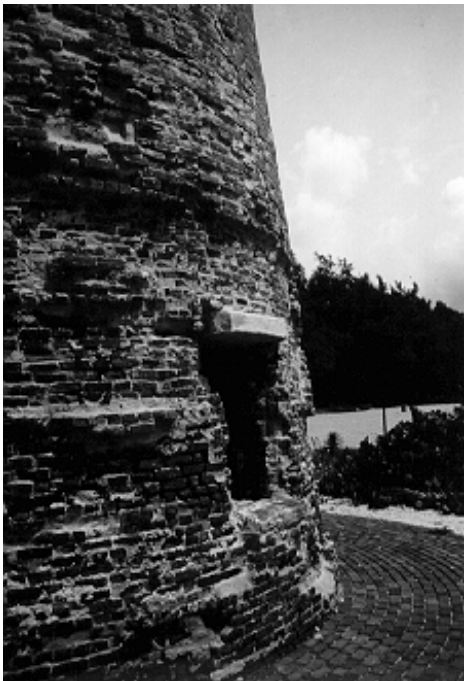
Figure 26. View of the lower tower window; note the depth of the brick deterioration at the window openings. The face of the protruding granite lintel above the window opening represents the face of the original wall.

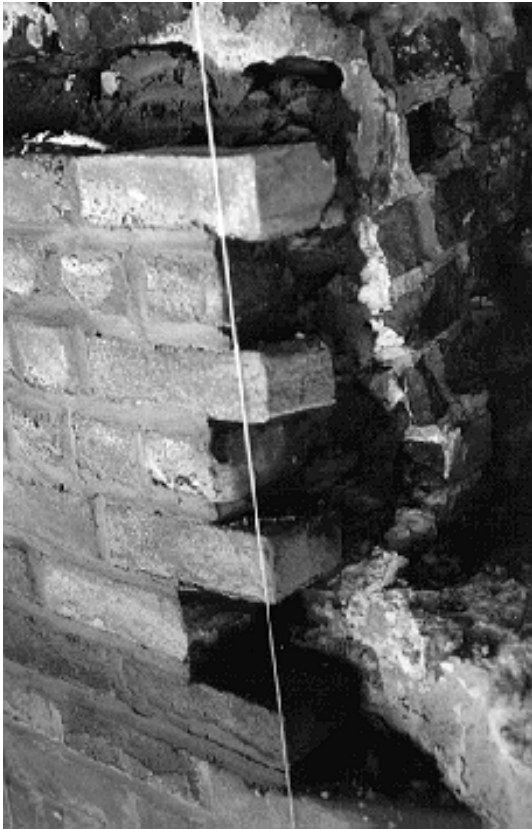
Figure 27. View of repairs being made to the exterior wall. A new brick wythe is being installed where bricks were missing, using mortar that matches the strength of the new and historic bricks. Masonry anchors are used to attach the new wythe to existing wall. The deteriorated mortar joints in the extant wall were repointed with a matching mortar mix.

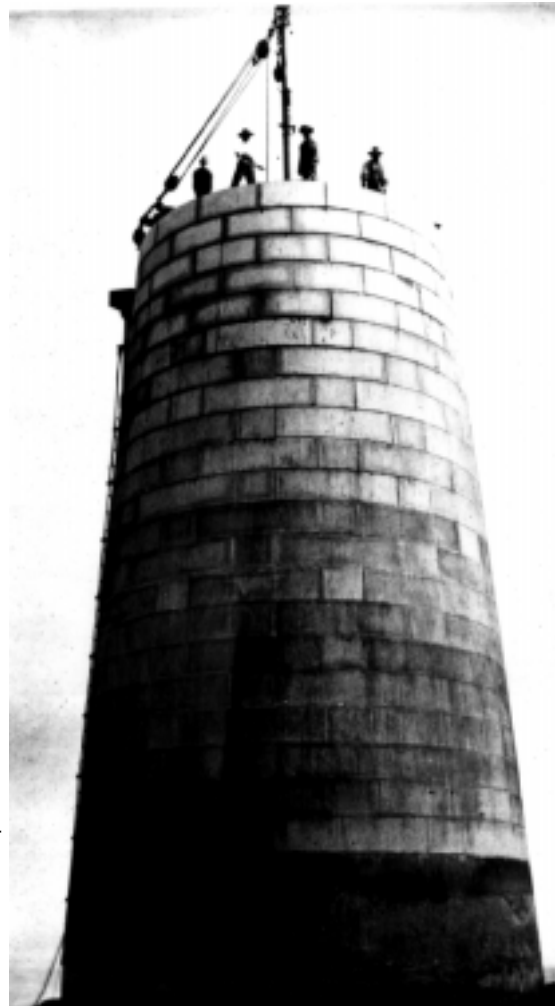
Figure 31. Work on Minots Ledge Lighthouse as it progressed just above the entrance level which is visible on the left. The tower below this level was essentially solid.
