ASRS

Directline

ISSUE No. 9

MARCH 1997

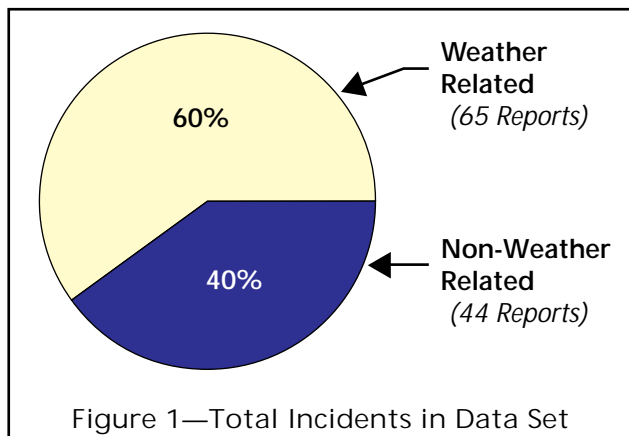
Sixty-five of the 109 reports (60 %) listed weather factors as the cause of the incident. (See Figure 1.)

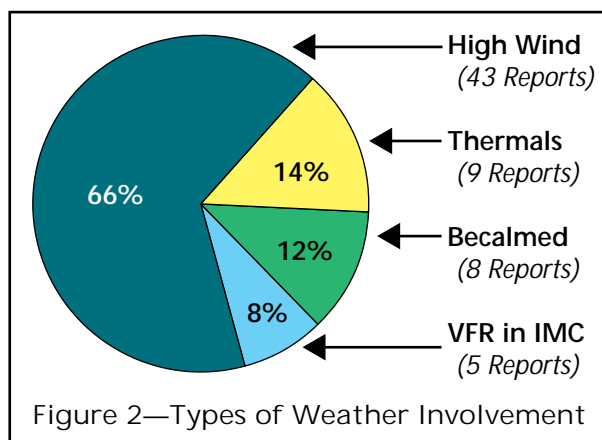
As may be seen in Figure 2 below, forty-three of the weather-involved reporters (66 %) listed unforecast increasing winds as their problem. Nine reports attributed their difficulties to thermals, or other downdrafts, forcing the balloon into the ground. An additional eight reports listed becoming becalmed as the source of their dilemma—not enough wind can be almost as hazardous as too much. One aeronaut became becalmed over trees at sunset, and pulled himself to a clearing by using the treetops. Finally, five reports were received from pilots who found themselves VFR in IMC due to fog or fast-forming clouds underneath.
