## PRESERVATION TREATMENTS

### Protection and Stabilization (Mothballing)

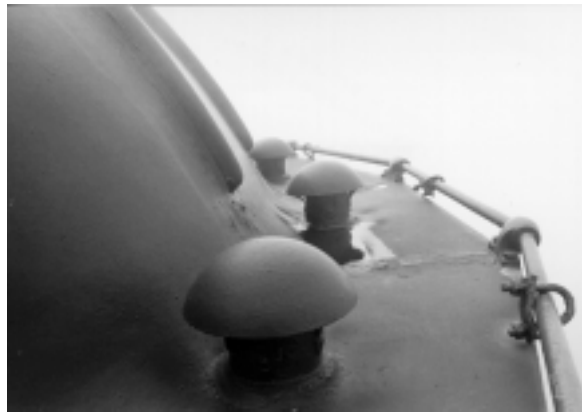
**Figure 17.** Roof vents such as these should be inspected for leaks and maintained during the mothballing period. This shroud-style vent allows air to pass while preventing rain from entering.

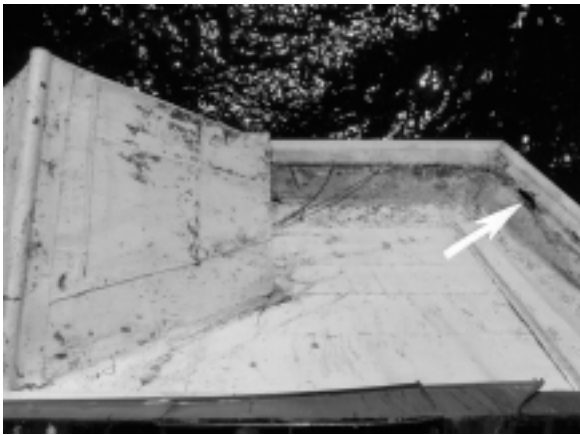
**Figure 18.** View of built-in gutter on a caisson lighthouse; arrow indicates fist-size hole. This condition must be treated before mothballing.

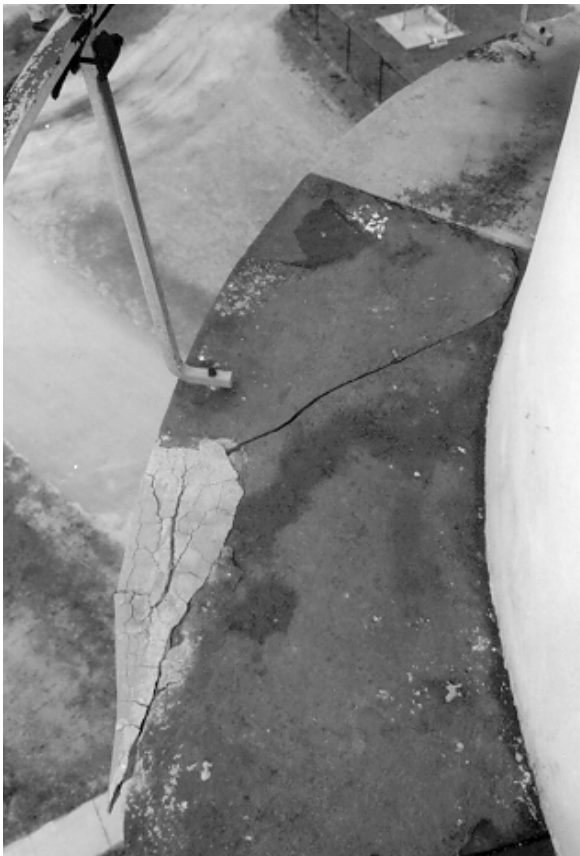
**Figure 19.** The repair made to this stone gallery deck has begun to deteriorate; moisture penetration is occurring. This condition should be addressed before mothballing.

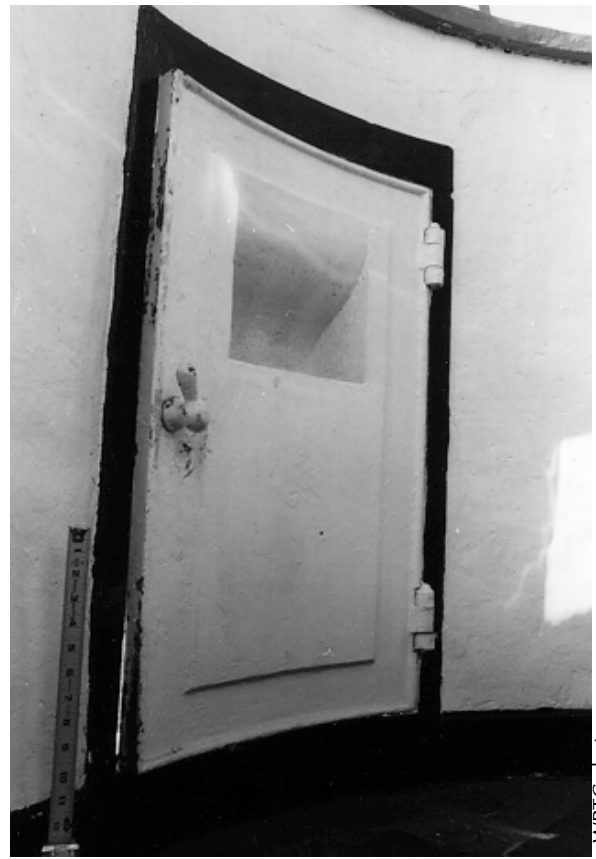
**Figure 20.** Close-up of a vented parapet hatch in a fourth-order lantern. The hatch should have a good seal and still remain operable. The built-in vent should also be kept open to maximize ventilation of the lantern and tower.

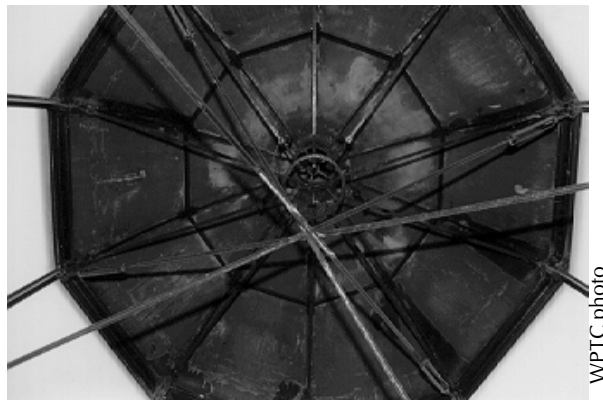
**Figure 21.** The diagonal tension rods in this empty lantern were installed to brace the lantern against lateral loading caused by high winds.

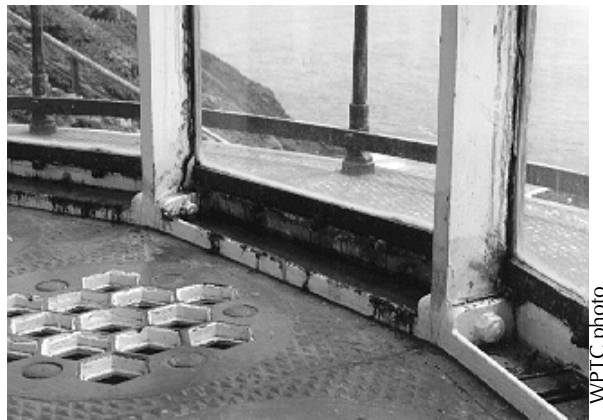
**Figure 22.** Close-up of sill vents in a first-order lantern. The vents should be kept open during the mothballing period to maximize lantern and tower ventilation.

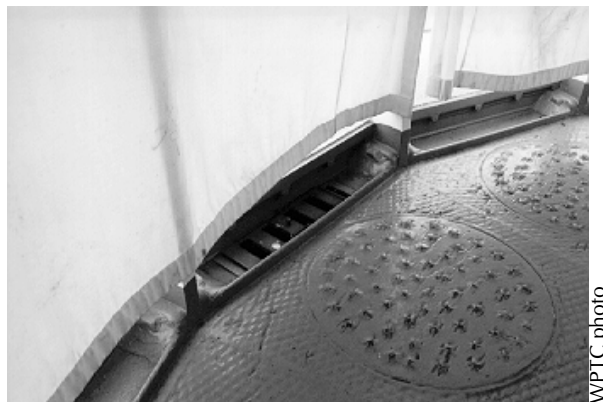
**Figure 23.** As part of the lantern mothballing treatment the lantern glass sill vents should be kept open (except in extremely damp climates) to allow for the free flow of air through the lantern.

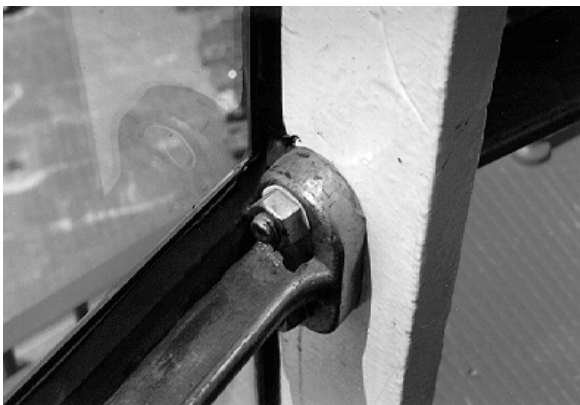
**Figure 24.** The stainless steel through bolts used to join this bronze sash bar to the vertical lantern post is isolated from the bronze using a nylon washer as a barrier.

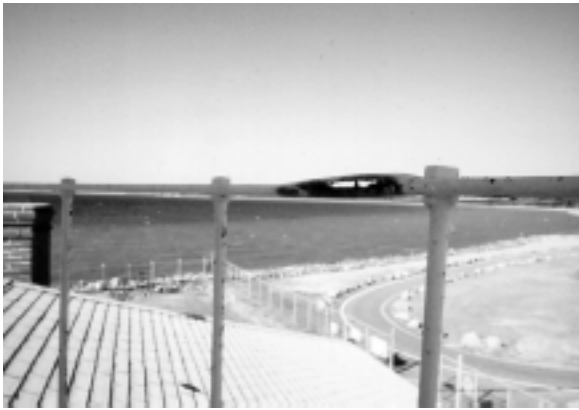
**Figure 26.** Detail of handrail that is being deformed by rust-jacking.

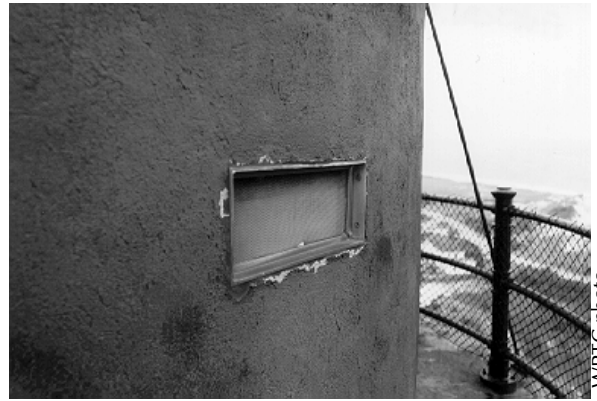
**Figure 27.** This lantern vent opening has been covered with a fine stainless steel screen that prevents insect infiltration while maximizing air movement through the vent and into the lantern.

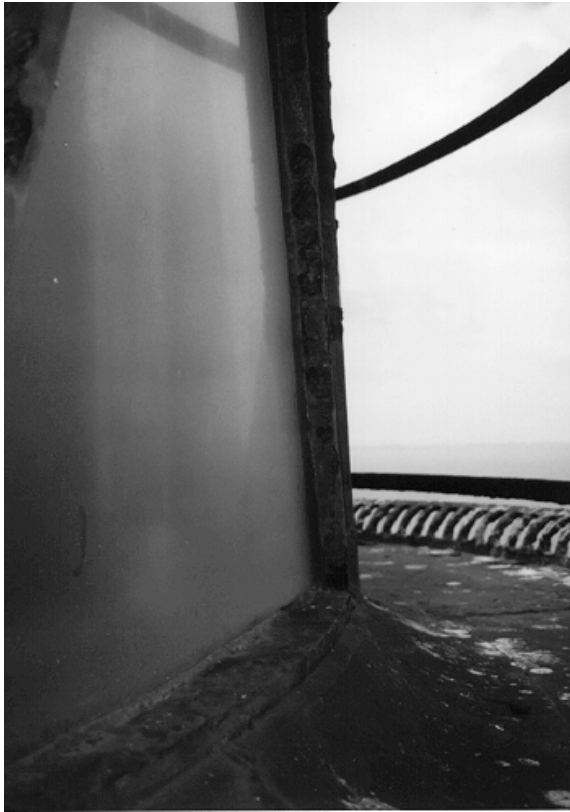
**Figure 28.**

**Figure 28 (top left).** Close-up view of severely hazed Lexan replacement panel. Note the limited visibility caused by only ten years of sunlight and salt air exposure.

In 1986 the wire-glass in the lantern of the Sombrero Key Lighthouse was replaced with Lexan (plastic) panels. A 1996 site visit found the Lexan panels hazed by sunlight and salt air exposure. This condition greatly reduces the transmission of light and therefore reduces the effective range of the aid to navigation. The inability of the Lexan panels to withstand the conditions of the marine environment gives the panels a short life expectancy when compared to glass. With these inherent limitations, Lexan or other plastic panels should only be used as a temporary repair and not be relied upon as a long-term lantern glass material.

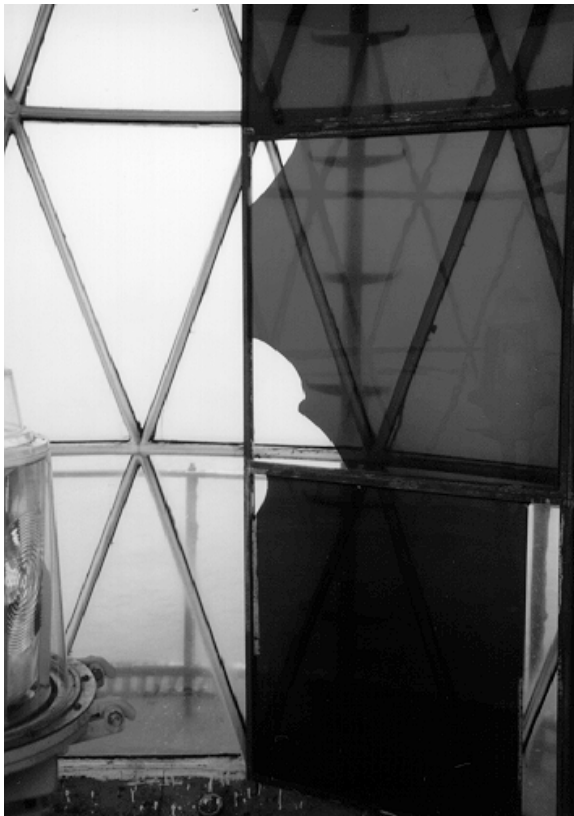
**Figure 29.**

**Figure 29 (bottom left).** Looking out through severely hazed Lexan panels, note the limited amount of light transmission; this greatly hinders the effectiveness of the aid to navigation. If the panels are not replaced, the degradation may continue and diminish the light transmission, ultimately rendering the aid to navigation ineffective.

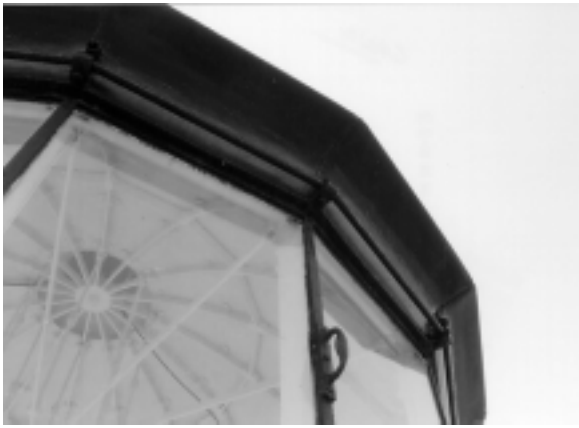
**Figure 30.** Close-up of a first-order lantern that retains its lantern glass; note the clarity.

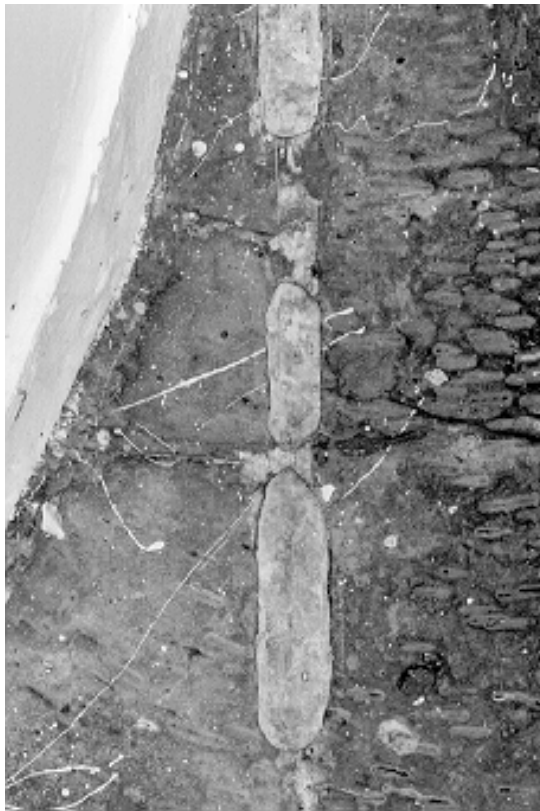
**Figure 32.** This sheet-copper-covered lantern gallery deck has been repaired several times by soldering sheet copper patches over the holes. This method of repair, if performed properly, greatly increases the life span of the roof covering.

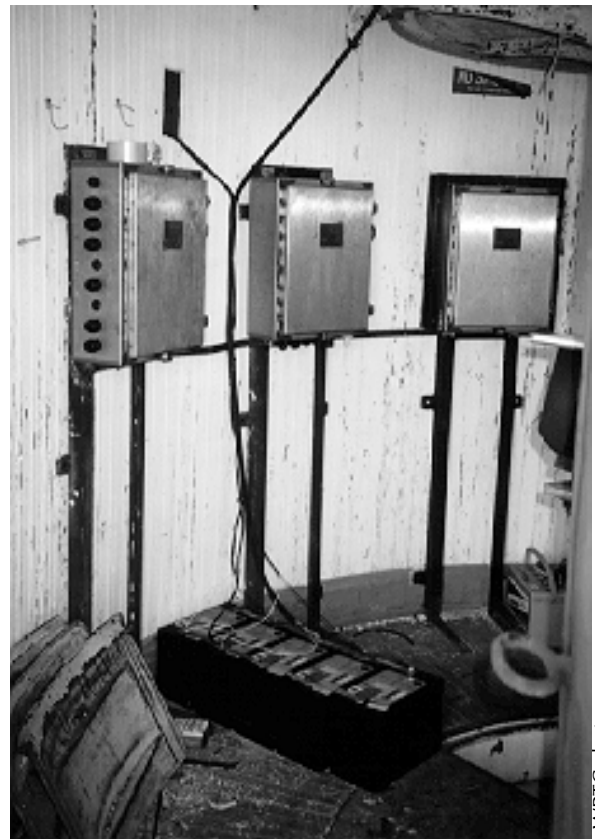
**Figure 33.** To minimize damage to historic wood beadboard panelling, these new panels should have been installed on a sheet of plywood attached to the historic wood beadboard panelling in four locations. These batteries stored on the floor should be in containment boxes in case the batteries leak.

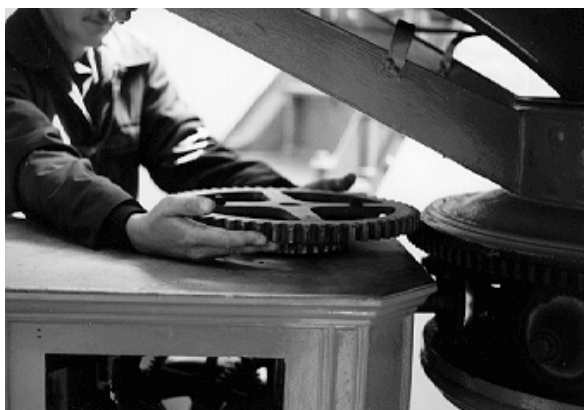
**Figure 34.** When this first-order classical lens was converted to AC power, the original drive gear (pictured here) was the crank used to wind the clockworks.

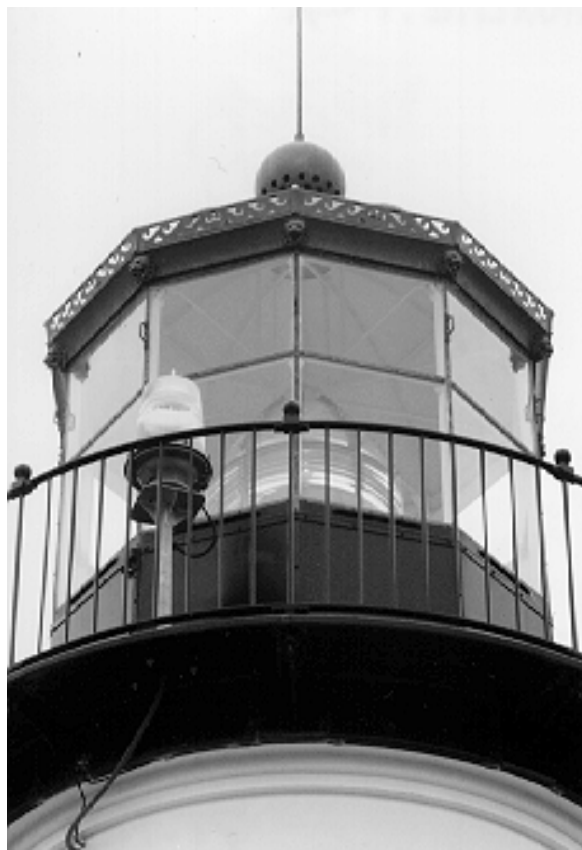
**Figure 35.** This is an acceptable auxiliary light installation. The light is mounted on an aluminum pedestal that has been bolted to the replacement aluminum deck.

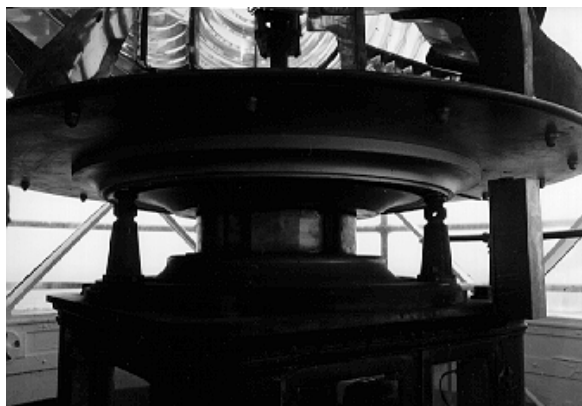
**Figure 36.** This c. 1926 lens was designed to be AC powered; the original lens jacks are still in place. The three jacks (the third is obscured by the brass bearing cover) were used to lift the lens assembly so that bearings could be serviced.
