Historic Lighthouse Preservation:

MASONRY

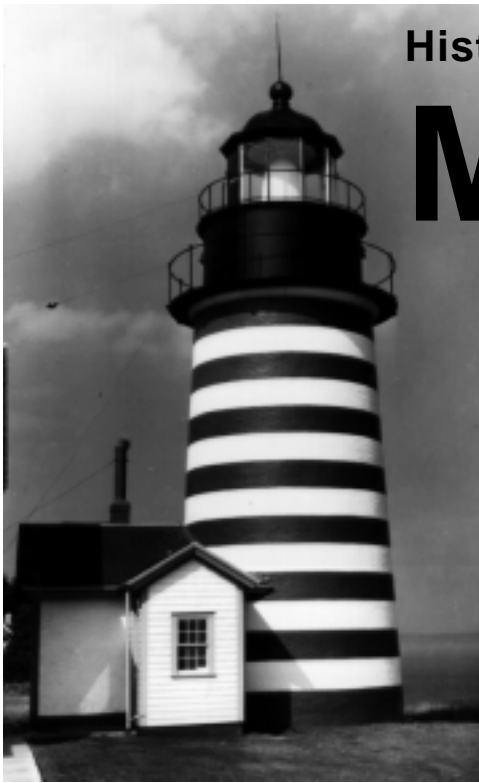
Figure 1. West Quoddy Head Lighthouse near Lubec, Maine

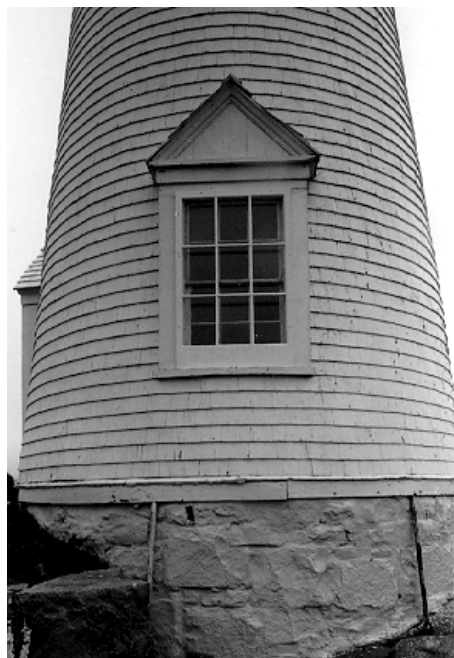
Figure 2. Stone masonry foundation in a 38-foot-tall wood-frame lighthouse in Maine.

Brick and stone masonry is the most commonly used building material in lighthouse construction.¹ Because of the harsh conditions associated with the locations of most lighthouses, brick and stone masonry was chosen for its durability. The use of masonry construction ranges from stone foundations of wood frame towers to the brick walls of tall towers (see Figures 2 and 4).

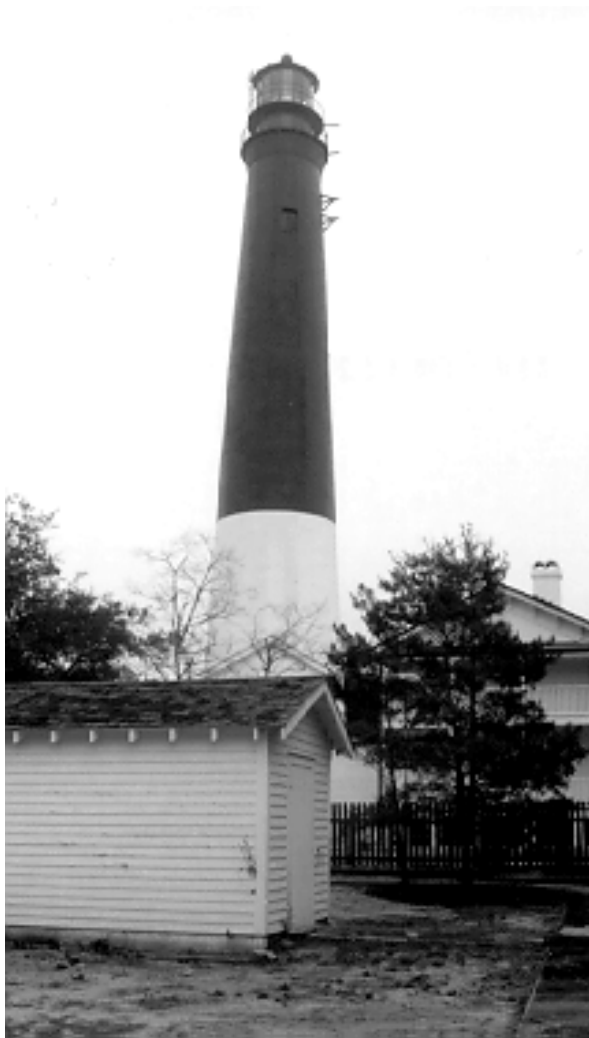
Figure 4. Brick masonry construction in the 171-foot-tall Pensacola Lighthouse in Florida.

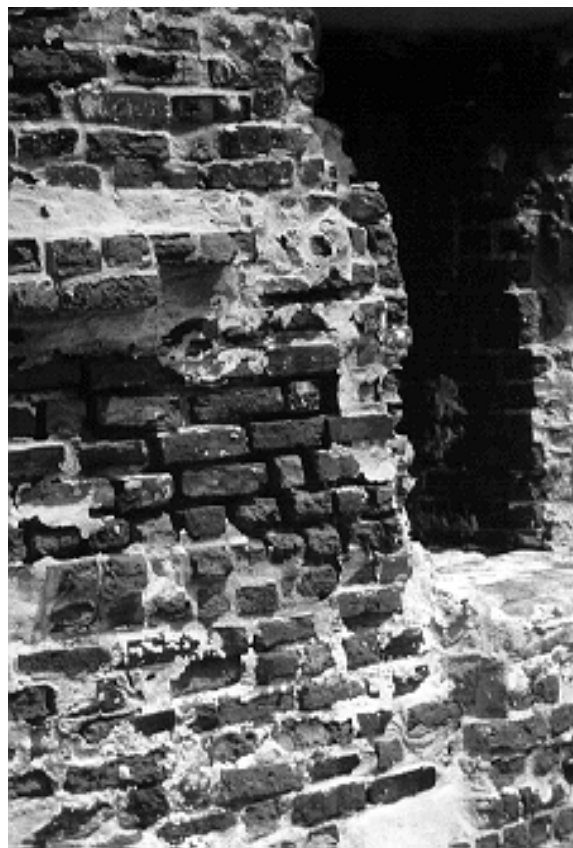
Figure 5. The coating that once protected the soft bricks of this lighthouse was not maintained; the severe deterioration required the replacement of nearly 25,000 bricks.
