MSHA Approval and Certification Center

REMOTE CONTROL CONTINUOUS MINING MACHINE CRUSHING ACCIDENT DATA STUDY

Date: May 11, 2006

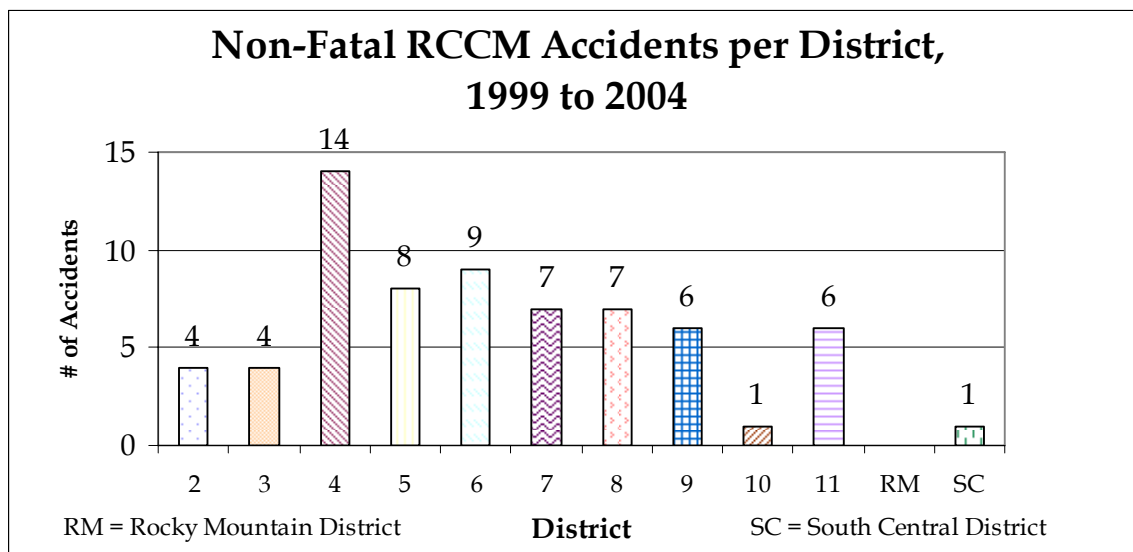
Figure 1: Non-Fatal RCCM Accidents per District, 1999 to 2004

The distribution of these 67 non-fatal RCCM accidents per mining district is represented in the following chart⁴.

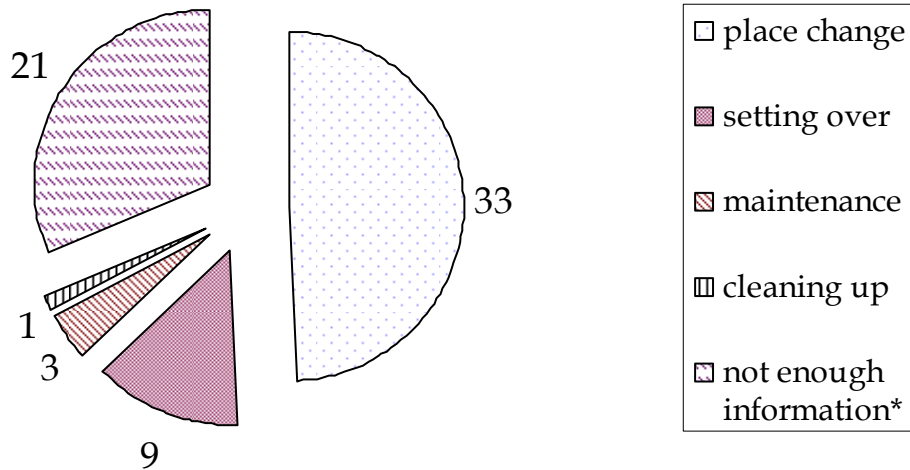
Figure 2: RCCM Data Sample: Activity during Non-Fatal Accidents as Determined from 7000-1 Forms

Based on accident narratives submitted by mine operators, the non-fatal accidents analyzed in this report have been characterized as shown in Figure 2. Many of the narratives lacked sufficient detail to discern the activity during the accident and are included in the “not enough information” group.

RCCM Data Sample: Activity during Non-fatal Accidents as Determined from the Narratives on MSHA 7000-1 Forms

*There was not enough information included in the accident narratives to determine the activity in 21 of the non-fatal accidents included in the data sample.

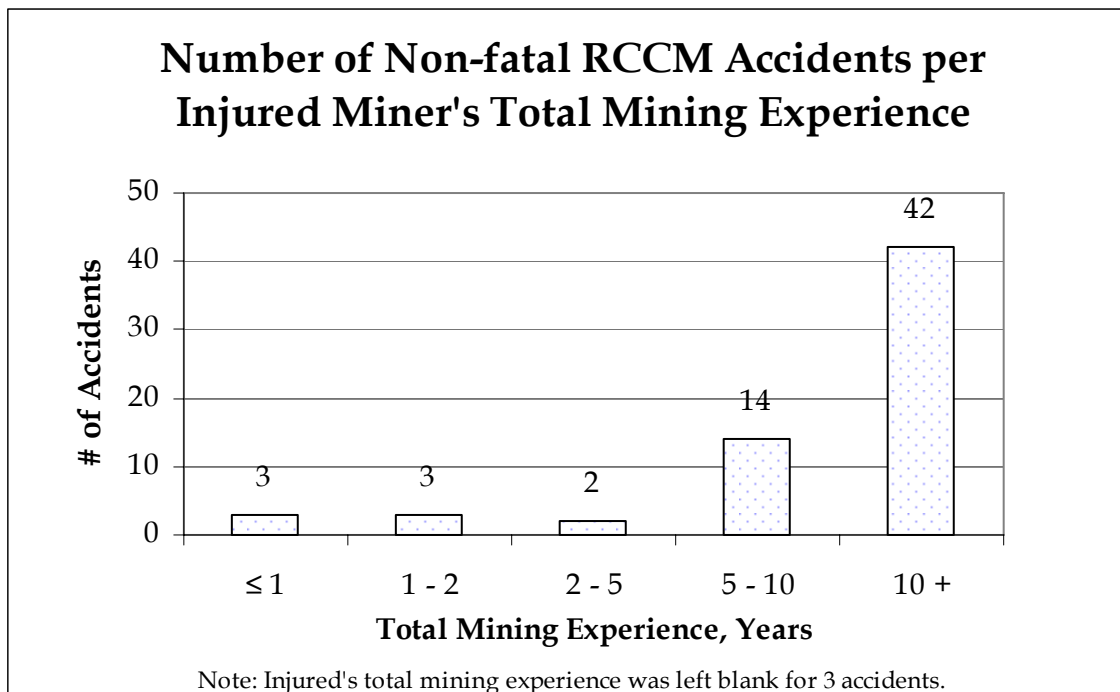
Figure 3: Number of Non-Fatal RCCM Accidents per Injured Miner's Total Mining Experience

The following chart shows the number of non-fatal RCCM accidents included in the data sample with respect to the accident victim's total mining experience. Personnel with more than 10 years of mining experience had an overwhelming majority of the 67 non-fatal RCCM accidents.

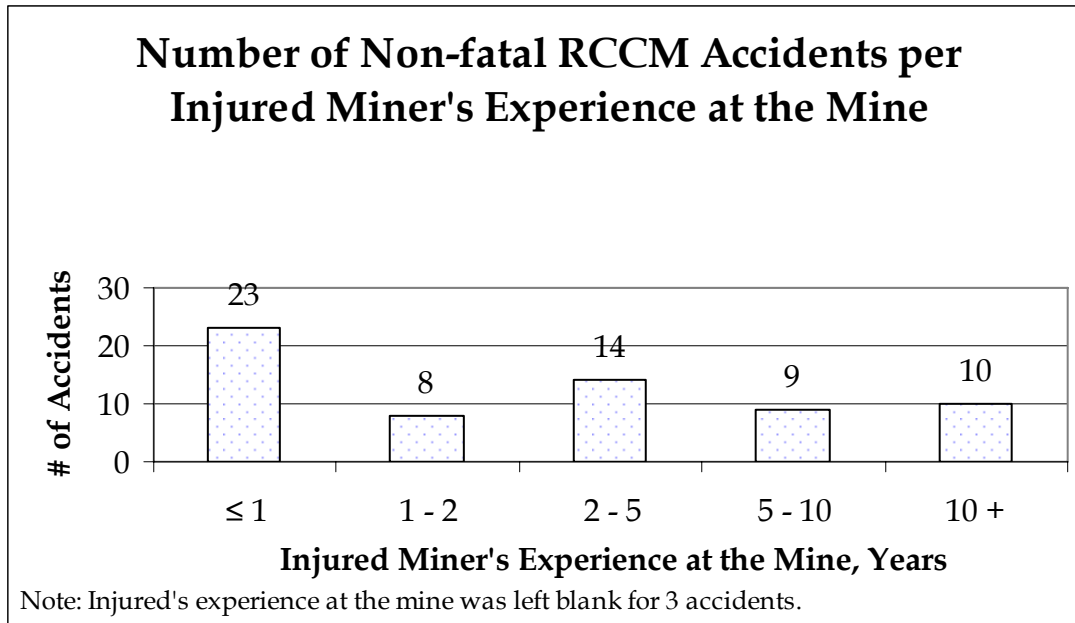
Figure 4: Number of Non-Fatal RCCM Accidents per Injured Miner's Experience at the Mine

The following chart displays the number of non-fatal accidents included in the data sample with respect to the injured miner's experience at the mine where the accident occurred.

Forty-six percent (46%) of the non-fatal crushing accidents sampled involved miners with two or less years of experience at the mine where the accident occurred.

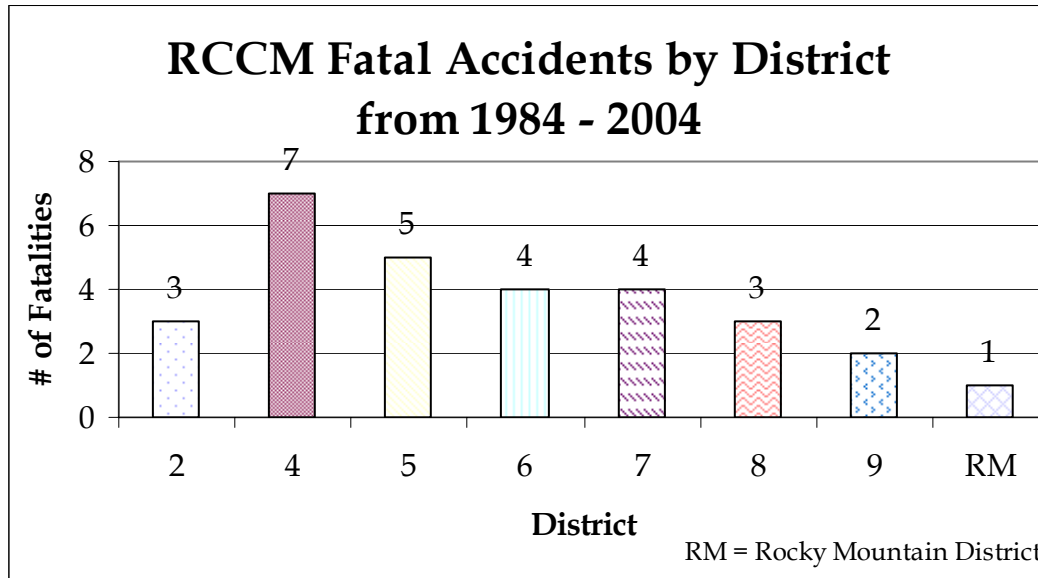
Figure 5: RCCM Fatal Accidents by District

The following chart shows the RCCM fatalities by District. Only those Coal and M/NM Districts that have experienced RCCM fatalities are depicted. The mine at which the trona RCCM fatality occurred is in Metal/Nonmetal's Rocky Mountain District.

Districts 4, 6, 7, and 5 currently have the largest populations of RCCMs, respectively. These four Districts have also experienced the largest number of RCCM fatal accidents. The data study did not yield information that explains why some Districts have not experienced RCCM fatalities, why some Districts have gone more than eight years without experiencing an RCCM fatality, or why some Districts only began experiencing RCCM fatalities since 2000. See Appendix A for more information about the RCCM population and distribution of fatal accidents among the Districts.

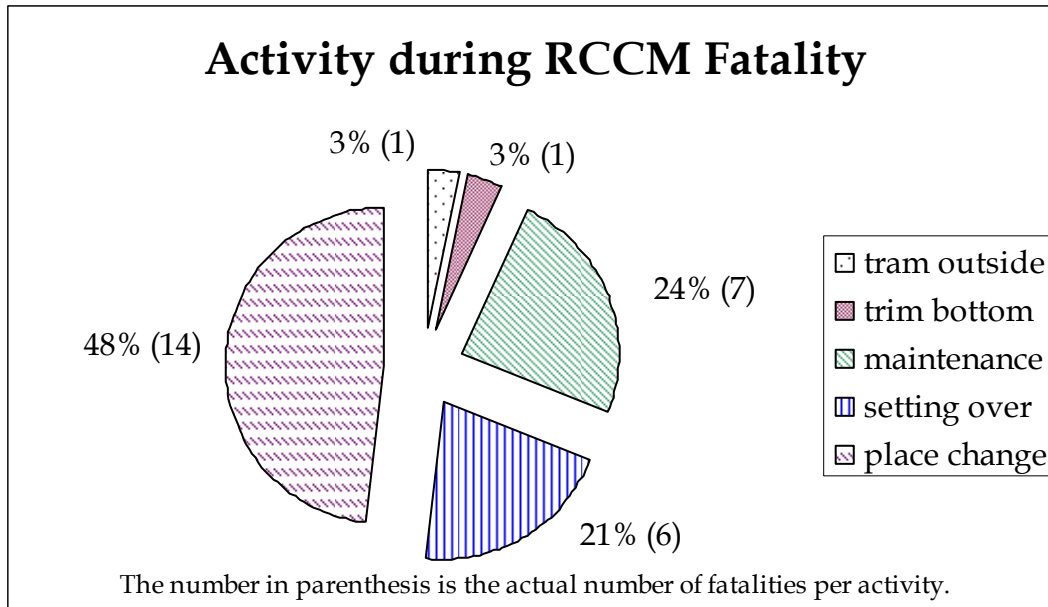
Figure 6: Activity during RCCM Fatality

The following chart shows the victim's activity when the RCCM fatal accident occurred. The data was gathered from MSHA's published fatal accident reports. This chart shows that 48% of RCCM fatal accidents occurred while the continuous miner was place changing (for both advancing and pillar recovery sections).

Fatal RCCM accidents have occurred while place changing in all the Districts except District 2 and the Rocky Mountain District. The following bullets present some observations about the RCCM place changing fatalities.

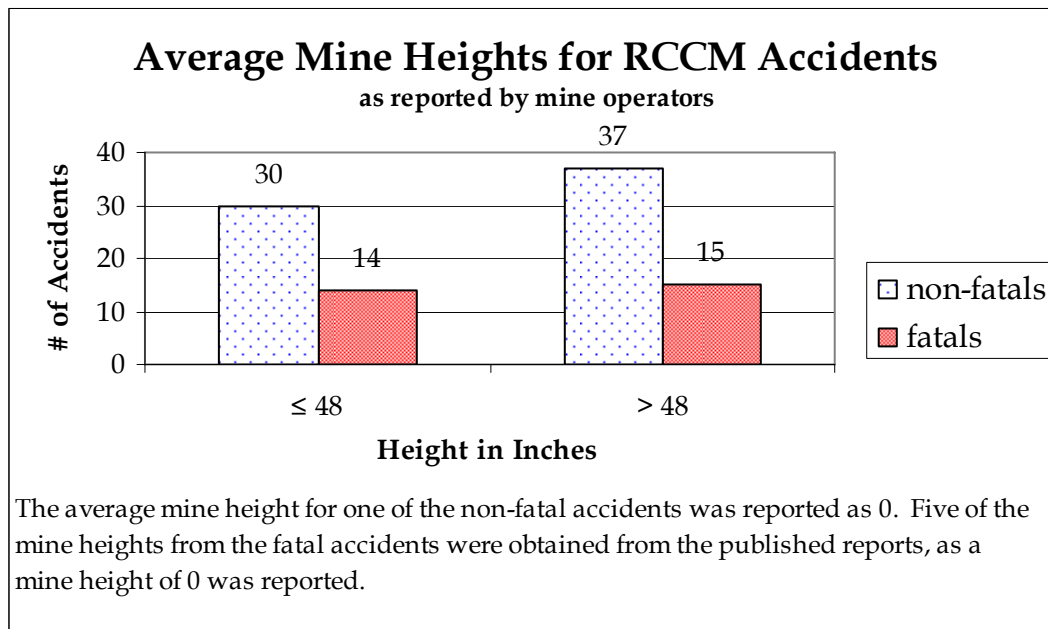
Figure 7: Average Mine Heights for RCCM Accidents

The following chart shows the working heights reported⁸ for mines that experienced non-fatal and fatal RCCM accidents.

The working height in approximately 45% of the non-fatal RCCM accidents was low; the working height in 48% of fatal RCCM accidents was low. However, during the time between 1999 and 2004 (the period from which the non-fatal data sample was taken) and according to the height at the accident scene listed in the fatal accident report

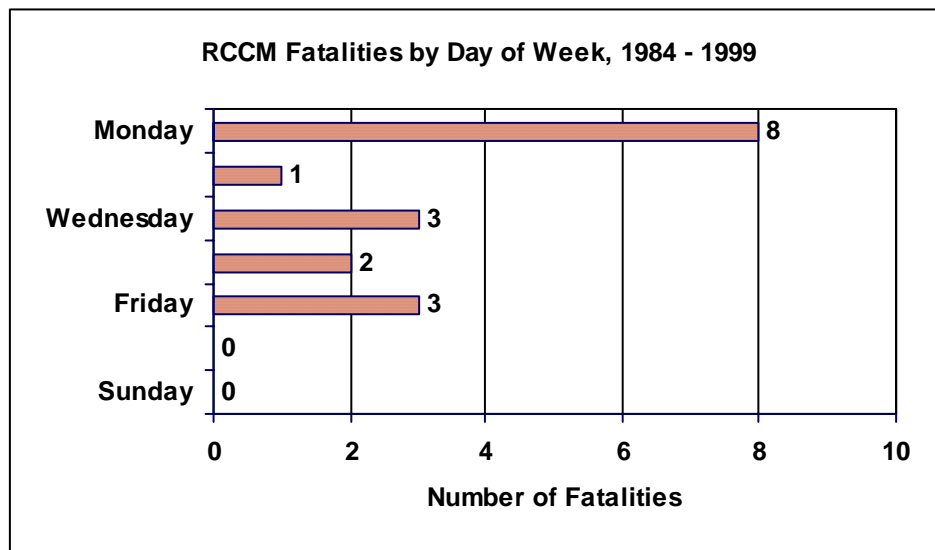
Figure 8: Fatal Accidents by Day of the Week, 1984-1999.

In recent years, the coal industry has switched from a traditional Monday through Friday to a seven day-per-week workweek. The RCCM Safety Presentation presented the fatal accidents by day of the week, but broke the accidents into two periods: up to 1999, and 2000 to 2004. The following are the distributions of fatal RCCM accidents:

Note that a clear majority of the earlier fatalities occurred on Monday, Wednesday and Friday shared the second highest amount of fatalities, and there were no RCCM fatalities on weekends. The latter RCCM fatalities are more evenly spaced throughout the entire week, with the highest numbers occurring on Tuesdays and Fridays.

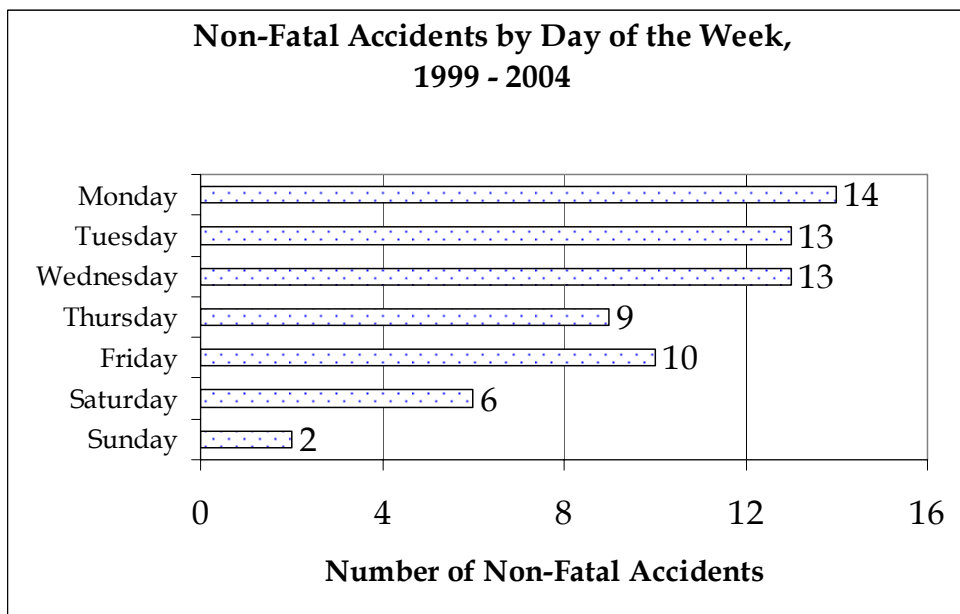
Figure 10: Non-Fatal Accidents by Day of the Week

The following is the distribution of non-fatal RCCM accidents collected in the data sample:

The days of the week for the fatal accidents displayed in Figure 9 occurred within the same years as the non-fatal accidents shown in Figure 10. Both charts show a more even distribution of RCCM accidents throughout the week than the fatal accidents up to 1999. Therefore, the day of the week does not appear to affect RCCM accidents.

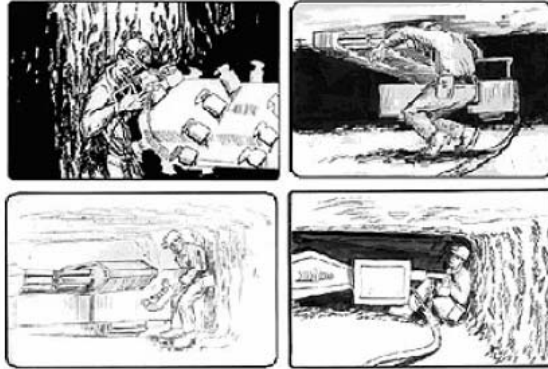
**Tramming While Positioned Within the Turning
Radius of the Remote Control Continuous Miner Can Be Fatal**

Fatal accident statistics show that the majority of all non-maintenance related crushing accidents involving remote controlled continuous mining machines happened when the victim was located within the turning radius of the machine while it was being trammed.

Statistics show that your location (**OUTSIDE** of the **MACHINE'S TURNING RADIUS**) is the single most important factor that prevents remote controlled continuous mining machine crushing injuries.
