PRESERVATION TREATMENTS

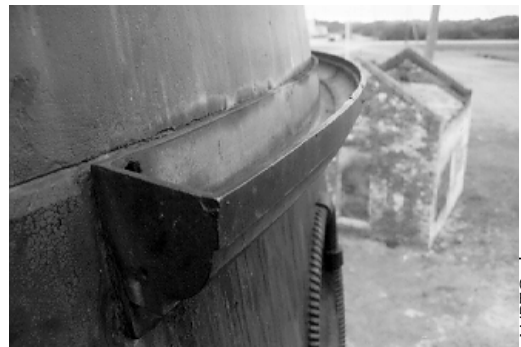
Figures 23 and 24. Two types of gutters found on iron lighthouses; the gutters must be in proper working order and checked regularly during the mothballing period.

- **Built-in guttering systems:** In order to prevent water from entering the interior cavity of double-wall iron or brick-lined iron wall systems, all rain water guttering systems (lantern roofs, or other tower roof forms) should be cleaned and checked for holes. It is imperative that all holes and non-functioning gutter system components are repaired. For more information refer to the discussion on roofing in the **Lantern** section of the handbook.

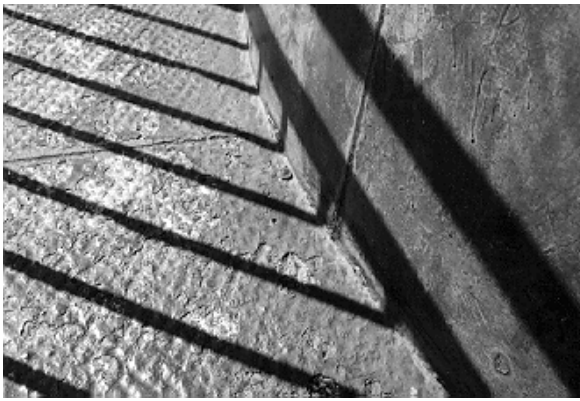
Figure 25. The seams between the deck and wall plates of this lighthouse were not properly sealed; as a result the areas collected water and began to rust.

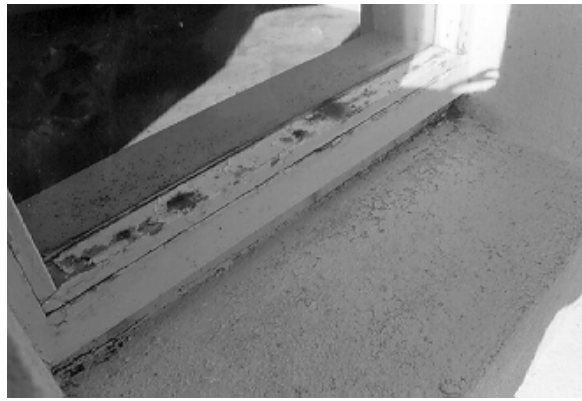
Figure 26. This steel casement window frame was not sealed properly and as a result has begun rusting from the inside out.

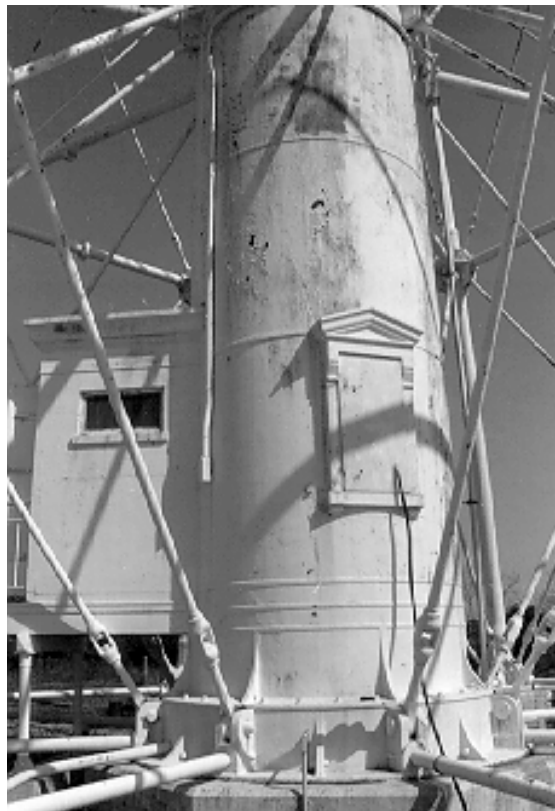
Figure 27. Blistering paint, as pictured here, should be removed and the affected areas properly primed and painted.

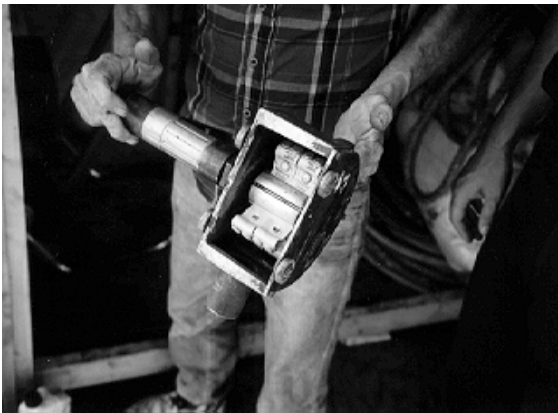
Figure 33. Close-up of the studded flaps mounted on the rotating head. To use the tool, it is held against the face of the iron member and as the studded flaps spin they “slap” the surface and “knock” the paint off the iron.

Figures 30 through 33 are paint removal tools used during the Sand Key Lighthouse rehabilitation. Sand Key Lighthouse is located in open water off the coast of Key West. The paint being removed contained lead; therefore it was essential that all debris be contained for proper disposal.

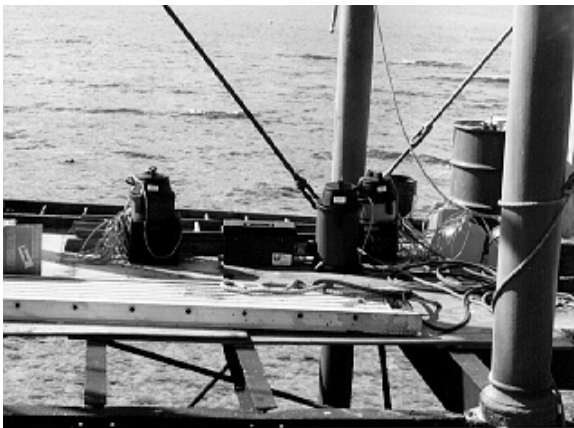
Figure 34. The small vacuums used at Sand Key Light are shown in this photo. Each vacuum has a HEPA filtration system to ensure that no lead dust escaped into the atmosphere. The conditions at Sand Key Lighthouse made the use of a large central vacuum system impractical. Using portable vacuums allowed for paint removal at numerous locations at any one time.

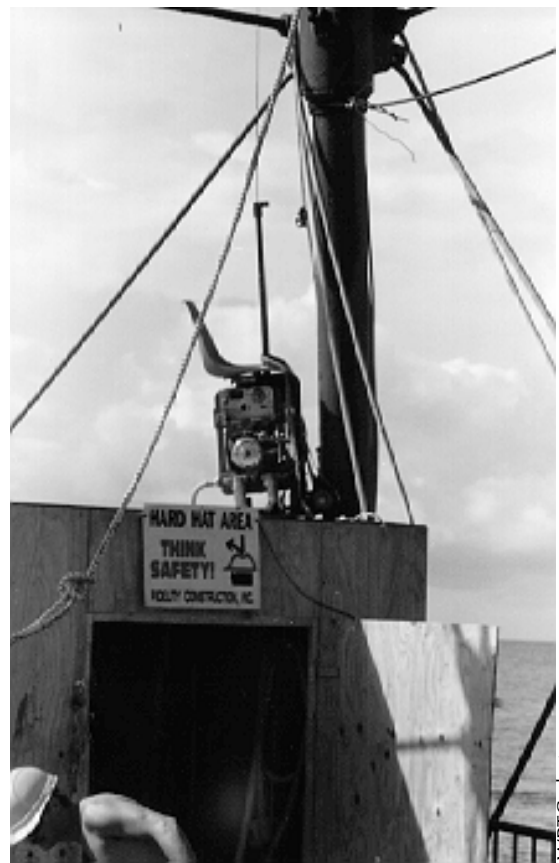
Figure 35. This motorized chair was used to hoist workers as they removed paint from the cast-iron columns at the Sand Key Lighthouse. The chair’s motor is attached to a hoist, so the chair actually climbs a cable that has been strung alongside the column.

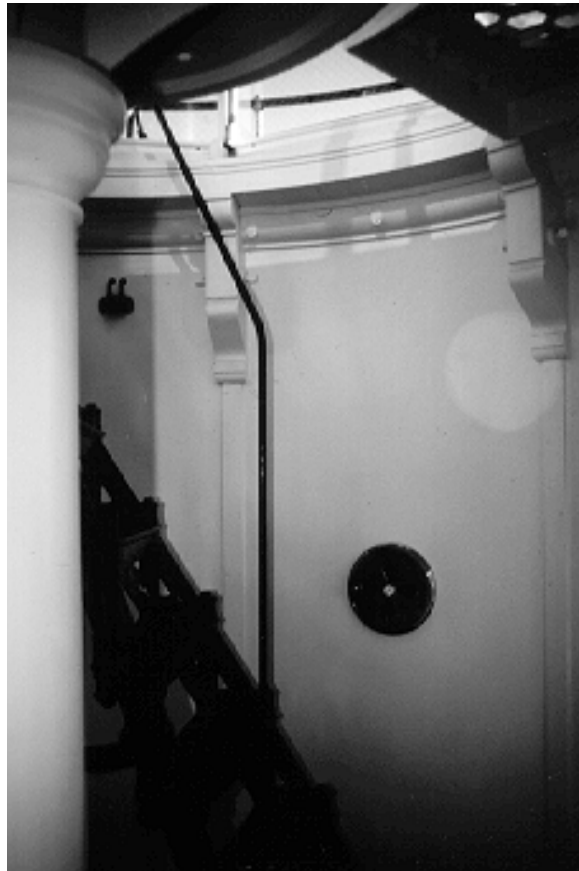
Figure 38. Service room bracket after chemical cleaning.

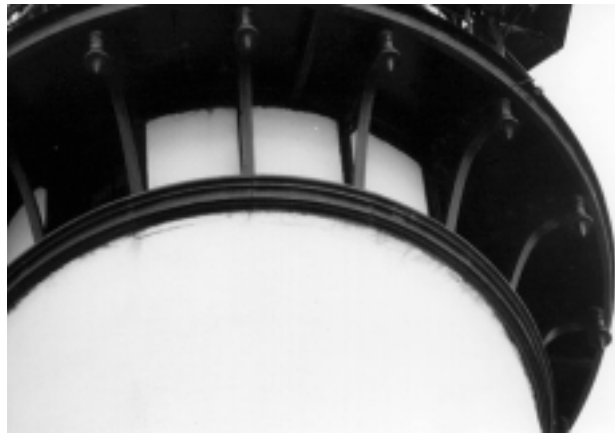
Figure 42 (above). The lower gallery deck of the same masonry lighthouse has rust-bleed occurring along the lower edge of the iron belt course that supports the gallery deck brackets.
