E. Aluminum Automotive Closure Panel Corrosion Test Program

Objective

- Develop a standardized cosmetic corrosion test for finished aluminum automotive body panels that provides a good correlation with in-service testing and field performance.

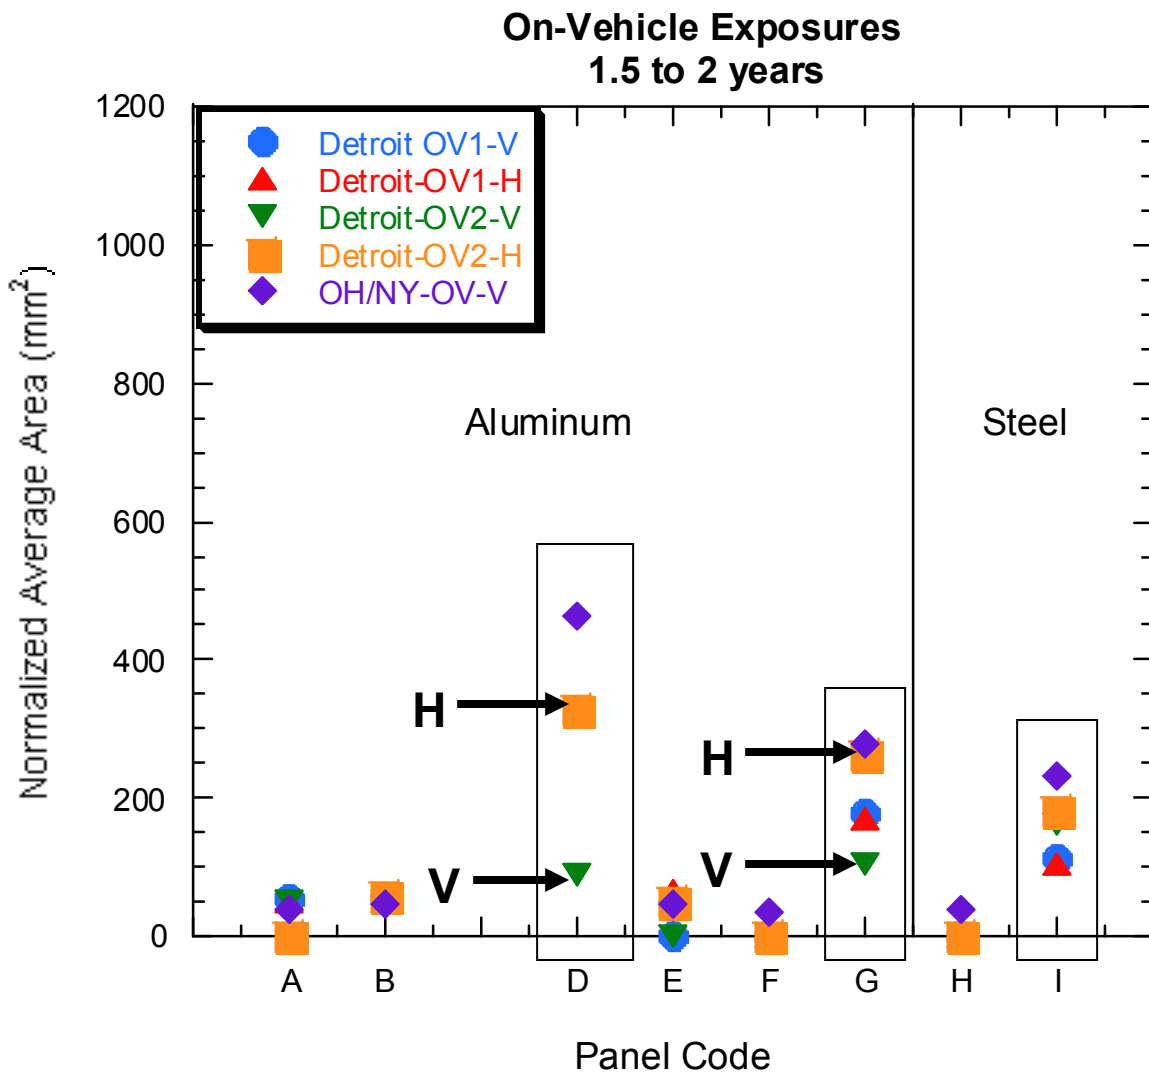
Figure 2. Normalized average area for preliminary on-vehicle service-relevant exposures.

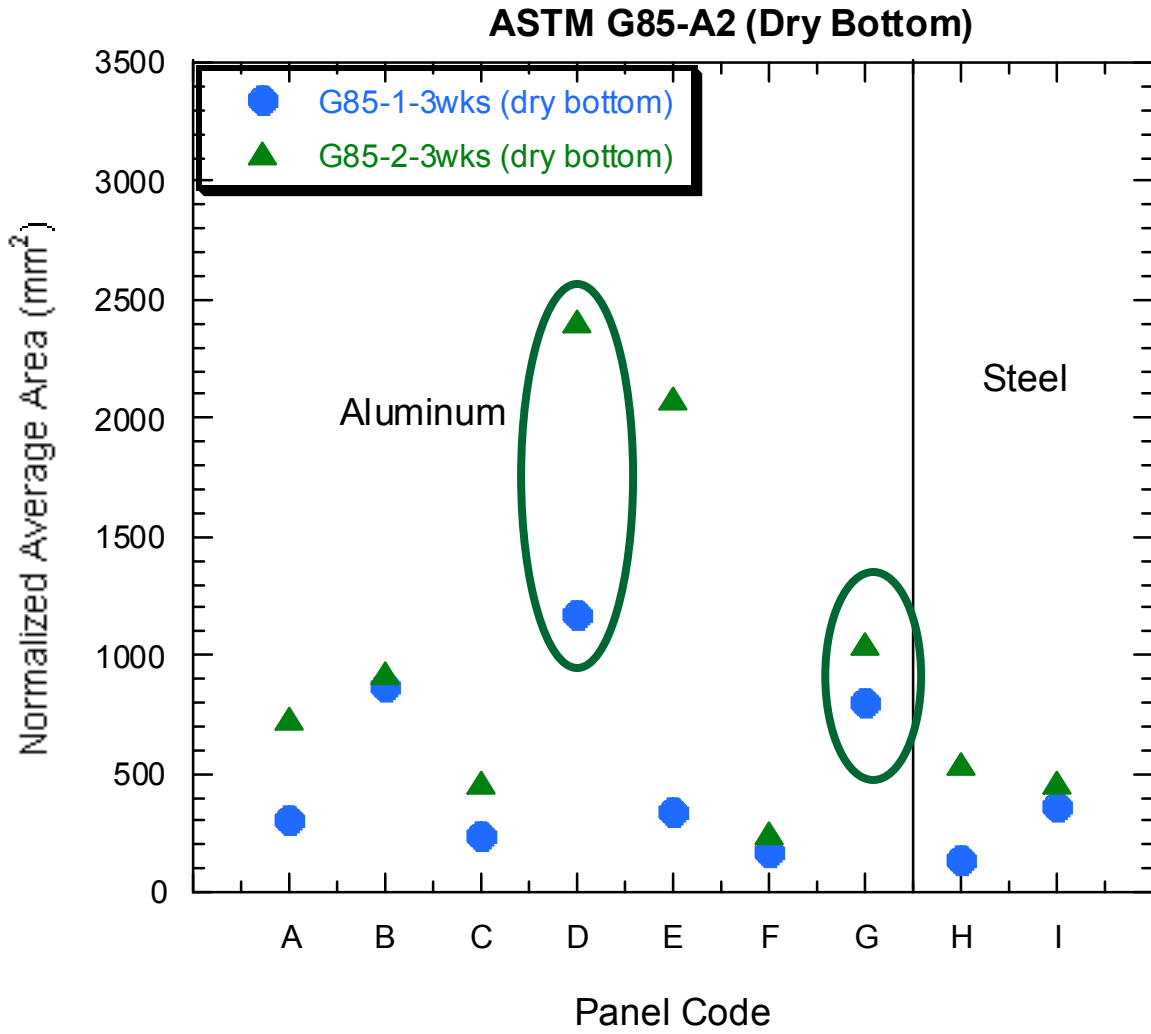
Figure 3. Normalized average area of corrosion for ASTM G85-A2.

Panels from the test tracks, outdoor tests, preliminary on-vehicle exposures and initial lab tests have been analyzed. At this point only a very limited amount of service-relevant results from the on-vehicle exposures is available. From these preliminary on-vehicle results it is qualitatively apparent that the panels with metal finishing (D & G) have significantly more corrosion than the other substrates (Figure 1). The preliminary results for normalized average area from on-vehicle service relevant exposures are plotted in Figure 2. Based on these preliminary results, accelerated tests that also show a significant difference between the substrates with metal finishing (i.e., sanding) and those without metal finishing would appear to correlate better with the preliminary observations from on-vehicle testing. Many of the accelerated lab tests do not show a significant difference between the substrates with and without metal finishing. Of the laboratory test methods evaluated thus far in the program, the ASTM G85-A2 test and the HCl dip test appear to show a significant difference in corrosion performance between the substrates with metal finishing (i.e., sanding) and those without metal finishing as illustrated in Figures 3 and 4. Also, the

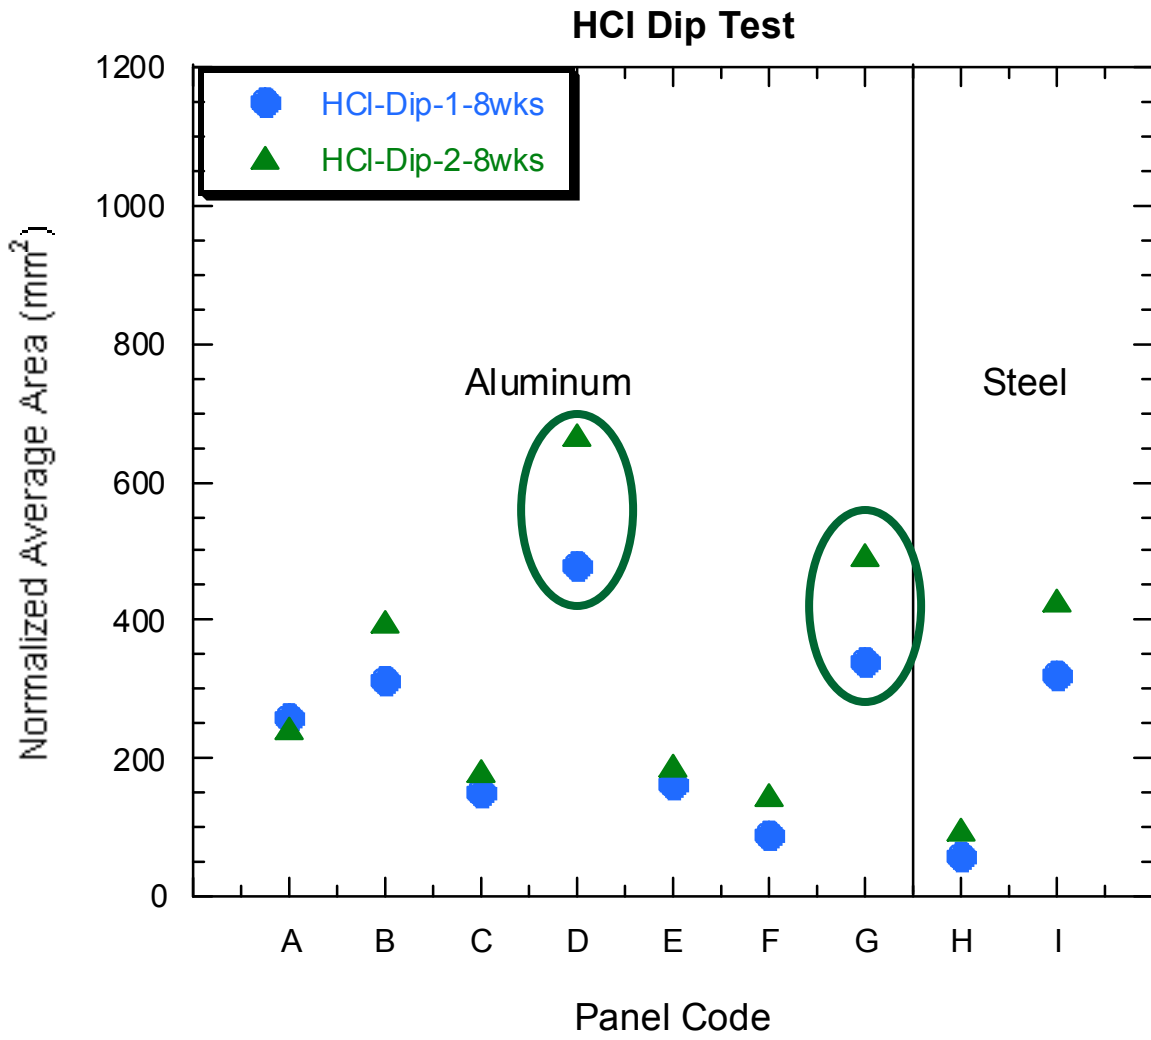
Figure 4. Normalized average area of corrosion for HCl Dip Test.

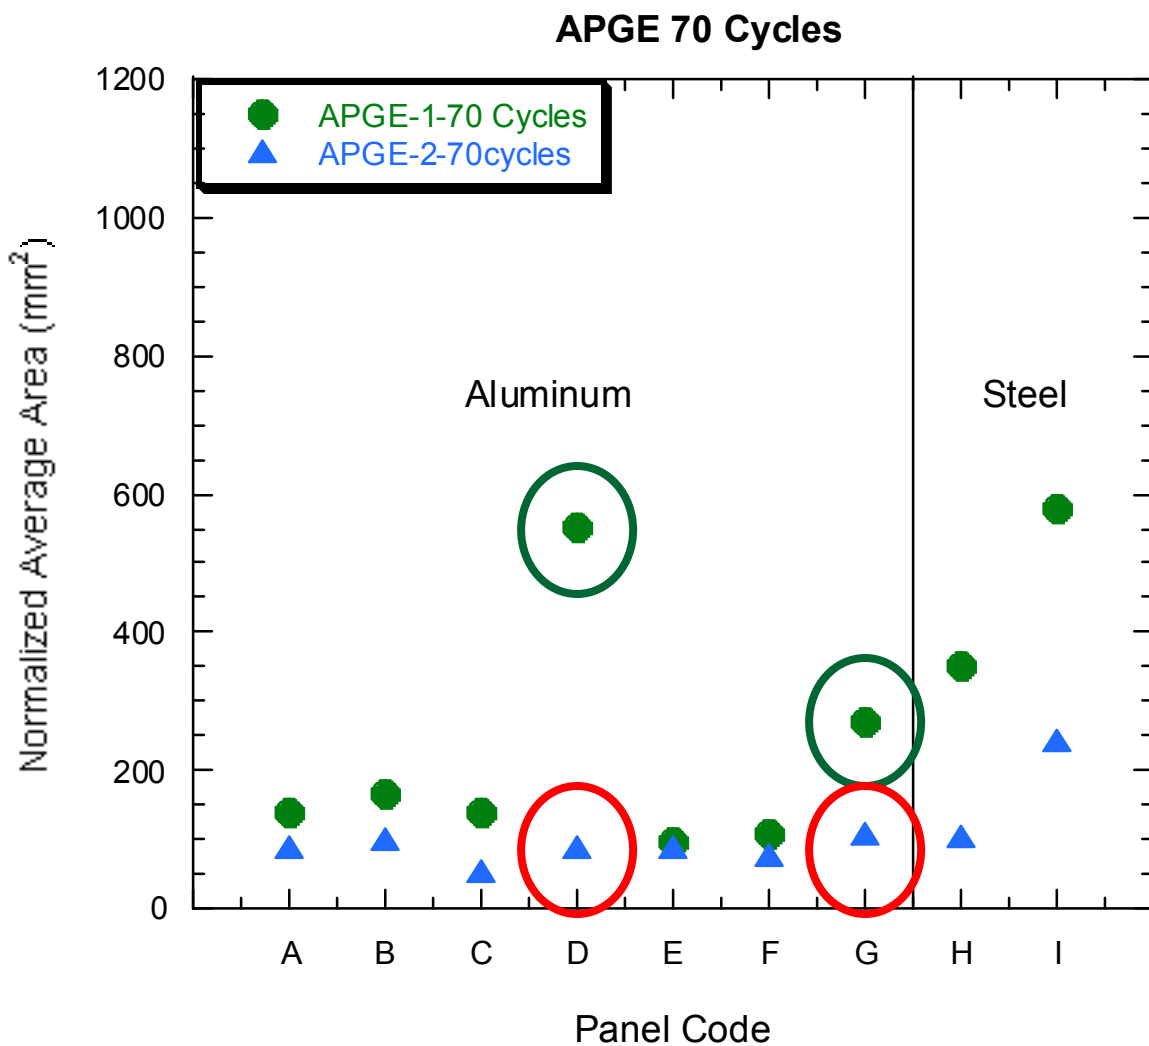
Figure 5. Normalized average area of corrosion for APGE.

APGE test showed this difference for one test lab, but not the second test lab as illustrated in Figure 5.

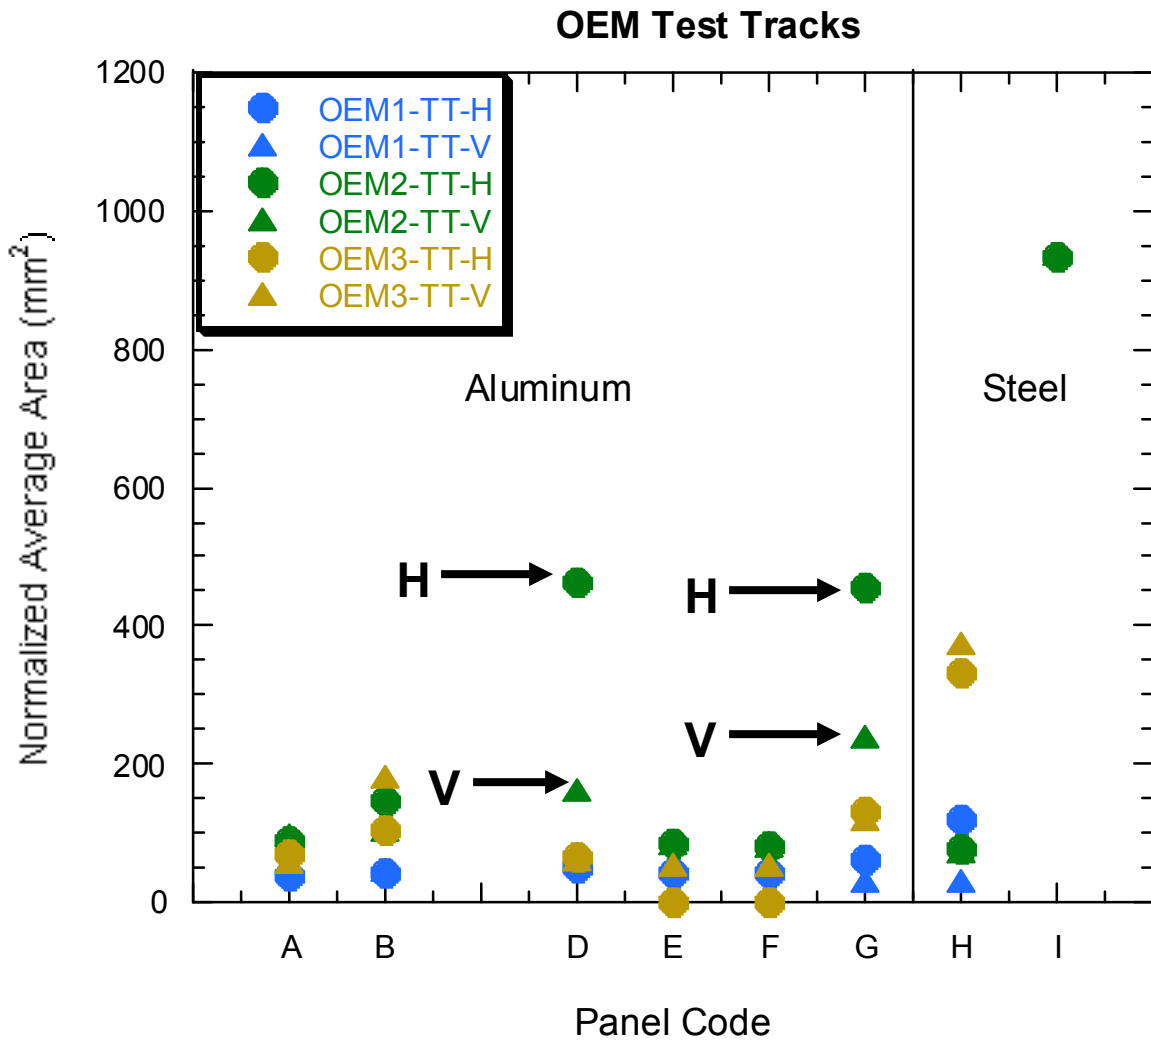
Figure 6. Normalized average area of corrosion for OEM test tracks

Likewise, test-track or proving-grounds tests that show a difference in performance related to metal finishing would qualitatively correlate better with the preliminary field test observations. One of the OEM test-track exposures appears to exhibit differences in the performance of substrates with and without metal finish that are consistent with the preliminary on-vehicle observations, but the other two OEM test tracks are not consistent with this difference as illustrated in Figure 6.
