Conduits through Embankment Dams

Zones of designed filter material have become the accepted method of preventing failures caused by uncontrolled flow of water through the embankment materials and foundation soils surrounding a conduit through an embankment dam. This chapter discusses the theory behind the concept for using filter zones to prevent erosion of earthen embankments near conduits caused by the uncontrolled flow of water through soils surrounding conduits that penetrate the embankment.

The type and configuration of the filter zone depend on site conditions and soils used in the embankment dam. Three basic designations for filter zones associated with conduits are discussed: filter diaphragms, filter collars, and chimney filters. Examples of typical designs used by the major design agencies are included.

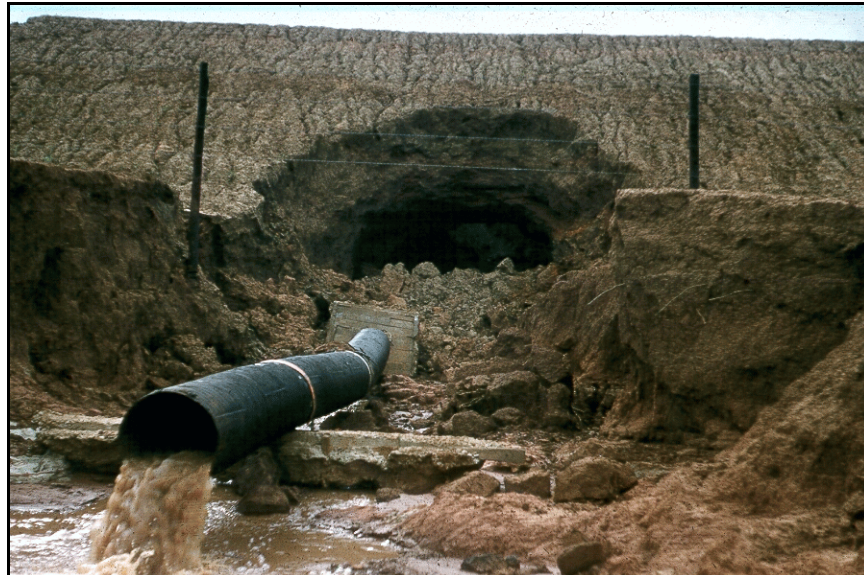
Figure 84.—An embankment dam in Mississippi constructed of dispersive clay soil, failed on first filling with low reservoir level. Failure was likely caused by cracks from differential settlement, hydraulic fracture, or poor compaction about the outlet works conduit. This embankment dam had no filter.

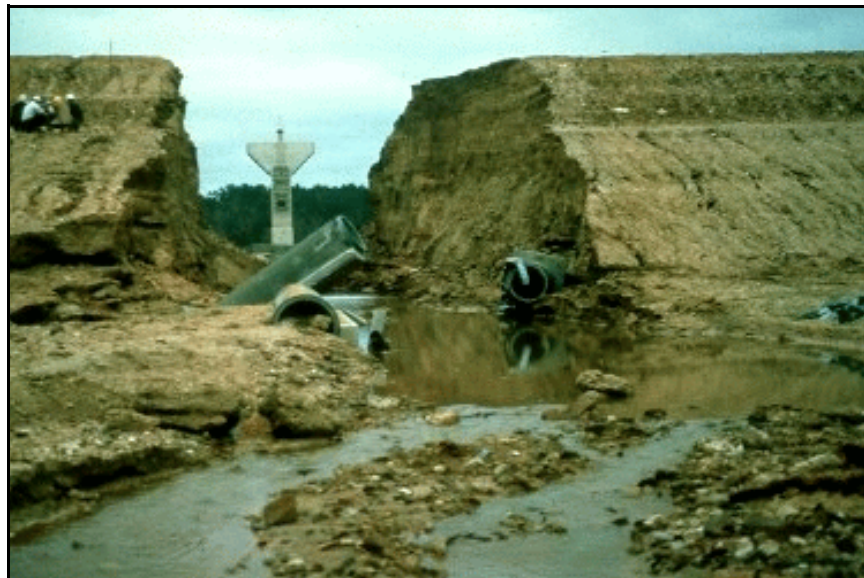
Figure 85.—This embankment dam constructed with dispersive clays failed on first filling of the dam.

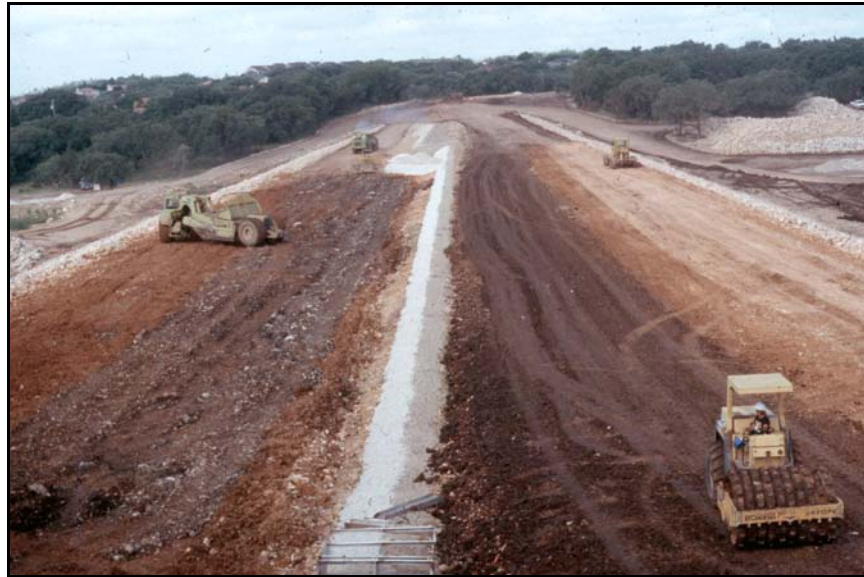
Figure 87.—Two stage chimney filter within an embankment dam located in Texas.

A chimney filter that extends upward to the highest probable pool level and extends across the length of the embankment from abutment to abutment is a common element for most high and significant hazard embankment dams. Chimney drains are also valuable for sites with a high permanent water storage level, because they intercept and lower the phreatic line and maintain a stronger downstream zone of unsaturated soil. Figure 87 shows a double gradation zone chimney filter being installed in the construction of a modern embankment dam.

- *The method of constructing the filter zone.*—If the chimney filter zone or filter diaphragm is constructed concurrently with the adjoining fill zones, using a width of 10 to 12 feet is suited to most construction equipment. A chimney filter designed with multiple filter zones complicates construction. Figure 87 shows such a design. If the filter zone is placed in a trench cut in compacted fill, a width of 3 feet is often specified, because that is typically the width of backhoe buckets used for this method of construction. A paper by Hammer (2003) includes good discussions of the advantages and disadvantages of various methods for constructing chimney filter zones. The discussions would apply equally well to sites where only a filter diaphragm was used instead of a full chimney filter section. The trenching method is illustrated in figures 6, 7, and 8 of that paper.

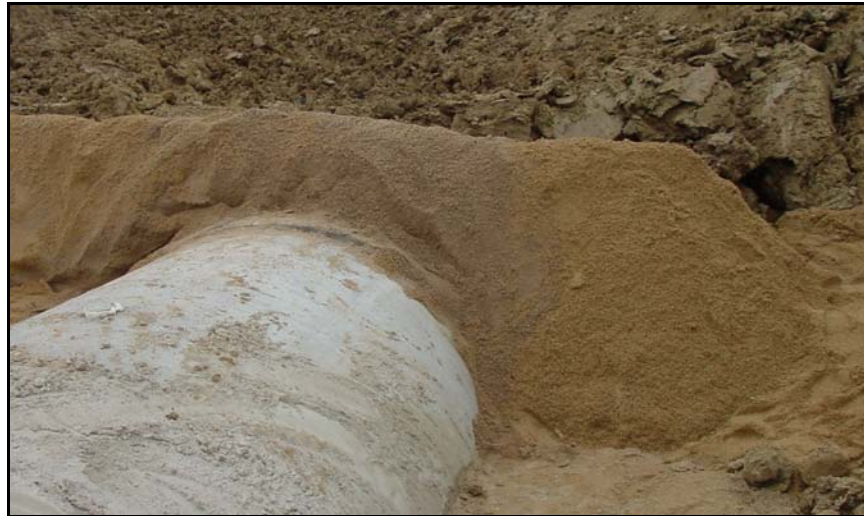
Figure 90.—Construction of a filter diaphragm within an embankment dam.

A filter diaphragm (figures 90 and 91) is a designed zone of filter material constructed around a conduit in which a chimney filter is not being used (usually in

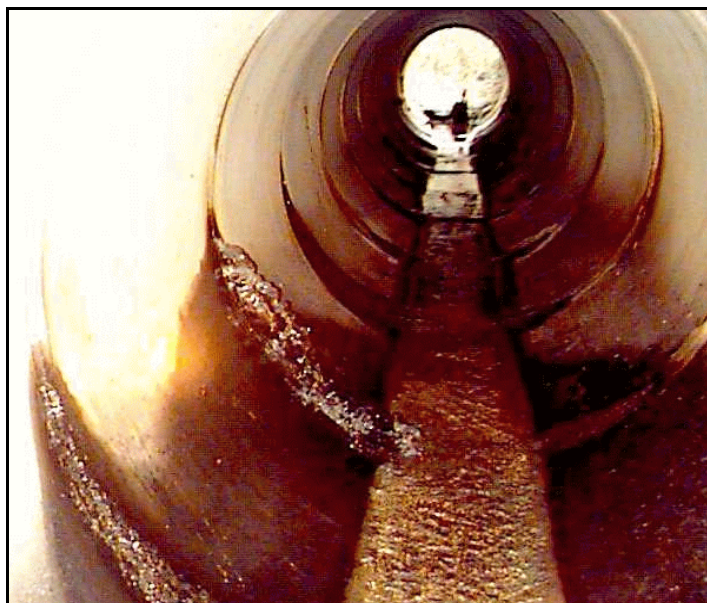
Figure 96.—Leaking joints in a 60-inch diameter RCP spillway. Several large voids were also observed in the adjacent earthfill on the upstream slope.

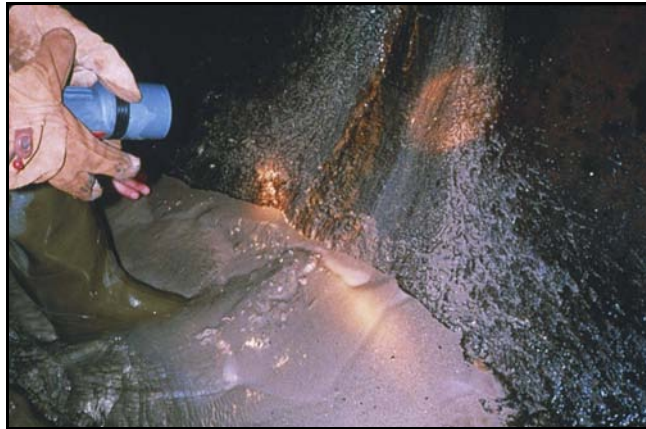
Figure 97.—Soil particles being carried into an outlet works conduit through a joint.

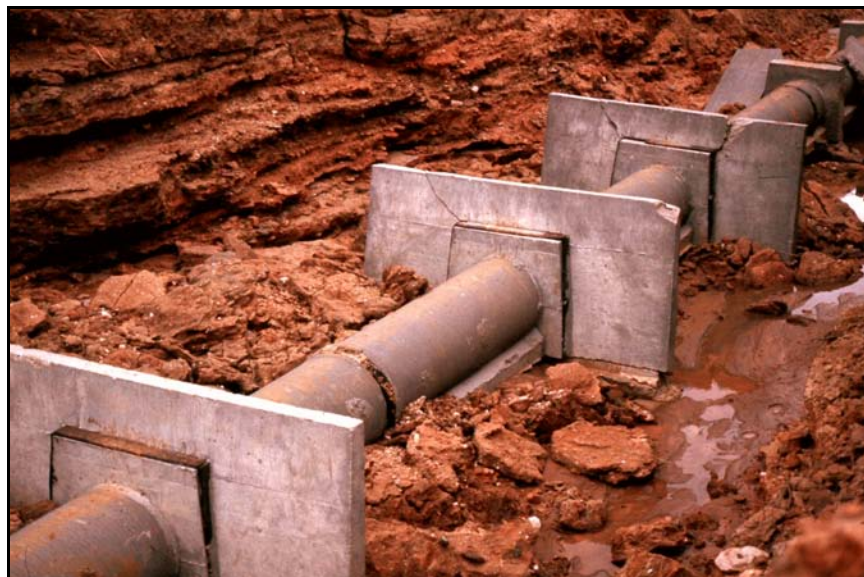
Figure 102.—Conduit with intact antiseepage collars. The collars would have interrupted flow along conduit. Internal erosion or backward piping erosion likely occurred through hydraulic fractures in surrounding earthfill, resulting in failure of this embankment dam.

Figure 102 shows a conduit with its antiseep collars intact after an internal erosion failure of the embankment dam. In this case, it appears unlikely that the flow path for the failure was a continuous uninterrupted flow along the conduit, but at least part of the flow path was in the earthfill surrounding the conduit. In most cases, it has not been possible to determine the exact flow path that water followed in internal erosion failures, because the evidence was destroyed by the failure. If hydraulic fracture and other causes of cracks in compacted backfill were ignored as the potential cause for failures, one might incorrectly assume that all failures that occur in the vicinity of conduits are attributable to flow along the conduit. In Failure Mode No. 4 (discussed in the following section), hydraulic fractures occur in the soil mass beyond the immediate vicinity of the conduit, usually associated with differential settlement in the fill caused either by the conduit or excavations made to install the conduit, or uneven bedrock profiles near the conduit.

No. 4 more often than Failure Mode No. 3, where water is assumed to flow directly along the conduit. The reason for this conclusion is the known high quality of the compaction effort used to place low permeability clays around the conduits of these structures, plus several eyewitness accounts where the flow path was known to be as much as 15 feet above and to the sides of the conduit. The known cause of those failures was hydraulic fracture of the embankment dam, not always immediately in the vicinity of the conduit.

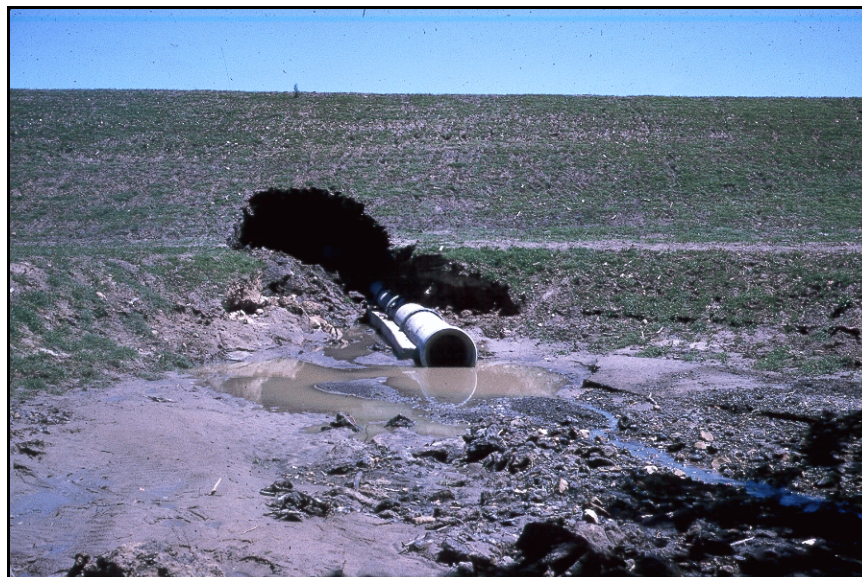
Figure 104.—Failure of an embankment dam due to internal erosion of hydraulic fracture cracks upon first filling of the reservoir.

Figure 104 shows a small embankment dam that failed by internal erosion. The conduit created differential settlement in soils above the conduit that resulted in hydraulic fracture. The embankment soils were highly dispersive clays.

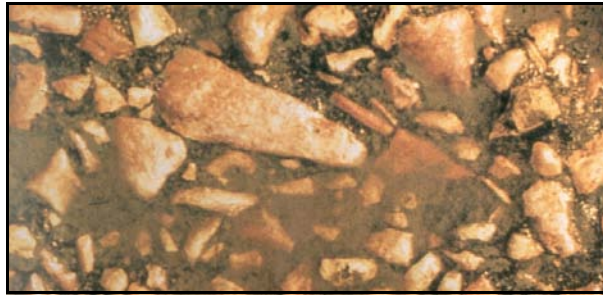
Figure 105.—Abrasion/erosion damage to concrete from flowing water containing sand and silt.

Abrasion in conduits is an erosional process and is a function of velocity and turbulence in the flow, the hardness of the abrasive material, and the quality of the surface experiencing abrasion. Abrasion is caused by water flowing through a conduit at high velocities and containing silts, sands, gravels, or stones (figure 105).

This flow causes a scouring or grinding effect on the exposed surface. Most conduits do not carry significant amounts of abrasive materials in the flow. However, conduits used for diversion during construction or for reservoir sediment release are especially vulnerable. Increases in the velocity of the flow can increase the abrasive power.

In concrete conduits, abrasive damage has been experienced in concrete with low strength and poor quality aggregates. Abrasive flow usually erodes the cement mortar mix matrix, leaving an exposed, polished, and coarse aggregate surface. As the abrasion process continues, the concrete may be eroded down to the reinforcement. The extent of damage depends on the flow duration and velocity, concrete quality, and compressive strength. In concrete conduits, abrasion is generally not a factor when velocities are less than 15 ft/s. In metal conduits, abrasive flow can erode protective linings and coatings and expose the surface to corrosion.

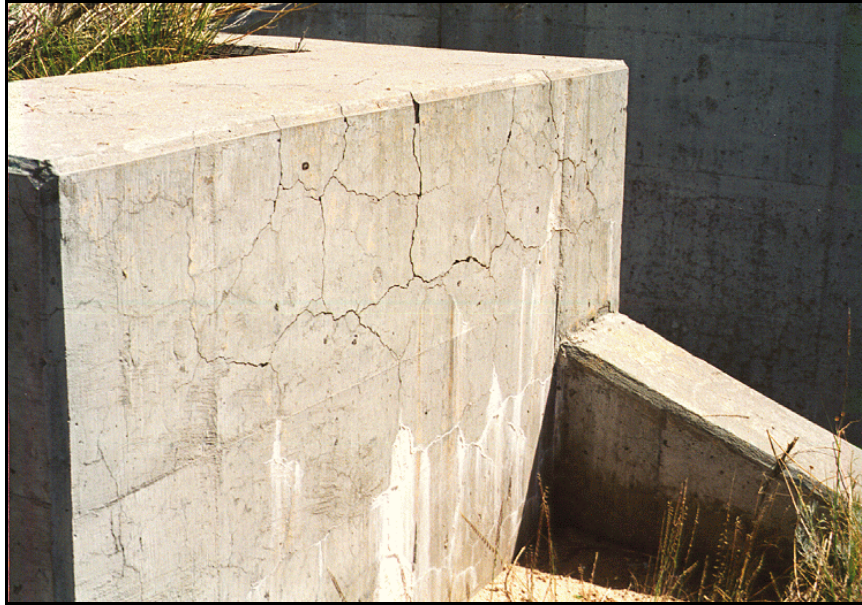
Figure 107.—Concrete deterioration from alkali-aggregate reaction.

- *Alkali-aggregate reaction.*—Alkali-aggregate reaction (AAR) occurs when certain types of sand and aggregate (e.g., opal, chert, flint, or volcanic material with a high silica content) are exposed to sodium and potassium hydroxide alkalis in portland cement. In a moist environment, a gel is formed around the reactive aggregate, creating tension cracks around the aggregate and extensive expansion and fracturing of the concrete. This expansion, cracking, and loss of concrete strength can lead to pathways for seepage or localized collapse of the conduit. Concrete containing alkali-reactive aggregate may show immediate expansion and deterioration, or it may remain undisturbed for many years. Concrete experiencing AAR is characterized by pattern cracking on the surface. Figure 107 shows a concrete wall that has experienced AAR. In new construction, aggregate sources containing negligible potentially alkali-reactive materials, low alkali cements, and pozzolan replacement of a portion of cement, should be used. When abundant potentially alkali-reactive materials are available, low alkali portland cements and fly ash pozzolan have been found to eliminate or greatly reduce the deterioration of reactive aggregates. There is no proven method for eliminating AAR in existing structures (Reclamation, 1997, p. 6).
