Randle Ranger Residence (Building #1135)
Silverbrook Road
Randle
Lewis County
Washington

HABS No. WA-187

HISTORIC AMERICAN BUILDING SURVEY
RANDLE RANGER RESIDENCE (Building No. 1135) HABS No. WA-187

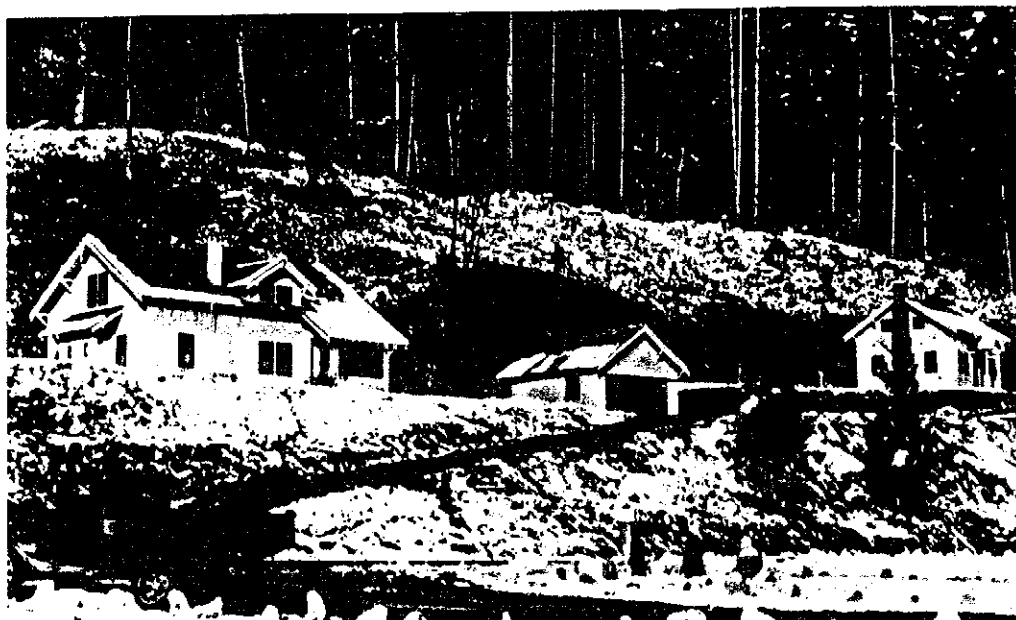
1935 photograph of Randle Ranger Residence (left), associated garage and Protection Assistant Residence (right). View is to NNE from junction of Silverbrook and Slagle Roads.

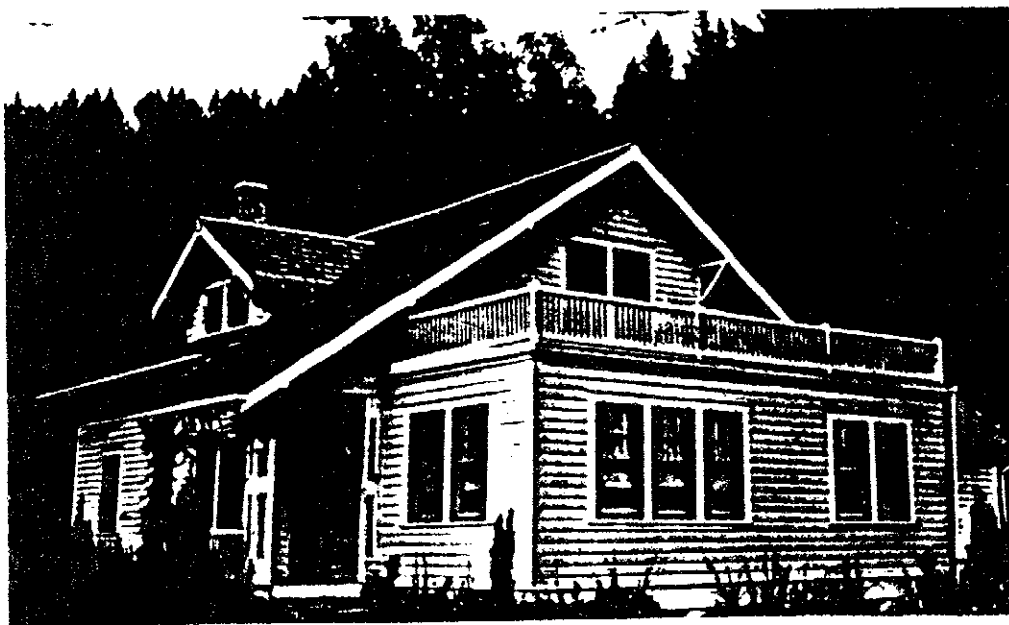
1937 photograph showing the 1936 addition to east side of Randle Ranger Residence. View is to NW.

A number of changes were noted that are not documented in Forest Service records. The present chimney, which services a brick living room fireplace, also appears in the 1937 photograph of the house. A former chimney was found behind a wall in the kitchen. This chimney probably serviced a woodburning cookstove in the kitchen. The 1937 photo also shows a colonial-style railing over the flat-roofed living room/dinette addition. This was removed in later years and a single pitch roof added. In the 1930s the roof of the residence was comprised of cedar shingles. These were replaced in 1950 with composition shingles.
