ARMY GROUND RISK-MANAGEMENT PUBLICATION

# COUNTERMEASURE

SEPTEMBER 1998

## Human Error Leads Accident Causes

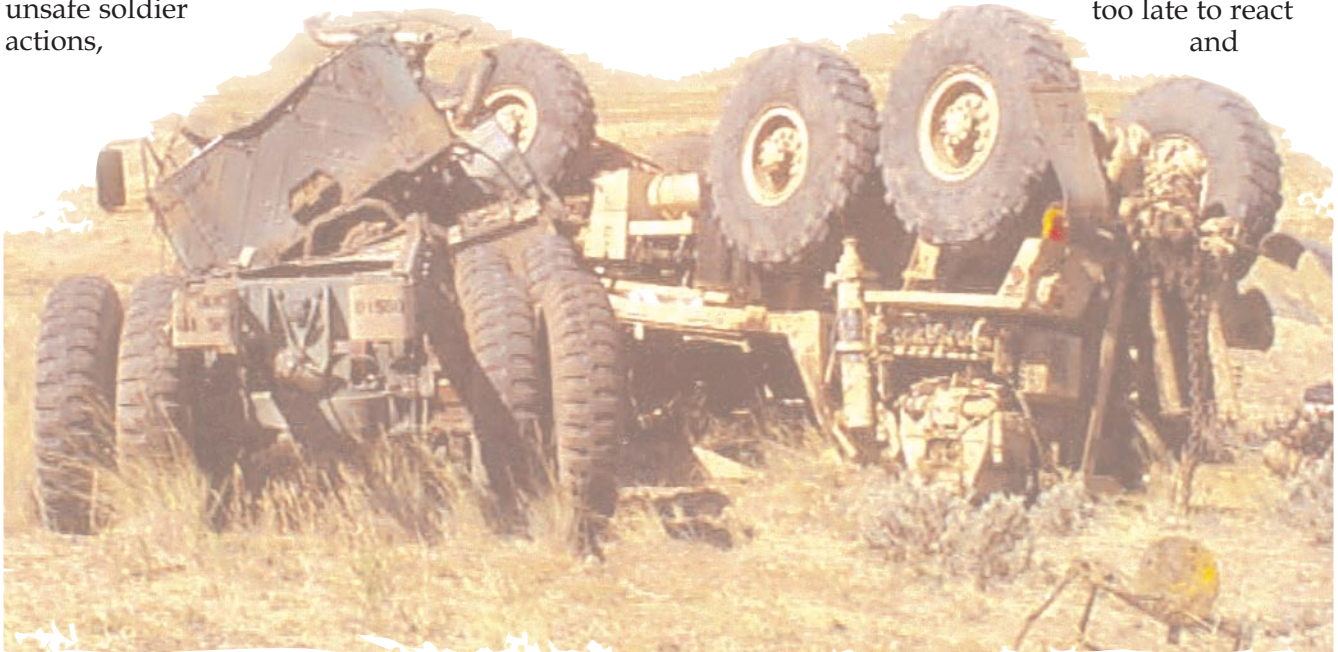
■ **Driving blind.** The driver was unfamiliar with the road and the route. The dirt road was unmarked. Consequently, it was not until about 875 feet from the curve that the driver realized that the road did not continue straight, but in fact, made a sharp 115 degree right turn. But, at his rate of speed, it was too late to react and

maintain vehicle control.

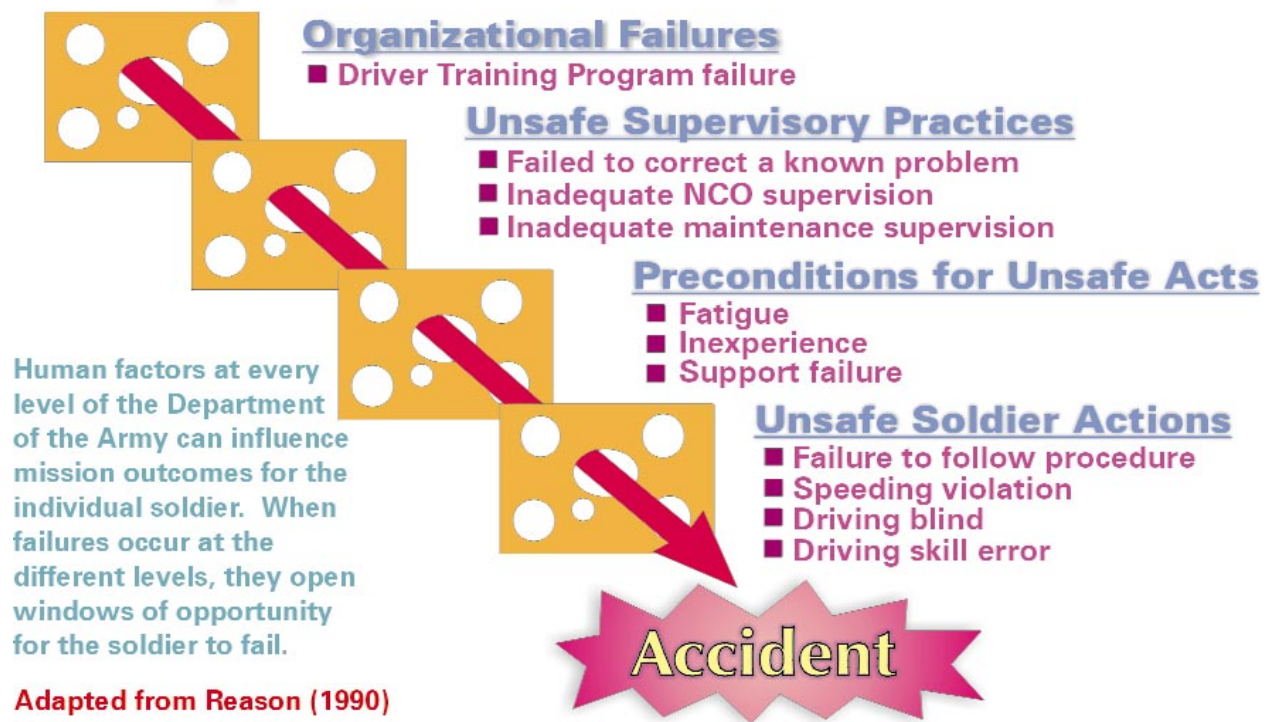
## A Soldier's Failure May Not Be Due to His Own Actions

Adapted from Reason (1990)

Adapted from Wiegmann and Shappell (1998)

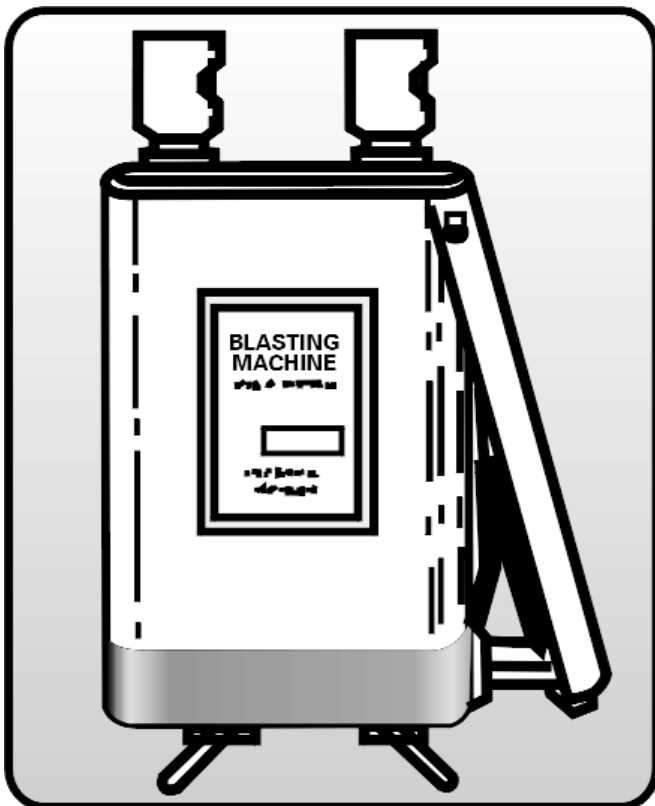
## M34 Blasting Machine

**D**eadline M34 Blasting Machine. TACOM-ACALA Rock Island, IL, AMSTA-AC-SF, 231846Z Jul 98, SOUM 98-05. This SOUM deadlines M34 Blasting Machines manufactured by Minowitz Manufacturing and all M34s for which the manufacturer cannot be identified. The M34

Blasting Machine, NSN 1375-00-567-0223, has demonstrated a safety problem.
