Module Tests

- Noise measurement using L0 prototype connected with only cable. → capacitance of analog cable.
- L0/L1 prototype modules being tested. The basic functionality working OK, however... there are a few unresolved problems and misbehaviors.
 - Noise due to (?????) preamp reset.
 - BW dependence not completely same as expected.
 - Big (and the same size of) noise in first a few events.
 - Too clean (no noise) in the rest of events for loaded channel.
 - Many zero ADC counts. ← firmware or operation dependence.

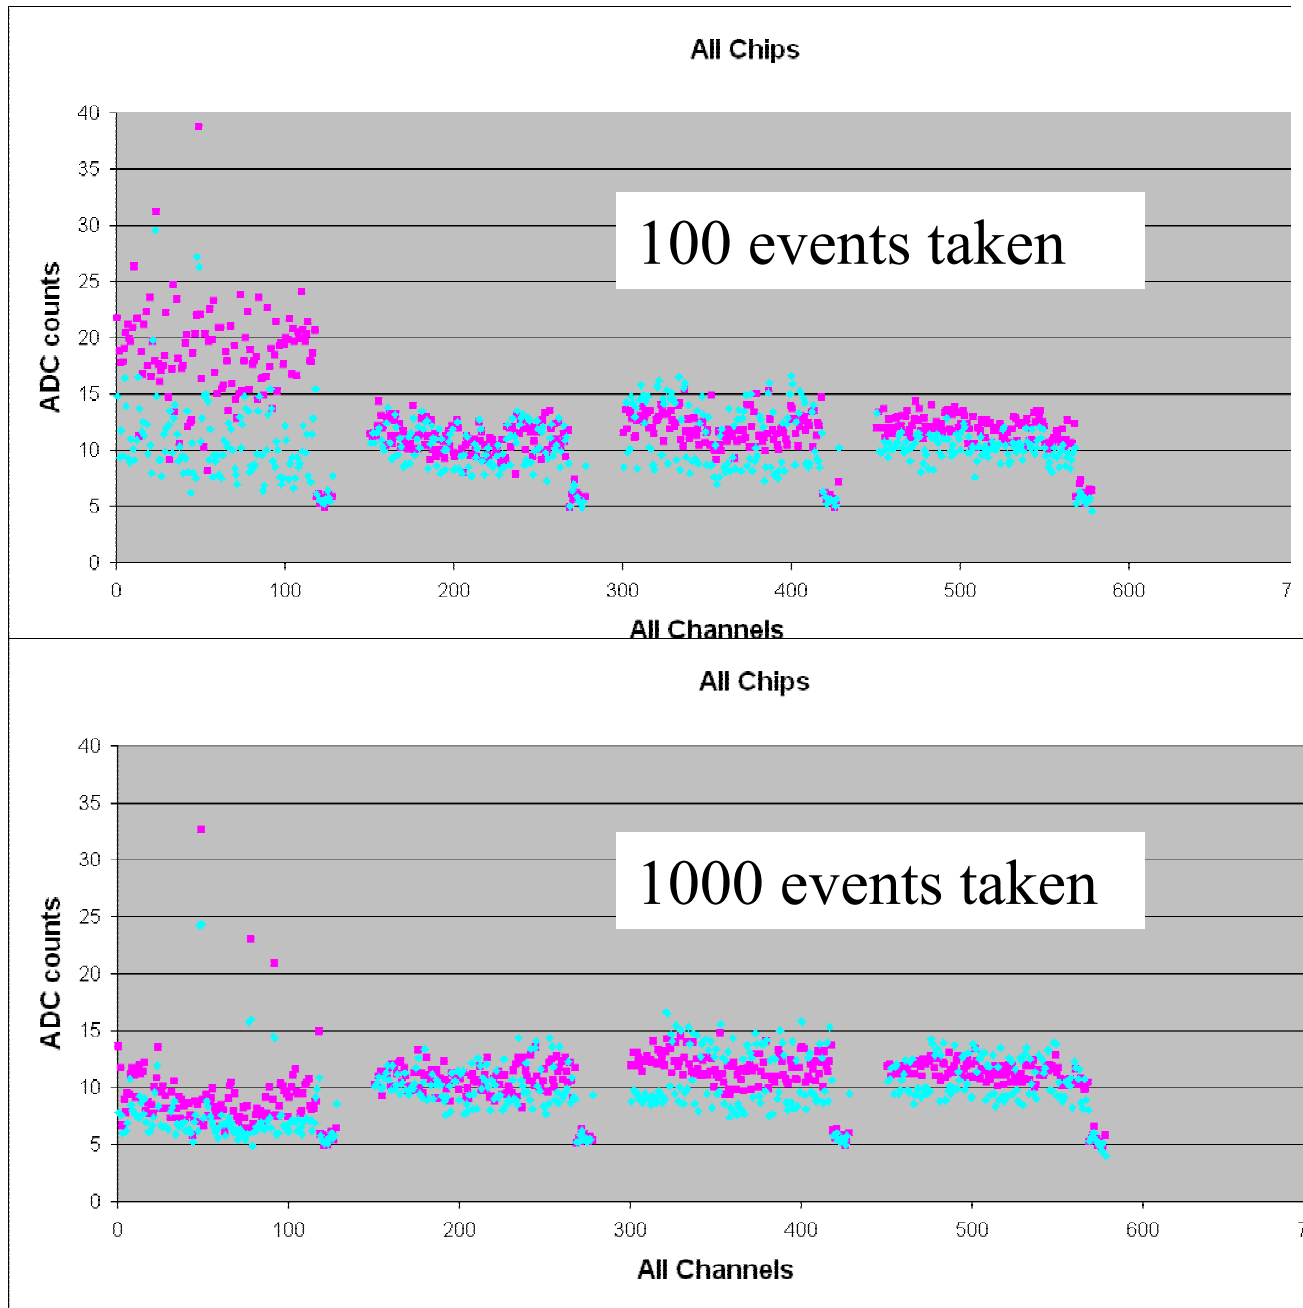
Misbehaviors 2 (w/ both cable and sensor)

- A few first events always noisy.
- The rest is too less noisy.

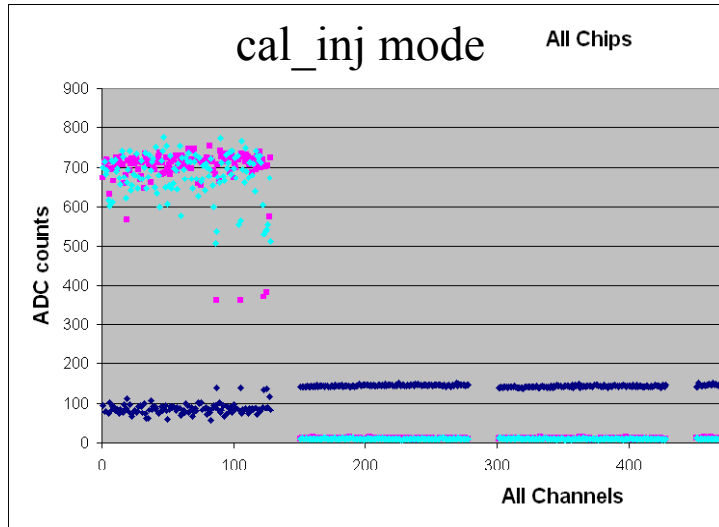
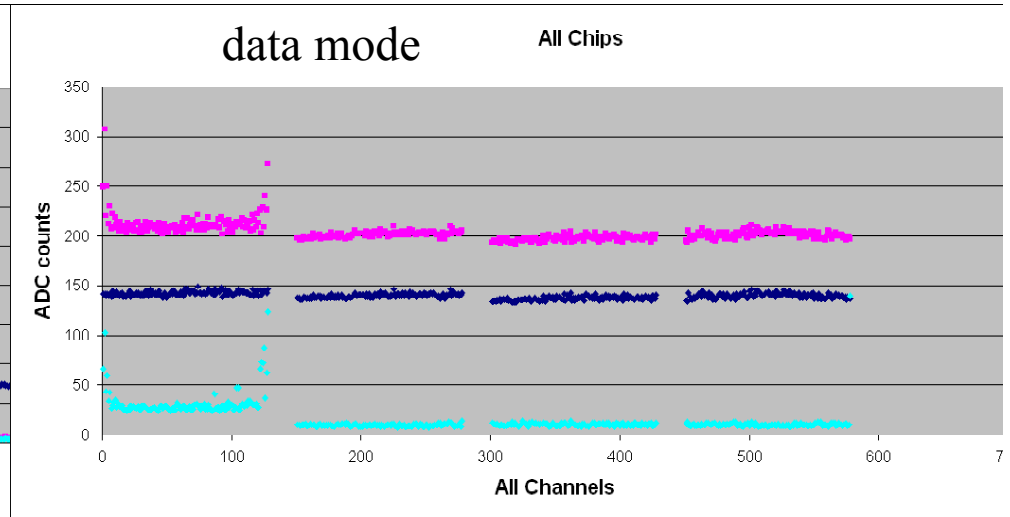
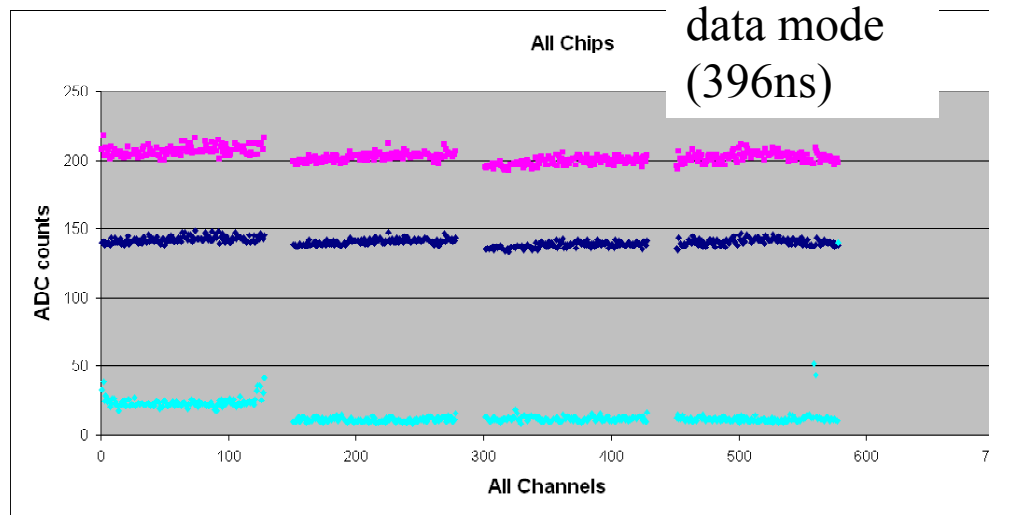
Misbehavior 3 (by the older firmware)

- There seems to be huge noise, but ... (see next slide)

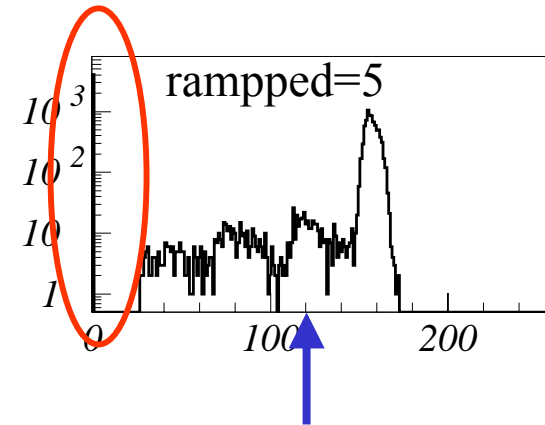
Pedestal Shape (cal_inject mode)

Lower limit of ADC counts in usual condition

- Note the fraction of zero.

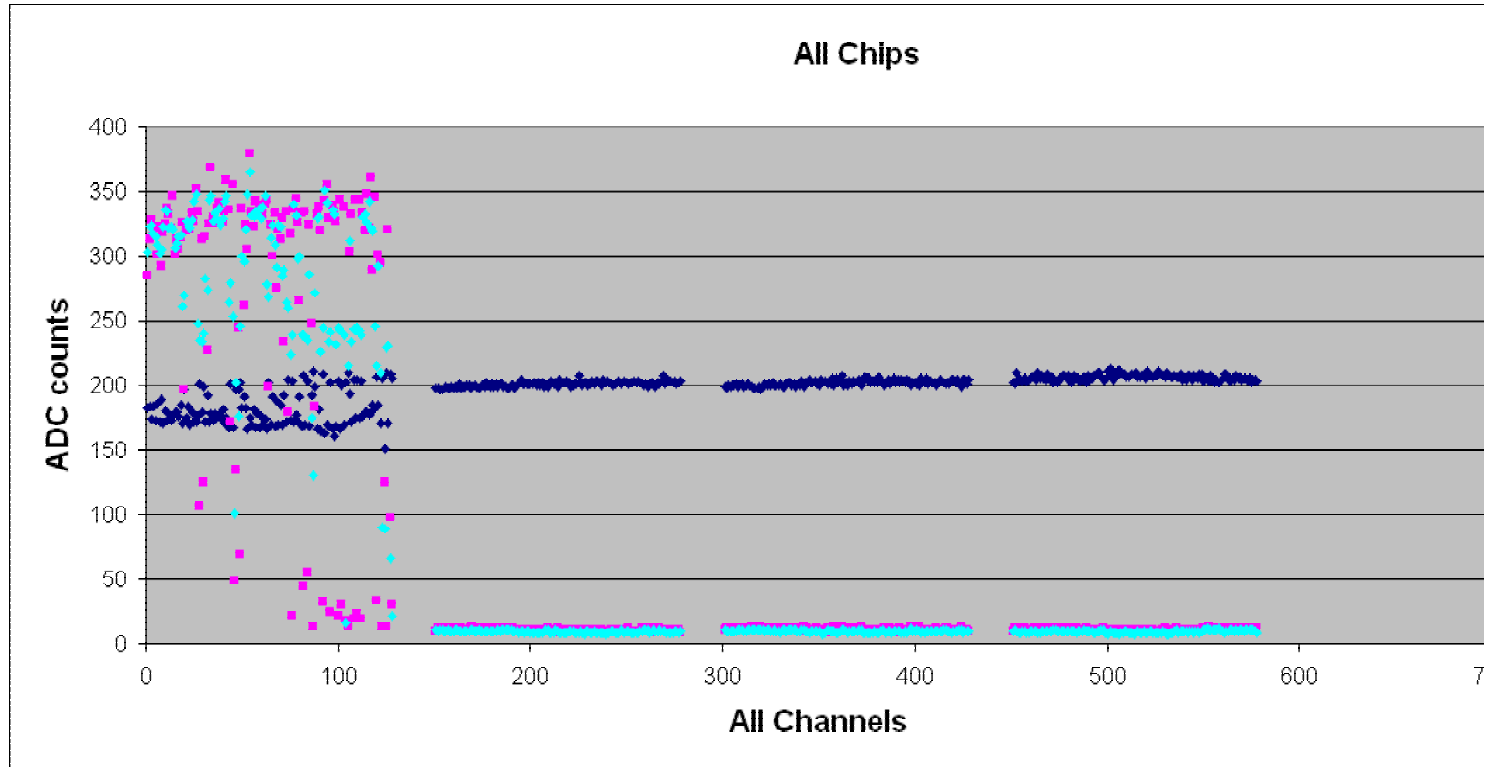
Even Odd Effect?

- The fraction of ADC=0 events differs between even and odd channel. → next page.
