# Volume II

## Appendix D.19

### Qualification and Interpretation of Sensor Data from STS-107

# Qualification and Interpretation of Sensor Data from STS-107

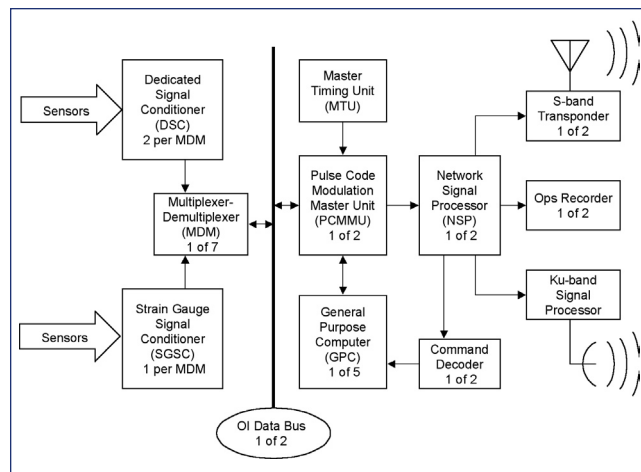
into a digital pulse code modulated (PCM) format, and combines and organizes the digital data from all of the sensors into a one-second long major data frame, using time division multiplexing (TDM). Time stamps generated by the master timing unit (MTU) are also added to each data frame by the PCMMU. The network signal processor (NSP) routes the data frame to either the S-band or Ku-band communications transceivers for transmission back to the mission control center (MCC) on the ground, or to a reel-to-reel tape recorder for permanent storage. The communications transceivers also receive commands from the MCC on the ground and pass them to the general purpose computers (GPCs) on the orbiter for processing and execution. A simplified block diagram of the OFI system is shown in Figure 1.

Figure 1. Operational Flight Instrumentation (OFI).

The orbiter flight instrumentation (OFI) is designed to monitor those sensors and systems which are involved with the real-time operational command of the vehicle and its mission. The OFI system collects the analog signals from a variety of physical sensors as well as digital logic signals which give the status of various vehicle functions. This diversity of input signals is put into a common format by the dedicated signal conditioners (DSCs) which are distributed throughout the vehicle's fuselage. Some sensors require more specialized signal conditioning, such as the strain gauges, and strain gauge signal conditioners (SGSCs) are also distributed within the vehicle avionics bays to accomplish this. The conditioned signals from the DSC and SGSC units are collected by seven multiplexer-demultiplexers (MDMs) which perform analog-to-digital conversion, buffer the converted data, and respond to transactions on the orbiter instrumentation (OI) data bus. The MDMs can also route commands from the OI bus to various subsystems in the vehicle. All of the OFI data is centrally handled by the pulse-code-modulation master unit (PCMMU), which converts the raw binary data

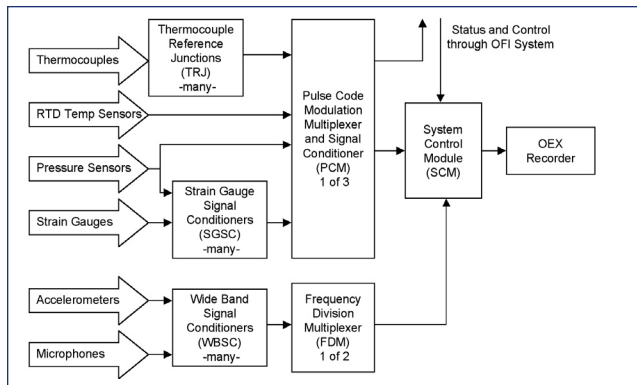
The orbiter experiment instrumentation (OEX) is an expanded suite of sensors for the MADS that was installed on the *Columbia* expressly for the purpose of engineering development. Since the *Columbia* was the first space shuttle orbiter to be launched, the engineering teams needed a means to gather more detailed flight data to validate their calculations of the conditions that the vehicle would experience during the critical flight phases of the mission. The voluminous data generated by the OEX suite required the installation of a particularly high capacity reel-to-reel tape recorder, known as the OEX recorder. The three flight phases of ascent, de-orbit, and re-entry are each recorded on chosen tracks of the OEX recorder. A simplified block diagram of the MADS/OEX system is shown in Figure 2.

Figure 2. Modular Auxiliary Data System (MADS) and Orbiter Experimental Instrumentation (OEX).

The modular auxiliary data system (MADS) is a supplemental instrumentation system that gathers vehicle flight data for processing after the mission is completed. Sensor inputs to the MADS system are almost exclusively physical sensor readings of temperature, pressure, mechanical strain, acceleration, or vibration. Sensors whose outputs vary comparatively slowly with time, such as temperature, pressure, and strain, are first signal conditioned by either thermocouple reference junctions (TRJs), strain gauge signal conditioners (SGSCs), or by the input circuits of one of the three pulse-code modulation (PCM) units. The PCM units perform analogous functions to what the MDMs and PCMMU do for the OFI system, performing analog-to-digital conversion of each sensor input, converting the raw binary data to pulse code modulation format, and combining all of the sensor readings into a time-stamped time-division-multiplexed frame of data. Sensors whose outputs vary rapidly with time, such as acceleration and vibration, are signal conditioned by wide band signal conditioners (WBSGs), and their data is collected by one of two frequency division multiplexers (FDMs). The FDMs modulate each input channel at different frequencies to combine the data into a single high-bandwidth track. Finally, the outputs from the three PCMs and two FDMs are routed to the appropriate tracks on a reel-to-reel tape recorder for playback once the vehicle is back on the ground. The MADS system is itself controlled by commands sent to it through the OFI system.
