Single-Event Effects Test Report on IEEE 1394

(Testing conducted at Texas A&M on 10/14/01)

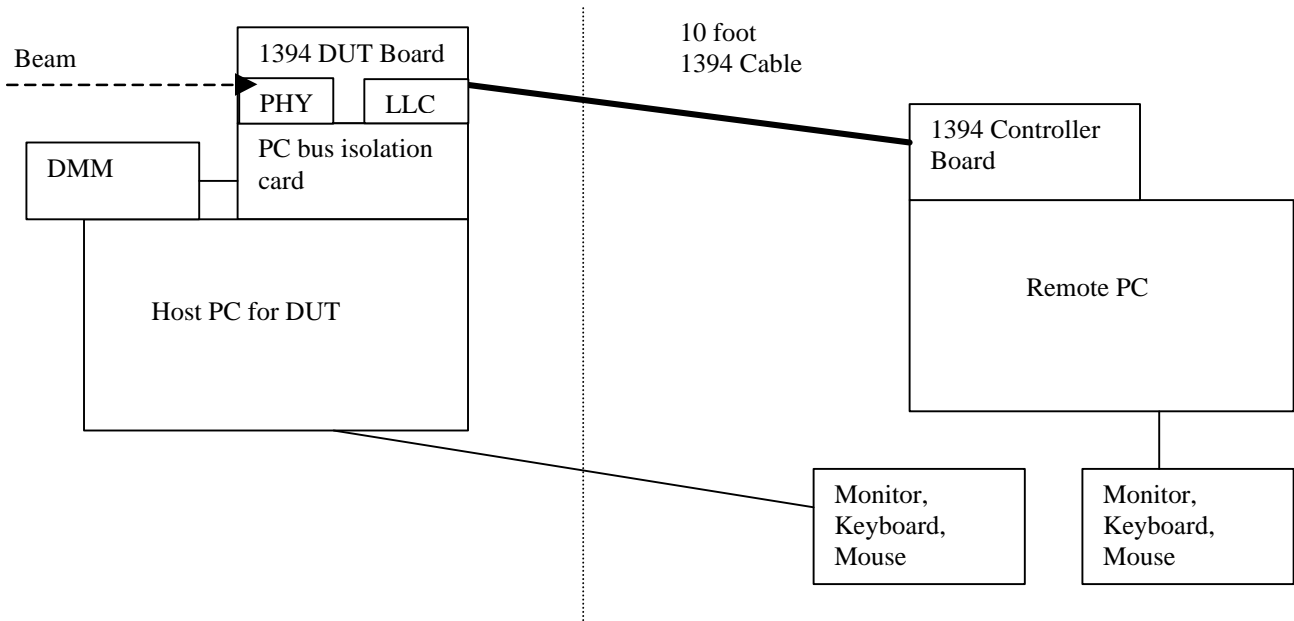
Two personal computers (PCs) with PCI slots were used in the test. Each PC contained an IEEE 1394 board and was connected to the other by an IEEE 1394 cable 10 feet long. One of the PCs was positioned close to the exit port of the accelerator and the other was located outside the chamber. The IEEE 1394 board containing the two devices-under-test (DUTs) was mounted on top of its host PC case and positioned in front of the accelerator exit port for exposure to the ion beam in air. The host PC was secured to a stage that could be moved linearly in all directions and could also be rotated. Only one of the DUTs at a time was exposed to the beam. A PCI bus isolation card was placed between the DUT board and its host PC, making it possible to measure the supply current to the DUT board from the host PC via the PCI interface. A HP34401A Digital Multi-Meter (DMM) was used to read and record the current to assist in identifying SEL. A monitor, mouse and keyboard were connected to the PC hosting the DUT via a bus extender. In that way both PCs could be controlled from outside the chamber. Fig. 1 shows the hardware setup.
