STREAM RESTORATION AT DENALI NATIONAL PARK AND PRESERVE

Roseann V. Densmore and Kenneth F. Karle

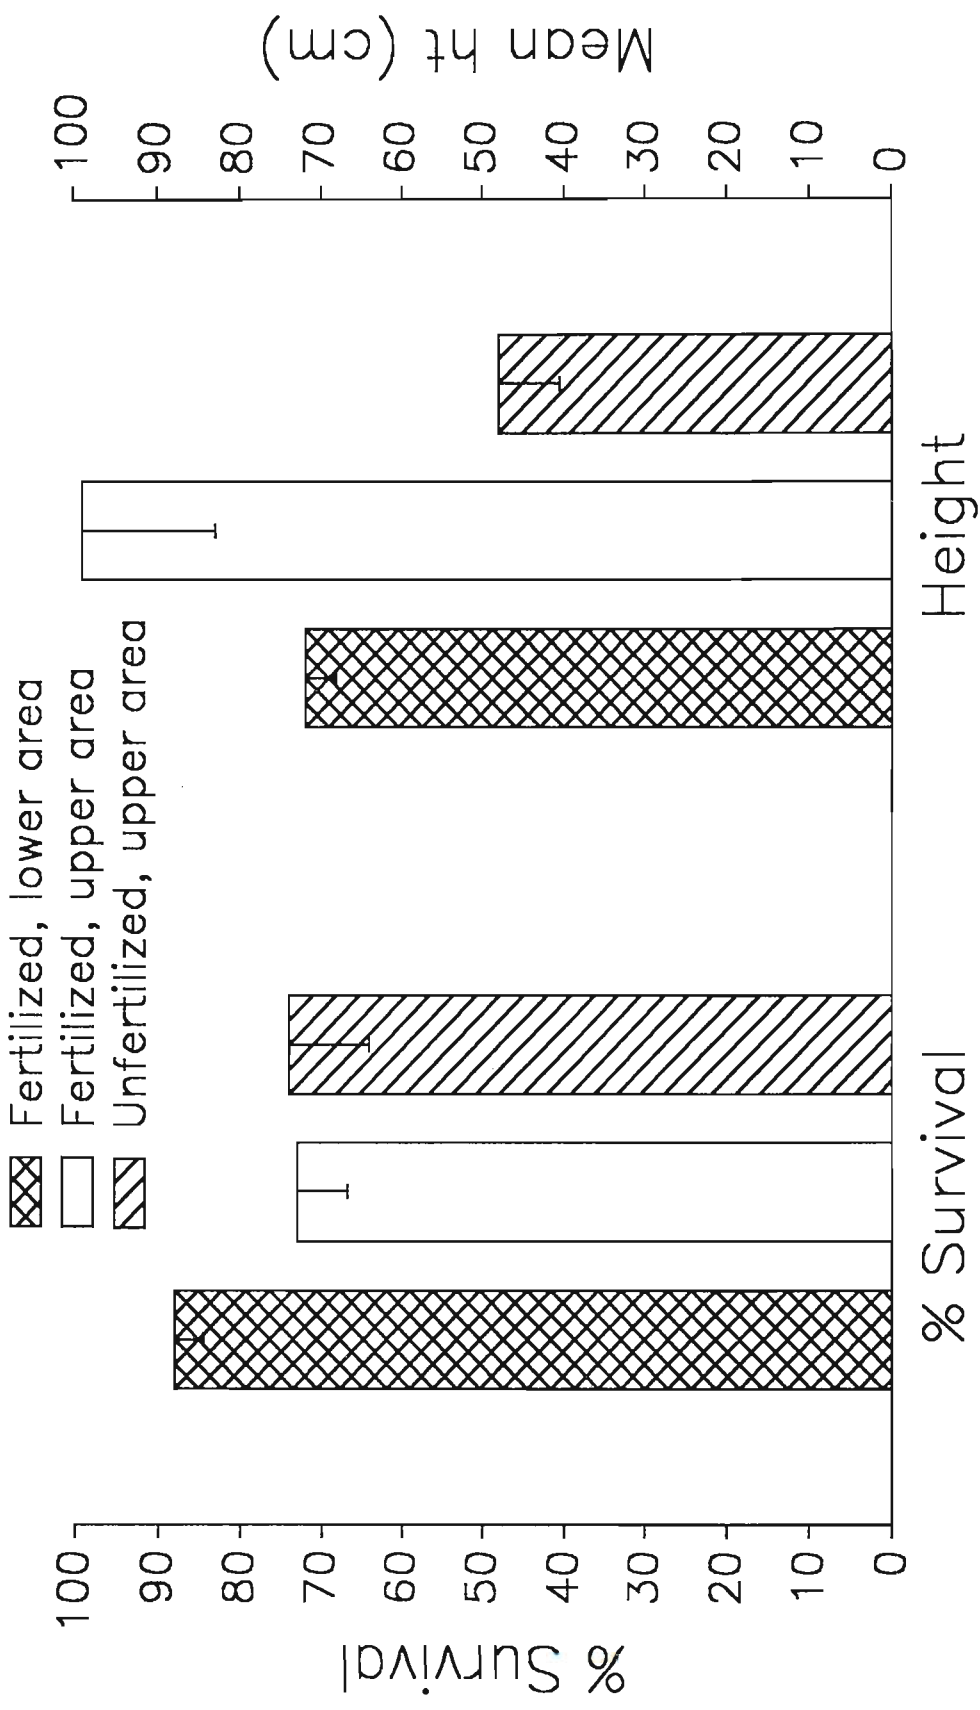
Fig 3

Fig. 3. Survival and growth of planted feltleaf willow cuttings after four years, with and without time-release fertilizer on the upper study area, and with time-release fertilizer on the lower study area.

Four years after planting, overall survival of cuttings which were not washed out was 80% (Fig. 3). On the upper study site, the fertilization treatment had no effect on survival, but fertilized cuttings were twice as tall as unfertilized cuttings (Fig. 3).
