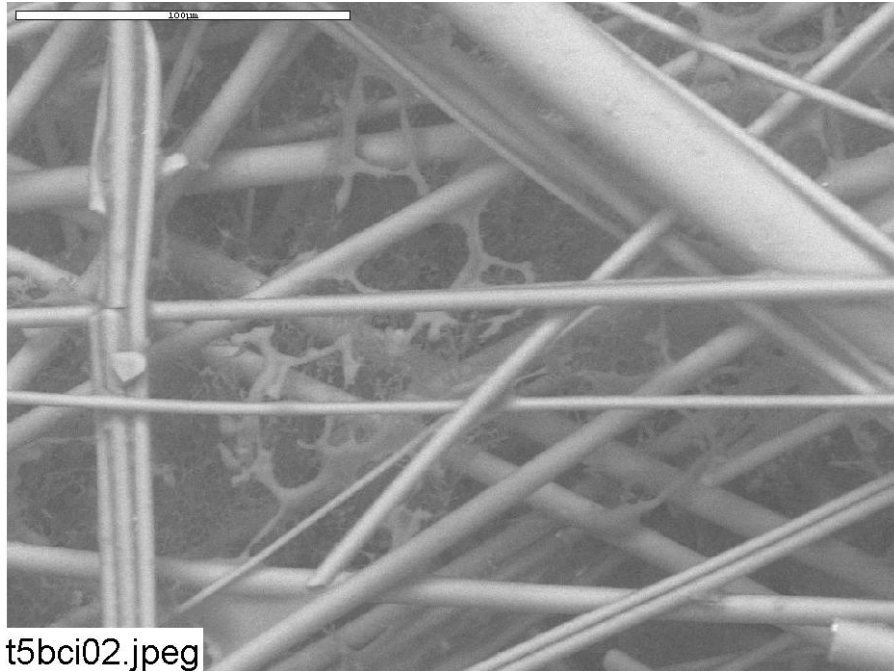
Figure 3-70. ESEM image magnified 500 times for a Test #5, Day-30 interior fiberglass sample in the birdcage.

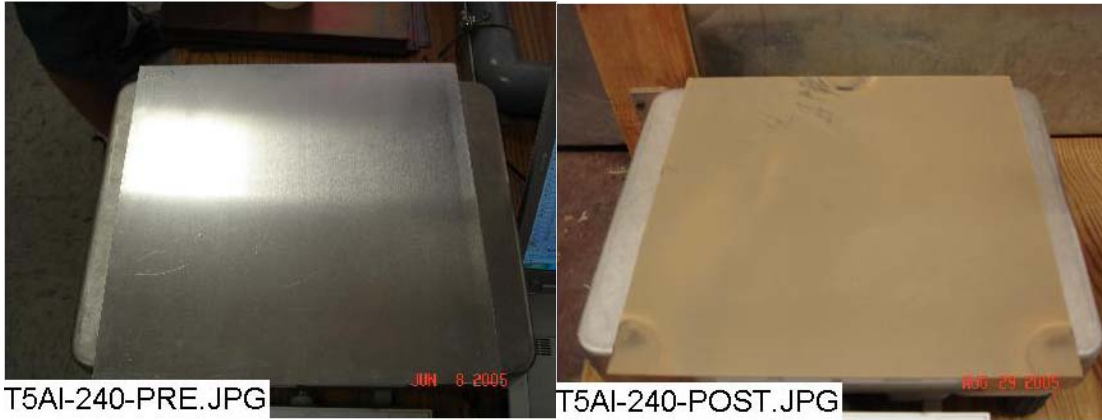
**Figure 3-71. AI-240 submerged, pre-test (left) and post-test (right).**

There are three submerged aluminum coupons in each test. Figures 3-71 through 3-73 are the pre- and post-test pictures of the Test #5 coupons. The aluminum coupons A1-240, A1-241, and A1-242 (see Figures 3-71 through 3-73) were located from east to west, respectively, in the tank. The submerged aluminum coupons turned brown, and they developed a brown, powdery film on the surface. The film resulted in the surface of the coupon becoming rough to the touch.

Type	Coupon No.	Pre-Test Wt. (g)	Post-Test Wt. (g)	Net Gain/Loss
Al	240	391.7	378.6	-13.1
Al	241	391.7	379.6	-12.1
Al	242	392.1	383.6	-8.5
GS	137	1043.2	1043.1	-0.1
GS	140	1067.5	1067.7	0.2
GS	141	1069.9	1070.0	0.1
IOZ	310	1652.9	1654.5	1.6
IOZ	312	1610.3	1611.6	1.3
CU	512	1322.6	1322.2	-0.4
CU	574	1306.0	1305.4	-0.6
US	14	1022.2	1022.2	0.0
Conc	003	7627.8	7853.7	225.9

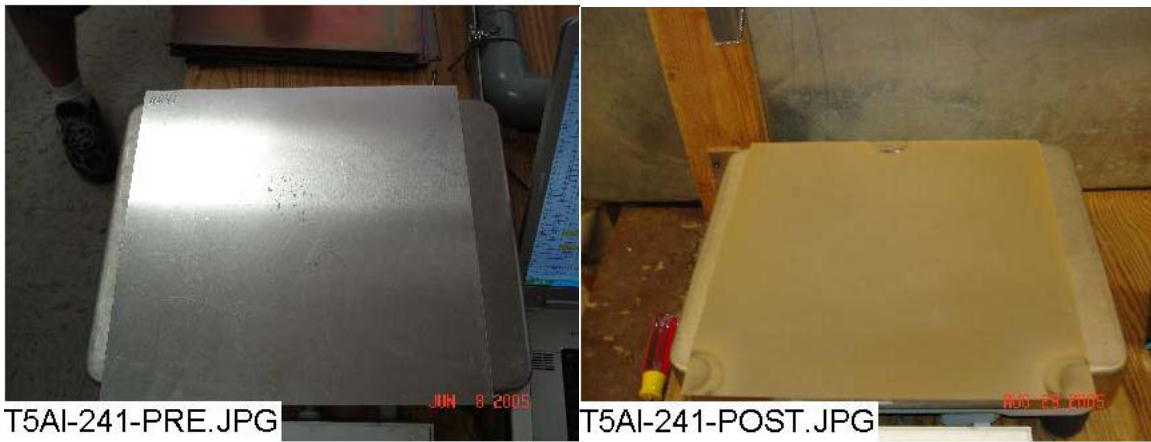
**Figure 3-72. AI-241 submerged, pre-test (left) and post-test (right).**

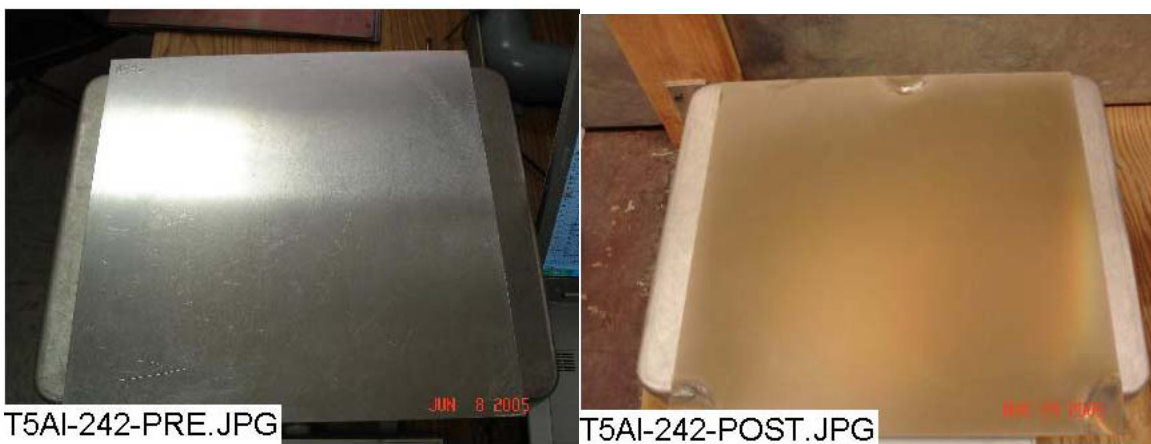
**Figure 3-73. AI-242 submerged, pre-test (left) and post-test (right).**

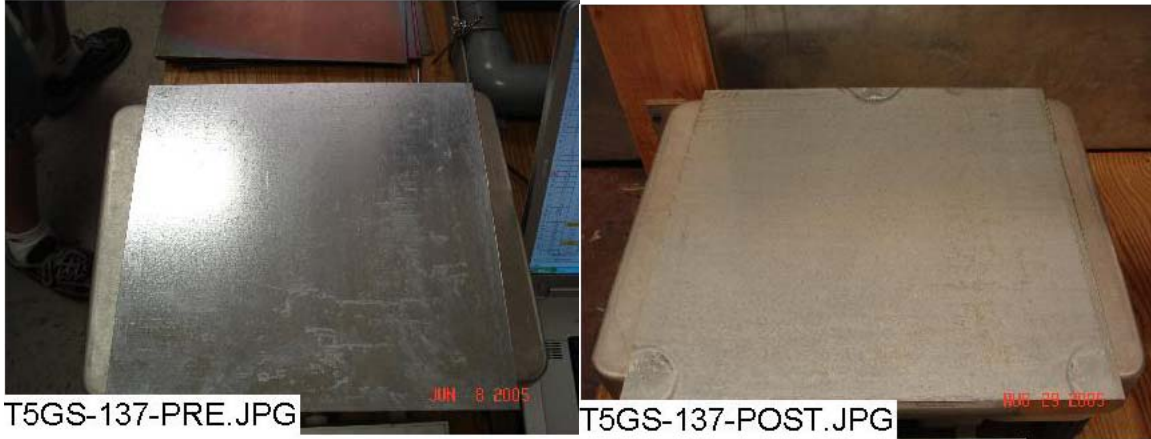
**Figure 3-74. GS-137 submerged, pre-test (left) and post-test (right).**

Figures 3-74 through 3-76 present the pre- and post-test pictures of three submerged galvanized steel coupons. The galvanized steel coupons developed a white precipitate on the surface of the coupons, which caused the surfaces to have a coarse feel. The surfaces of the coupons had horizontal lines composed of this same white precipitate. The horizontal deposits may have been left during the slow draining of the tank solution.

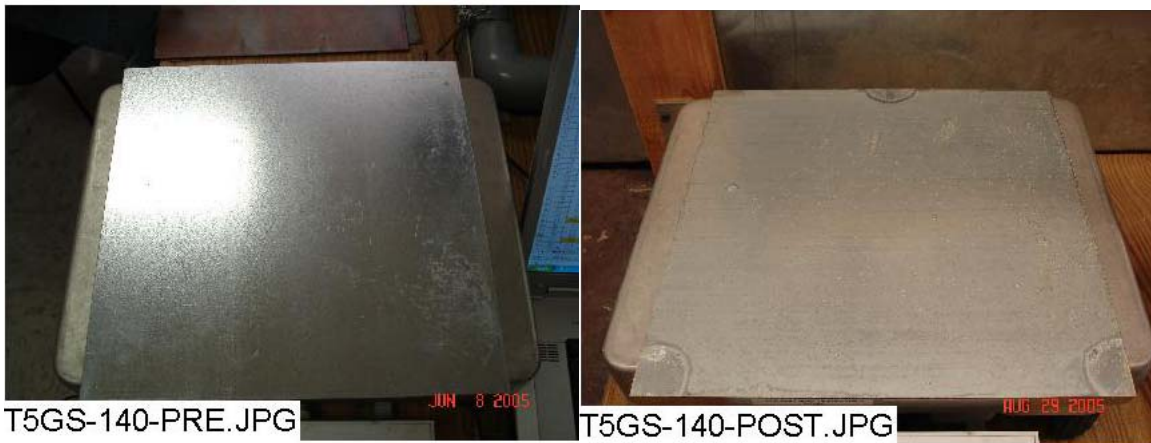
**Figure 3-75. GS-140 submerged, pre-test (left) and post-test (right).**

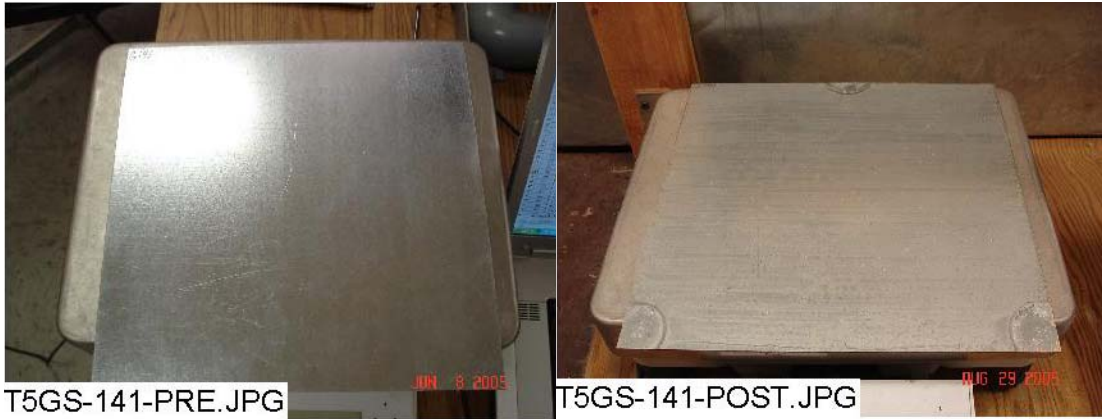
**Figure 3-76. GS-141 submerged, pre-test (left) and post-test (right).**

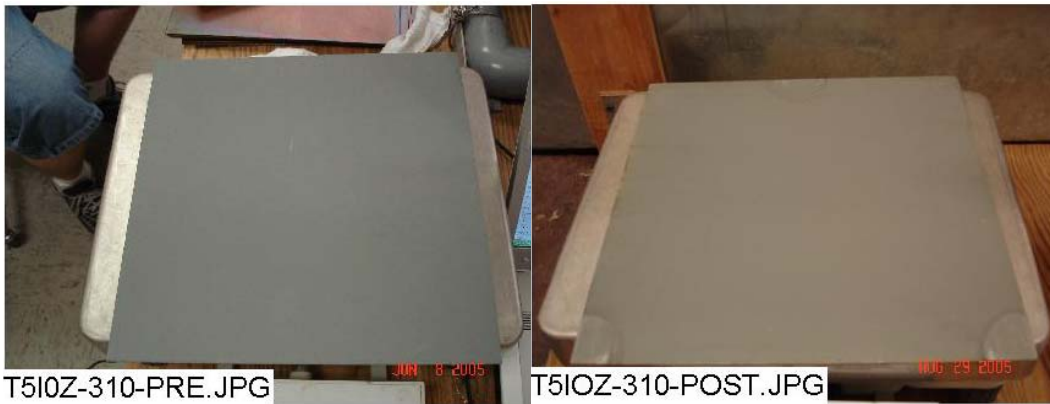
**Figure 3-77. IOZ-310 submerged, pre-test (left) and post-test (right).**

Figures 3-77 and 3-78 present the pre- and post-test pictures of two submerged IOZ-coated steel coupons. Both submerged IOZ-coated steel coupons have similar light particulate deposits. These coupons were covered with a brown coating over their entire surfaces.

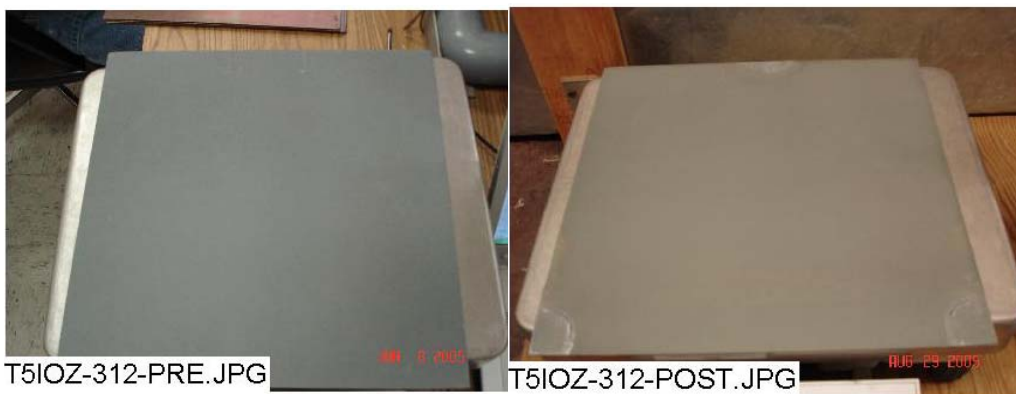
**Figure 3-78. IOZ-312 submerged, pre-test (left) and post-test (right).**

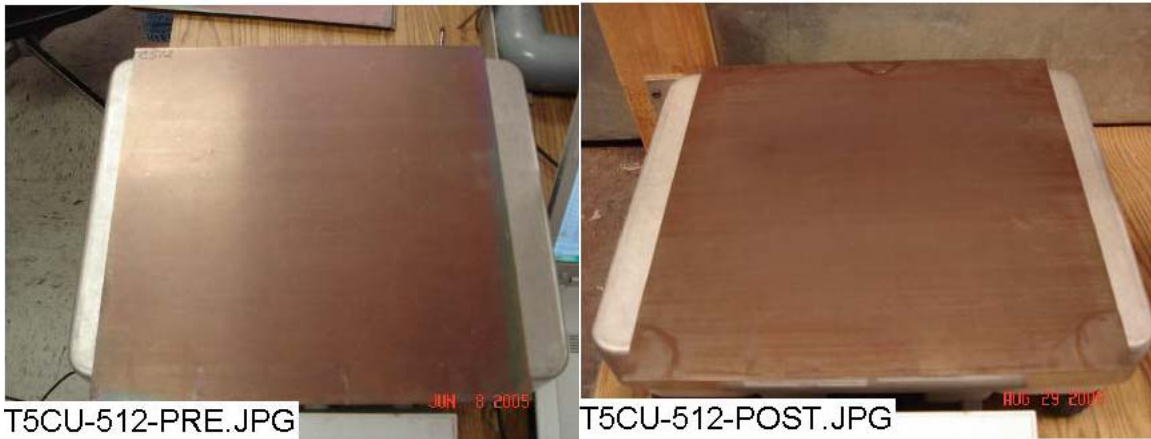
**Figure 3-79. CU-512 submerged, pre-test (left) and post-test (right).**

Figures 3-79 and 3-80 present the pre- and post-test pictures of two submerged copper coupons. The submerged copper coupons developed very light horizontal white deposits, which may be due to the slow tank draining process.

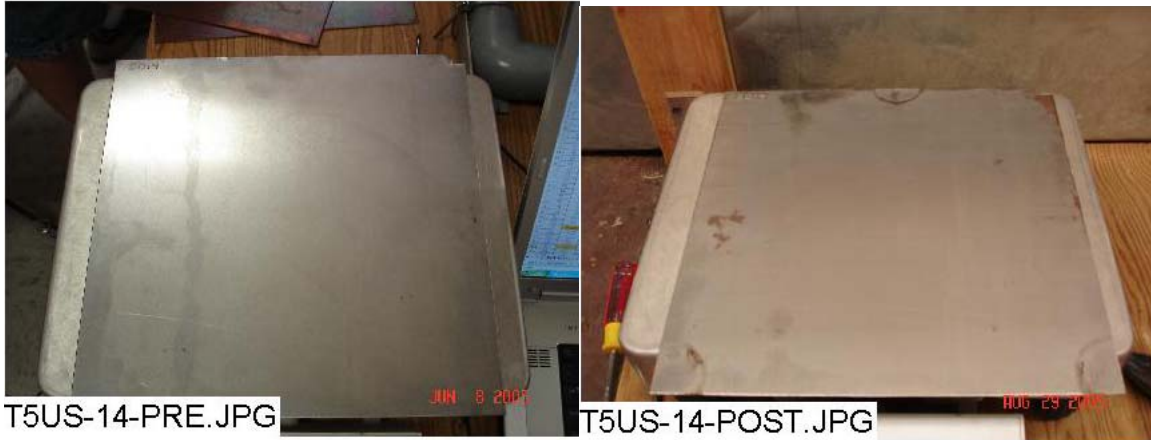
**Figure 3-81. US-14 submerged, pre-test (left) and post-test (right).**

Figure 3-81 presents the pre- and post-test pictures of the submerged carbon steel coupon. The surface of the coupon was roughened by the deposition of white precipitate. There were also areas of rust on the coupon.

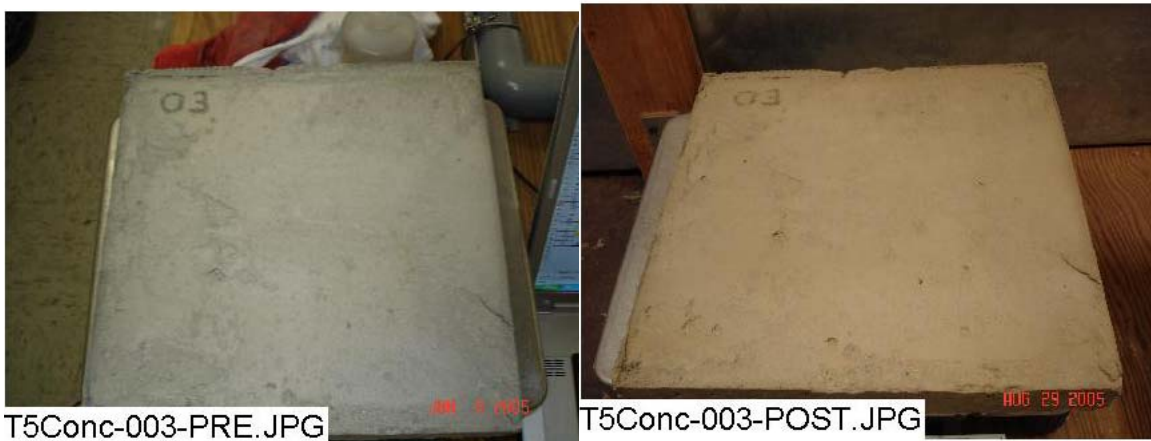
**Figure 3-82. Conc-003 submerged, pre-test (left) and post-test (right).**

Figure 3-82 presents the pre- and post-test pictures of the submerged concrete coupon. The post-test concrete coupon exhibits a brownish color.

The aluminum coupons' average weight differential was -11.2 g. The galvanized steel coupons' average weight gain was less than 0.1 g, and the coated steel coupons gained an average of 1.5 g. The representative copper coupons lost an average of 0.5 g, and the carbon steel coupon had no weight change. The concrete coupon gained 225.9 g, a gain of 3% of its original weight, which was likely due to post-test water retention.

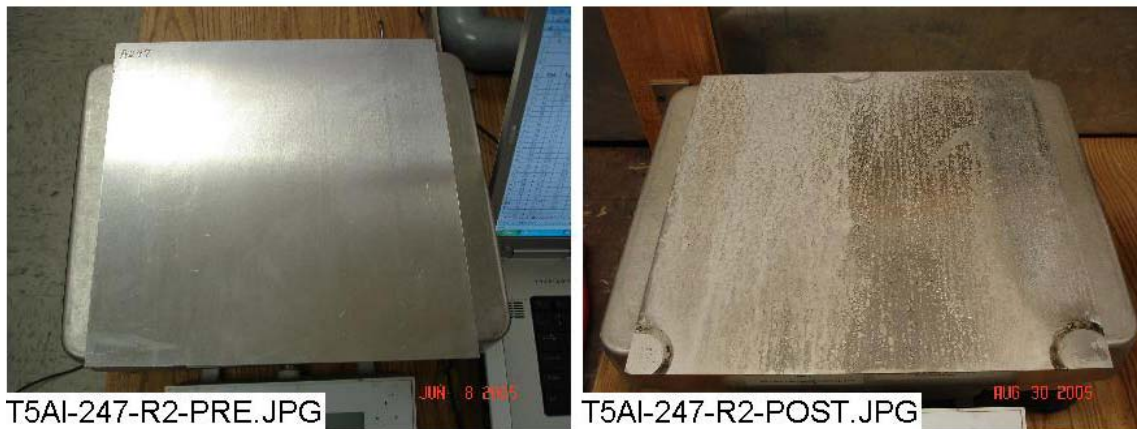
**Figure 3-83. Al-247 unsubmerged, pre-test (left) and post-test (right).**

Figures 3-83 and 3-84 show the pre- and post-test pictures of two unsubmerged aluminum coupons. Each unsubmerged aluminum coupon accumulated a white particle deposition along with some brownish areas. Also, the texture of each coupon is coarser, and the surface quality of each coupon is less lustrous than before the test. The reddish-brown color that was observed on the submerged coupons is absent on the unsubmerged coupons. The Al-247 coupon was loaded in Rack 2, which was located in the southern position of the middle tier of the tank. The Al-294 coupon was loaded in Rack 7, which was located in the northern position of the top tier of the tank.

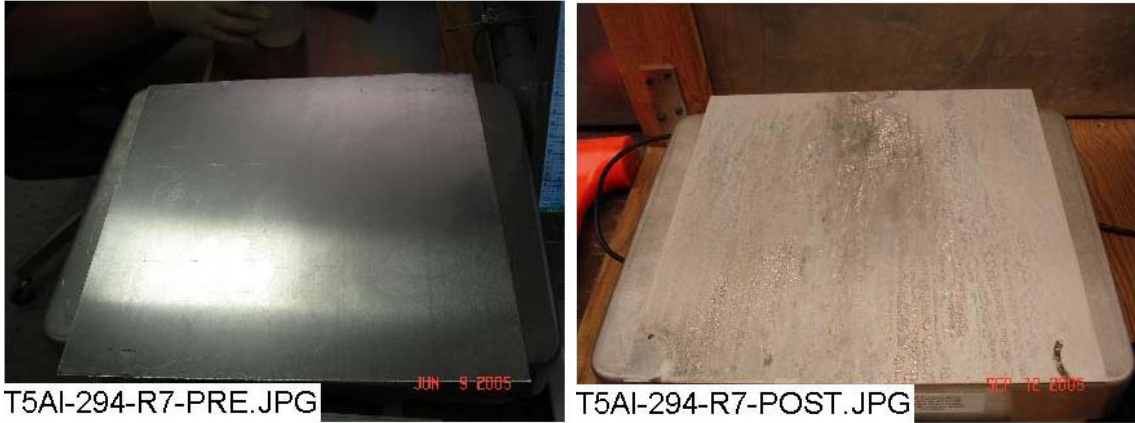
**Figure 3-84. Al-294 unsubmerged, pre-test (left) and post-test (right).**

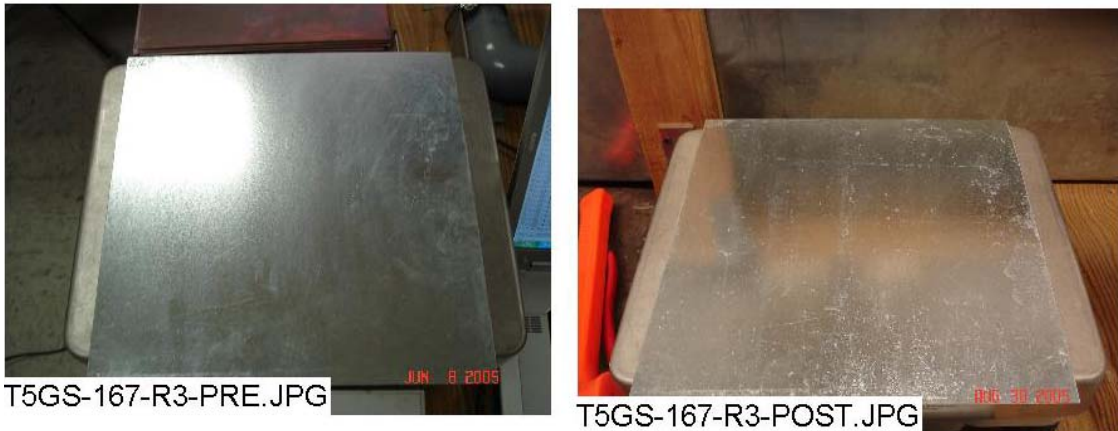
**Figure 3-85. GS-167 unsubmerged, pre-test (left) and post-test (right).**

Figures 3-85 and 3-86 show the pre- and post-test pictures of two unsubmerged galvanized steel coupons. There was some white deposition on the surface of these coupons, although it was in small amounts. This deposition is visibly different and less concentrated than that of the submerged coupons. The GS-167 coupon was loaded in Rack 3, which was located in the center position of the middle tier of the tank. The GS-638 coupon was loaded in Rack 6, which was located in the middle position of the top tier of the tank.

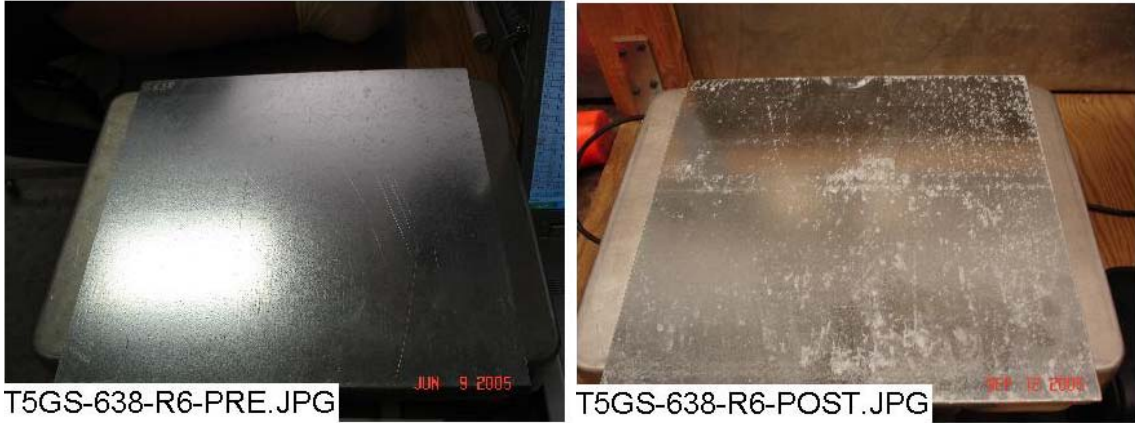
**Figure 3-86. GS-638 unsubmerged, pre-test (left) and post-test (right).**

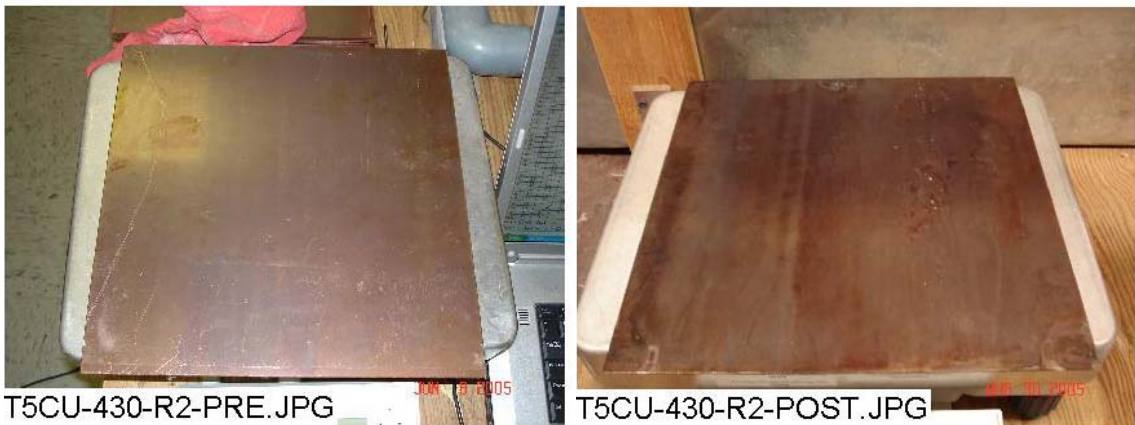
**Figure 3-87. CU-430 unsubmerged, pre-test (left) and post-test (right).**

Figures 3-87 and 3-88 present the pre- and post-test pictures of two unsubmerged copper coupons. All of the copper coupons had vertical water marks that were likely caused by water flowing downward on the coupon surface during the spray portion of the test. The copper coupons did not appear to accumulate any particle deposition. The CU-430 coupon was loaded in Rack 2, which was located in the southern position of the middle tier of the tank. The CU-587 coupon was loaded in Rack 7, which was located in the northern position of the top tier of the tank.

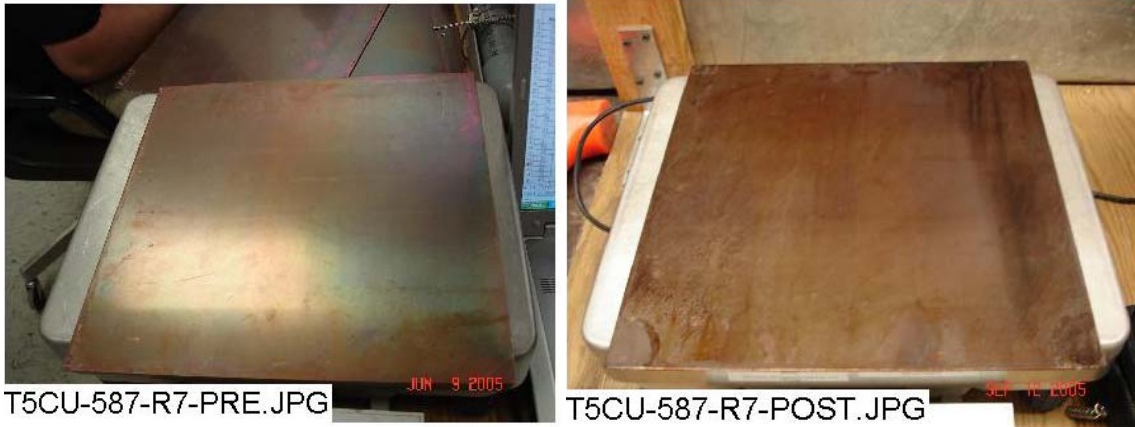
**Figure 3-88. CU-587 unsubmerged, pre-test (left) and post-test (right).**

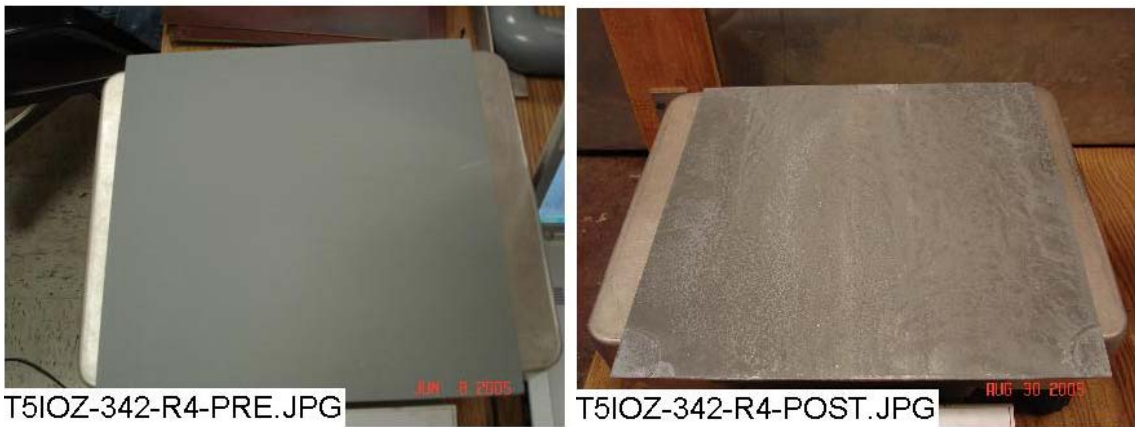
**Figure 3-89. IOZ-342 unsubmerged, pre-test (left) and post-test (right).**

Figures 3-89 and 3-90 present the pre- and post-test pictures of two unsubmerged IOZ-coated steel coupons. Each post-test coated steel coupon exhibits a similar pattern of deposition, which is less concentrated than that of the submerged coupons. The IOZ-342 coupon was loaded in Rack 4, which was located in the northern position of the middle tier of the tank. The IOZ-356 coupon was loaded in Rack 5, which was located in the southern position of the top tier of the tank.

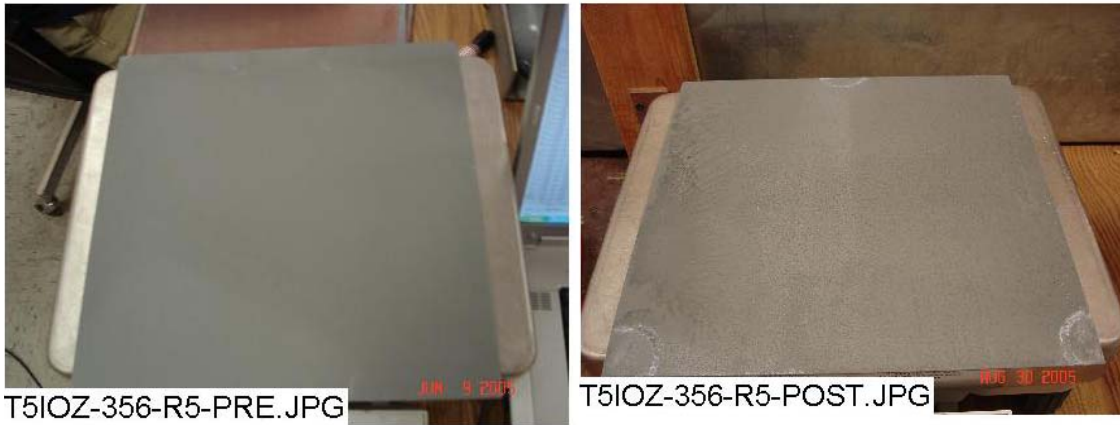
**Figure 3-90. IOZ-356 unsubmerged, pre-test (left) and post-test (right).**

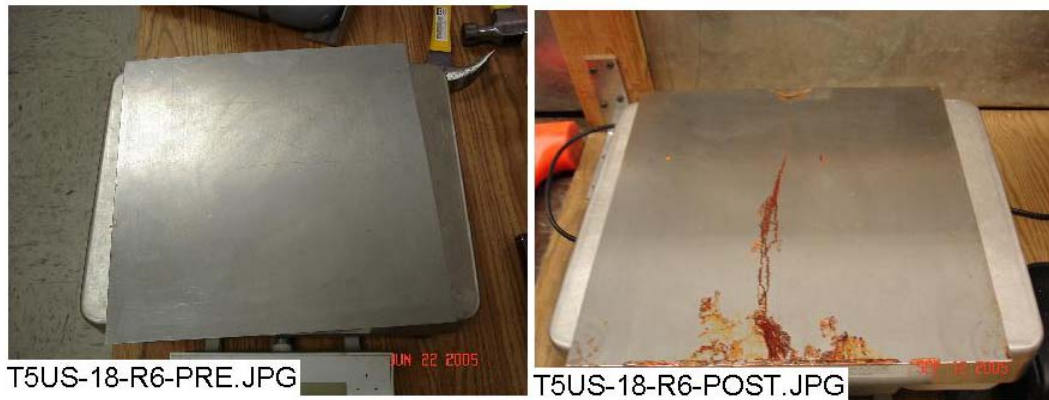
**Figure 3-91. US-18 unsubmerged, pre-test (left) and post-test (right).**

Figure 3-91 presents the pre- and post-test pictures of one unsubmerged carbon steel coupon. The post-test carbon steel coupon exhibits rust along its center line and around its bottom edge. The deposition concentration is greater than that of the submerged carbon steel coupon. The US-18 coupon was loaded in Rack 6, which was located in the center position of the top tier of the tank.

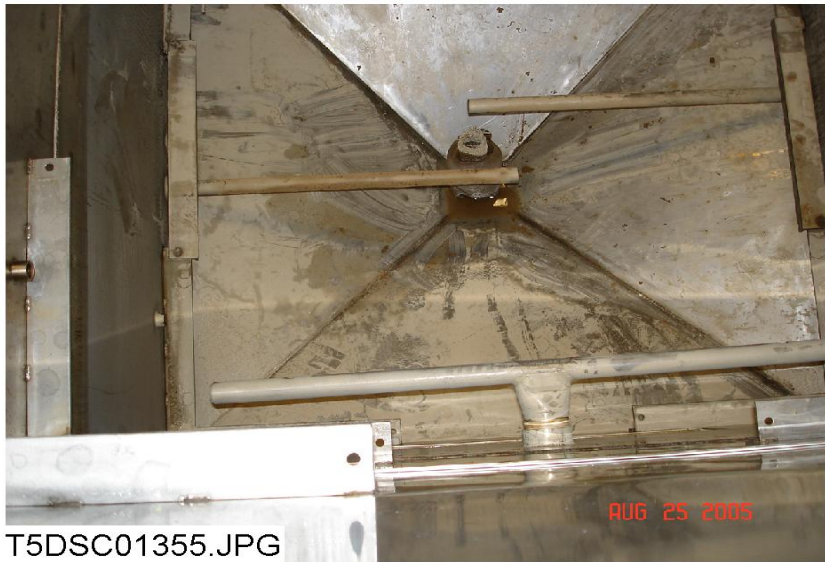
**Figure 3-93. Tank bottom after draining.**

Sediment was collected from the tank bottom after the test solution was drained. The entire amount recovered was 89 g, wet, as shown in Figure 3-92. Figure 3-93 shows the tank bottom with the sediment, after the test solution was drained and the samples were removed. Figure 3-94 shows the top of the drain screen with the drain collar still attached.

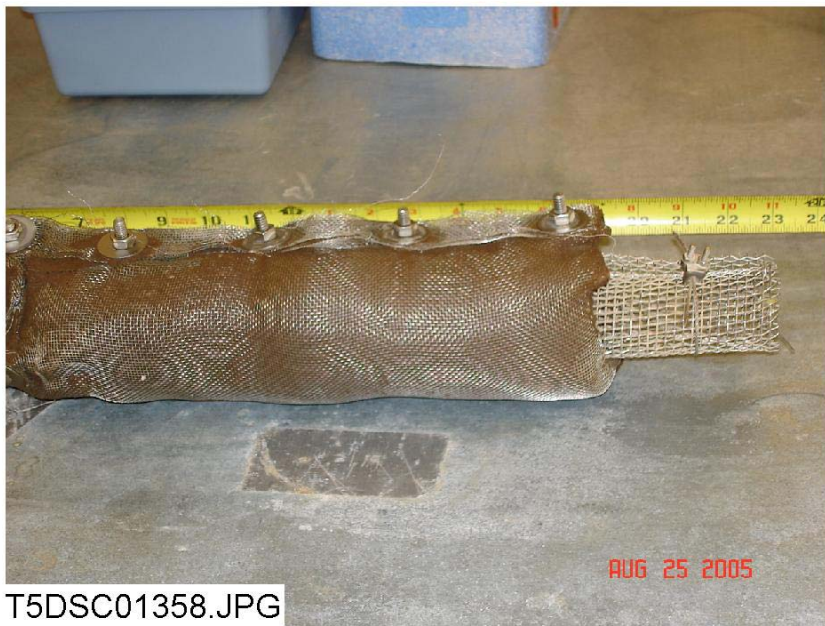
**Figure 3-94. Drain collar removed from the tank bottom.**

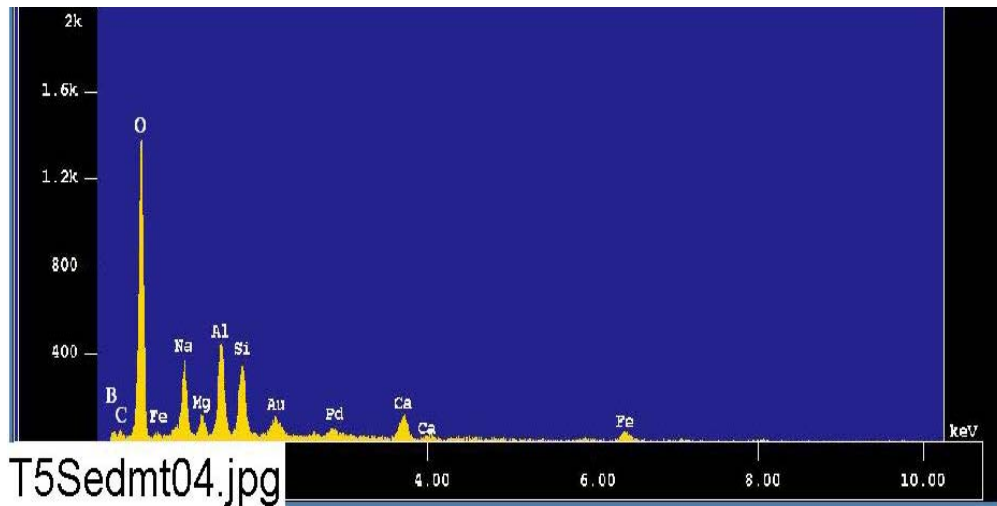
Figure 3-98. EDS counting spectrum for the particulate deposit shown in Figure 3-97.

Figures 3-95 through 3-99 and Table 3-6 provide SEM/EDS and XRD/XRF analysis results. The SEM/EDS and XRD/XRF analyses provided information on the morphology and composition of Test #5 sediment. SEM images show that the sediments were mainly

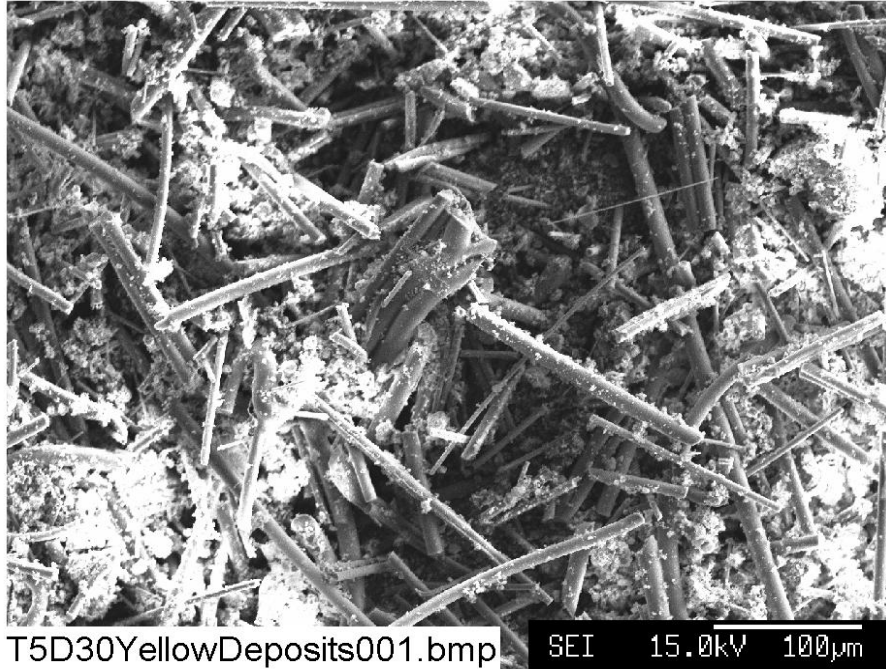
Figure 3-100. SEM image magnified 200 times for the Test #5, Day-30 fine yellow powder on the submerged rack.

For the ICET tests, one concern is the deposition of debris/corrosion products in the tank. To help understand this problem, the corrosion/deposition products were collected after completion of the test. These products are fine yellow powders removed from the submerged CPVC rack. SEM/ EDS results shown in Figures 3-100 through 3-102 indicate that the fine yellow powders were mainly composed of fiberglass debris and particulate deposits containing O, Na, Al, C, Ca, Mg, and possibly Si.

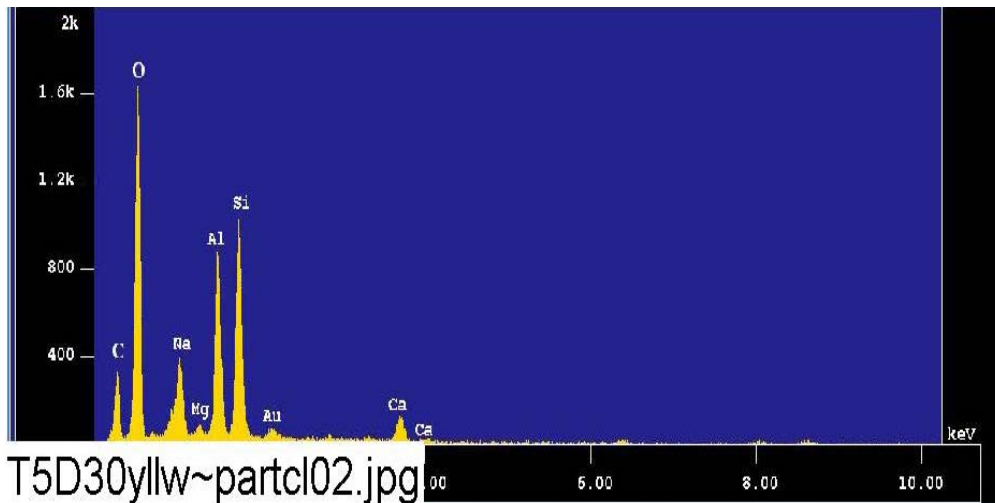
Figure 3-102. EDS counting spectrum for the particulate deposit shown in Figure 3-101.
