Chapter 2

Alternatives Considered

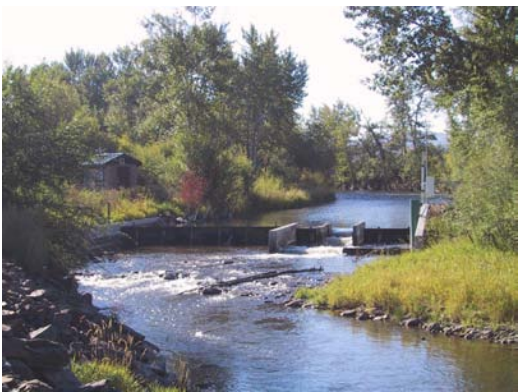
Photo 2.3-1. L6 Diversion structure on the Lemhi River.

Solution: Diversion structures can be modified to provide fish passage using NMFS-approved designs for both upstream and downstream migrants. If modification of the existing structure is not possible then replacement with a new structure with fish passage design may be necessary. Another alternative could be the use of infiltration galleries where irrigation water is collected through a perforated pipe buried in the streambed and transferred to the irrigation system by gravity or pumps. Solutions for diversion structures are often related to other system improvements such as headgate modification, replacement, or consolidation. An example is the recent L-6 diversion enhancement project on the Lemhi River, which was designed by Reclamation (Photo 2.3-1). The

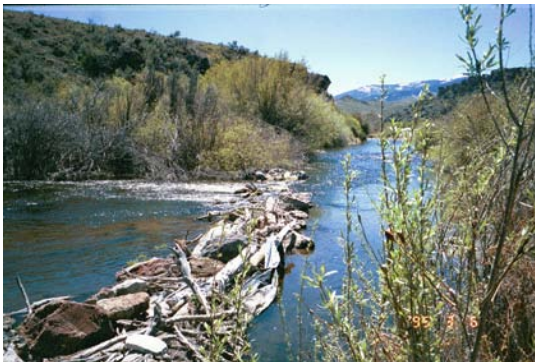
Photo 2.3-2. Push-up dam on Lemhi River.

Problem: Push-up dams (Photo 2.3-2) are created by using heavy equipment (such as a bulldozer or excavator) to move existing or place new gravel and rock, trees, stumps, cars, and refrigerators within the river to create a diversion structure. In some instances, the dam is repaired or replaced as needed if spring runoff washes it out. In others, it is removed annually, after one irrigation season, then replaced at the beginning of the next irrigation season. Although inefficient and harmful to water quality and fish, this traditional practice is a relatively inexpensive method of water diversion. These structures often prevent fish

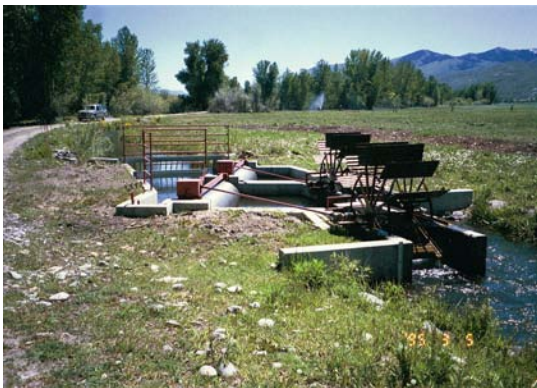
Photo 2.3-4. New fish screen in Lemhi Subbasin.

Solution: Fish screens should be designed according to NMFS criteria and return juveniles safely back to the river (Photo 2.3-4).

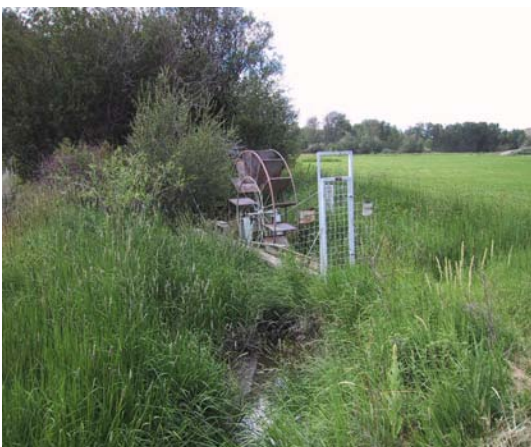
Photo 2.3-5. Nonconforming wiper-style fish screen.
