Injuries associated with continuous miners, shuttle cars, load–haul–dump and personnel transport in New South Wales underground coal mines

In the three years to June 2005, 959 injuries associated with continuous miners (CMs), shuttle cars (SCs), load–haul–dump and personnel transport (PT) were reported by NSW underground coal mines, comprising 23% of all injuries reported. The present paper reports an analysis of the narrative field accompanying these reports to determine opportunities for controlling injury risks. The most common combinations of activity and mechanism were: strain while handling CM cable (96 injuries); caught between or struck by moving parts while bolting on a CM (86 injuries); strains while bolting on CM (54 injuries); and slipping off a CM during access, egress or other activity (60 injuries). For the other equipment considered, the common injury mechanism was the vehicle running over a pothole or other roadway abnormality causing the driver or passengers to be injured (169 injuries). Potential control measures include: monorails for CM services; hydraulic cable reelers; handrails on CM platforms; redesign of CM platforms and bolting rigs to reduce reach dista

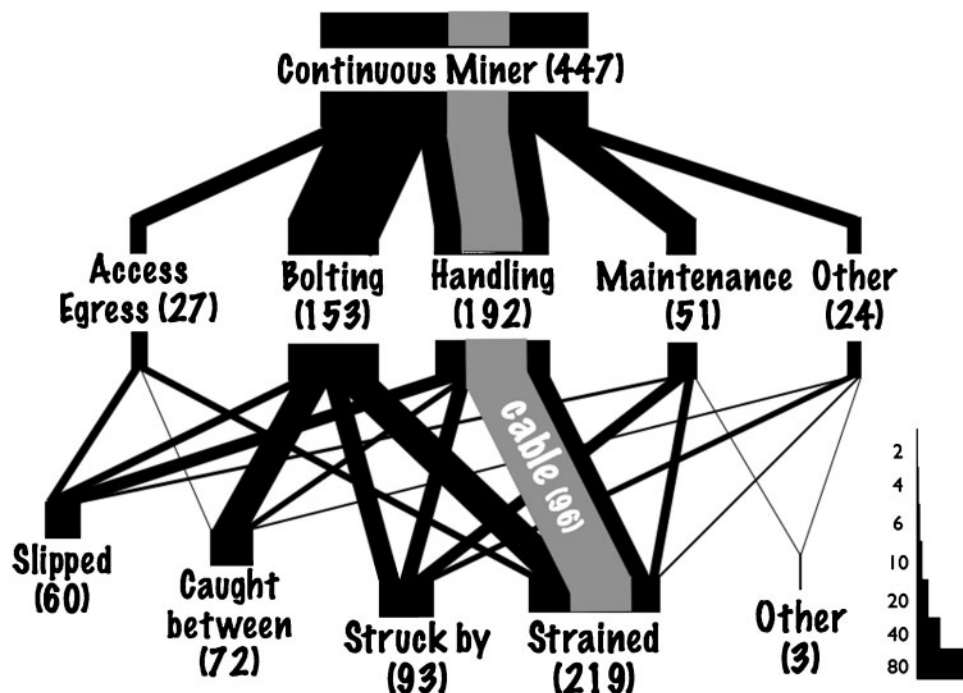
1 Combinations of activity and injury mechanism codes for injuries reported by NSW coal mines involving CMs for three years to June 2005

The data provided in Table 3 and illustrated in Fig. 1 highlight a number of opportunities for controlling injury risks associated with CMs. Strains while handling was the most frequent cause of injury associated with CMs. The majority of these injuries involved handling CM cable. Strains (typically of the shoulder) while bolting were also relatively common and are likely a consequence of handling drill steels and bolts at a distance from the body. Slipping off the CM platform, whether during access or egress, or during operation on the platform, accounted for 60 injuries in the three year period.

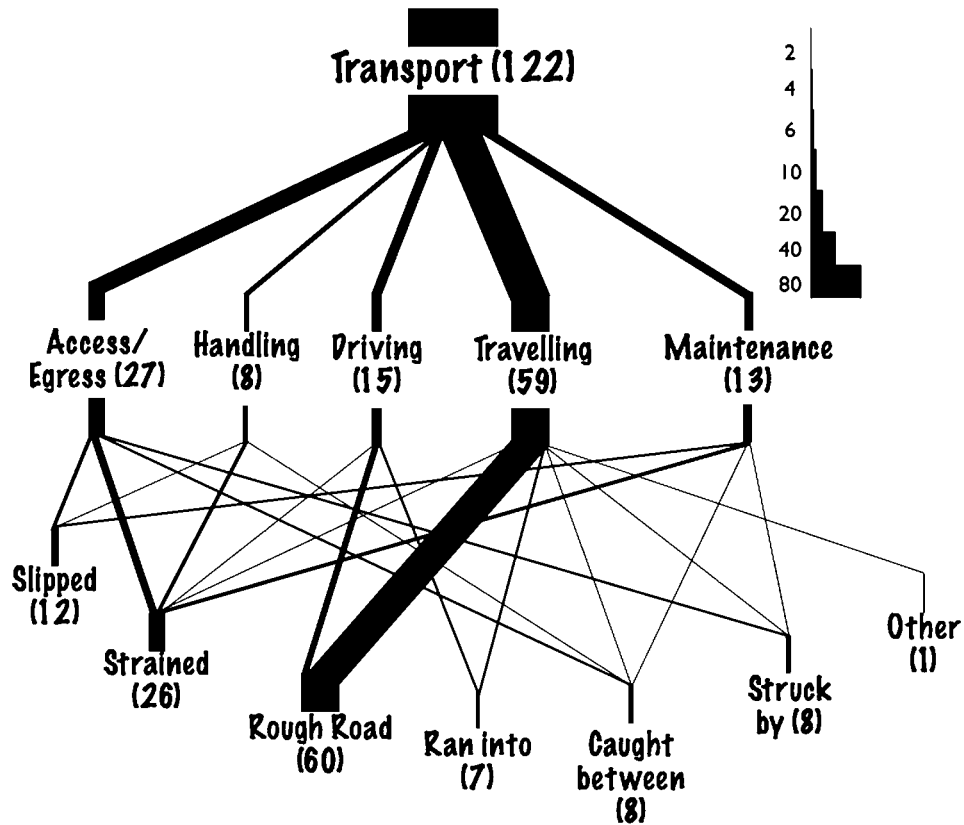
4 Combinations of activity and injury mechanism codes for injuries reported by NSW coal mines involving PT for three years to June 2005

The consideration of Figs. 2-4 reveals that the most common cause of injuries associated with LHD, SC and

PT vehicles occurred when the vehicle was driven over a pot hole or other roadway abnormality. This mechanism typically causes the driver and/or passengers to strike their head on an internal structure resulting in neck, back or shoulder injuries. An injury mechanism of particular concern because of the potential severity of consequences is 'ran into' while driving (or travelling) LHD, SC or PT (35 injuries).
