STS-114

FLIGHT READINESS REVIEW

June 29/30, 2005

Shuttle Processing

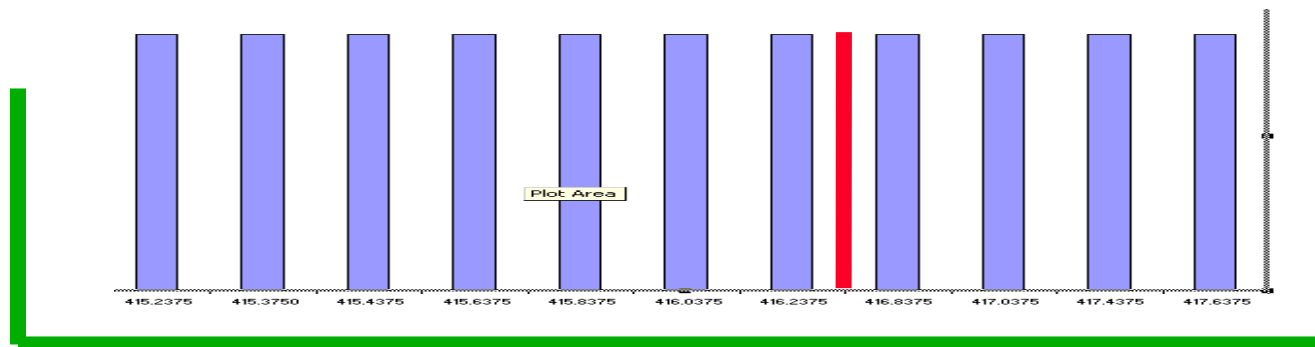
RSS IRD Receiver - Bandwidth is centered upon 416.5 MHz but has a bandpass of +/- 3 MHz. It is therefore able to detect radio transmissions from TRS handhhelds & mobiles

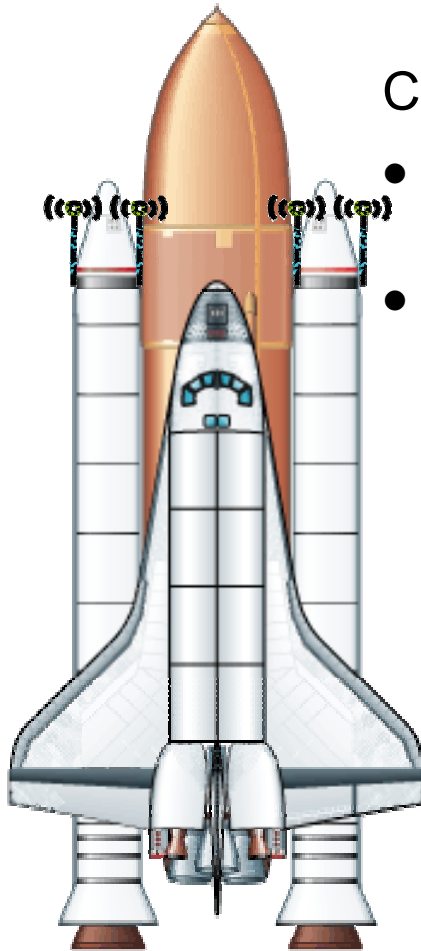
- Booster Integrated Receiver Decoder (IRD) is tuned to 416.5 ± 3 MHz or 413.5 to 419.5 MHz
- All portable trunking radio channels transmit within the IRD's pass band
 - Automatic Gain Control (AGC) may be driven below LCC levels
 - Commands may be corrupted in flight prior to decoding by IRD

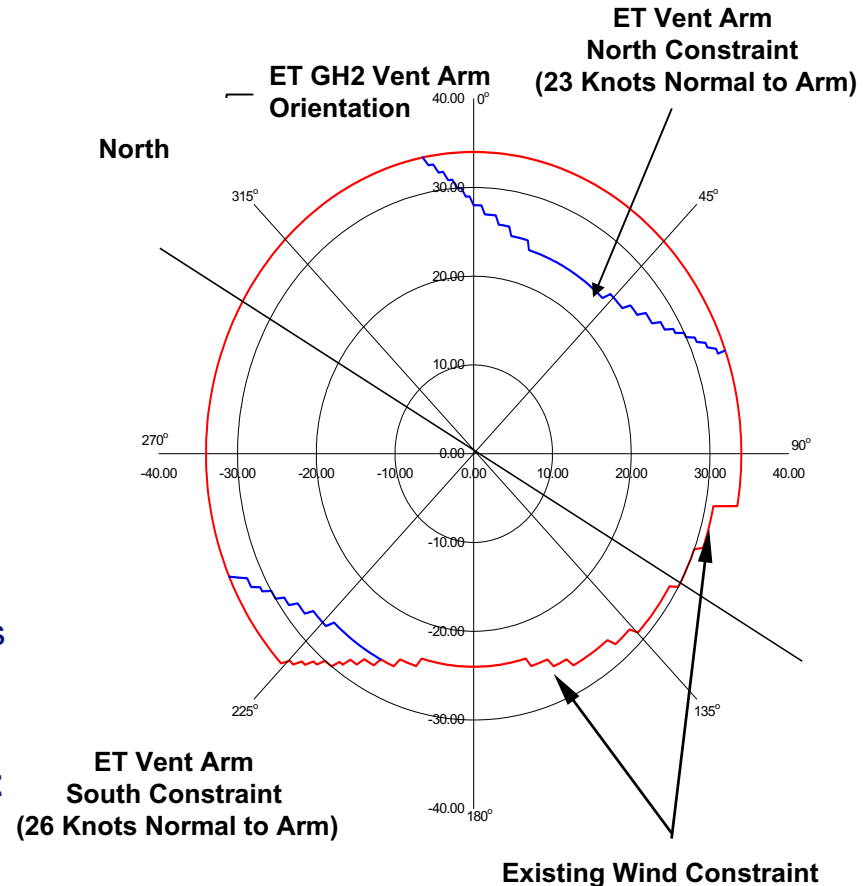
- **For STS-114 & subs - limit winds from NE and SW that exceed set wind criteria**
 - LCC GSE-24 (approved 06/23/05)
- **Evaluate loading / stresses for Trunnion Assembly – complete**
 - Analysis indicated that two components are less than design factor of safety (2:1)
- **NESC review ET GH2 Vent Arm ADAMS Model (in work)**

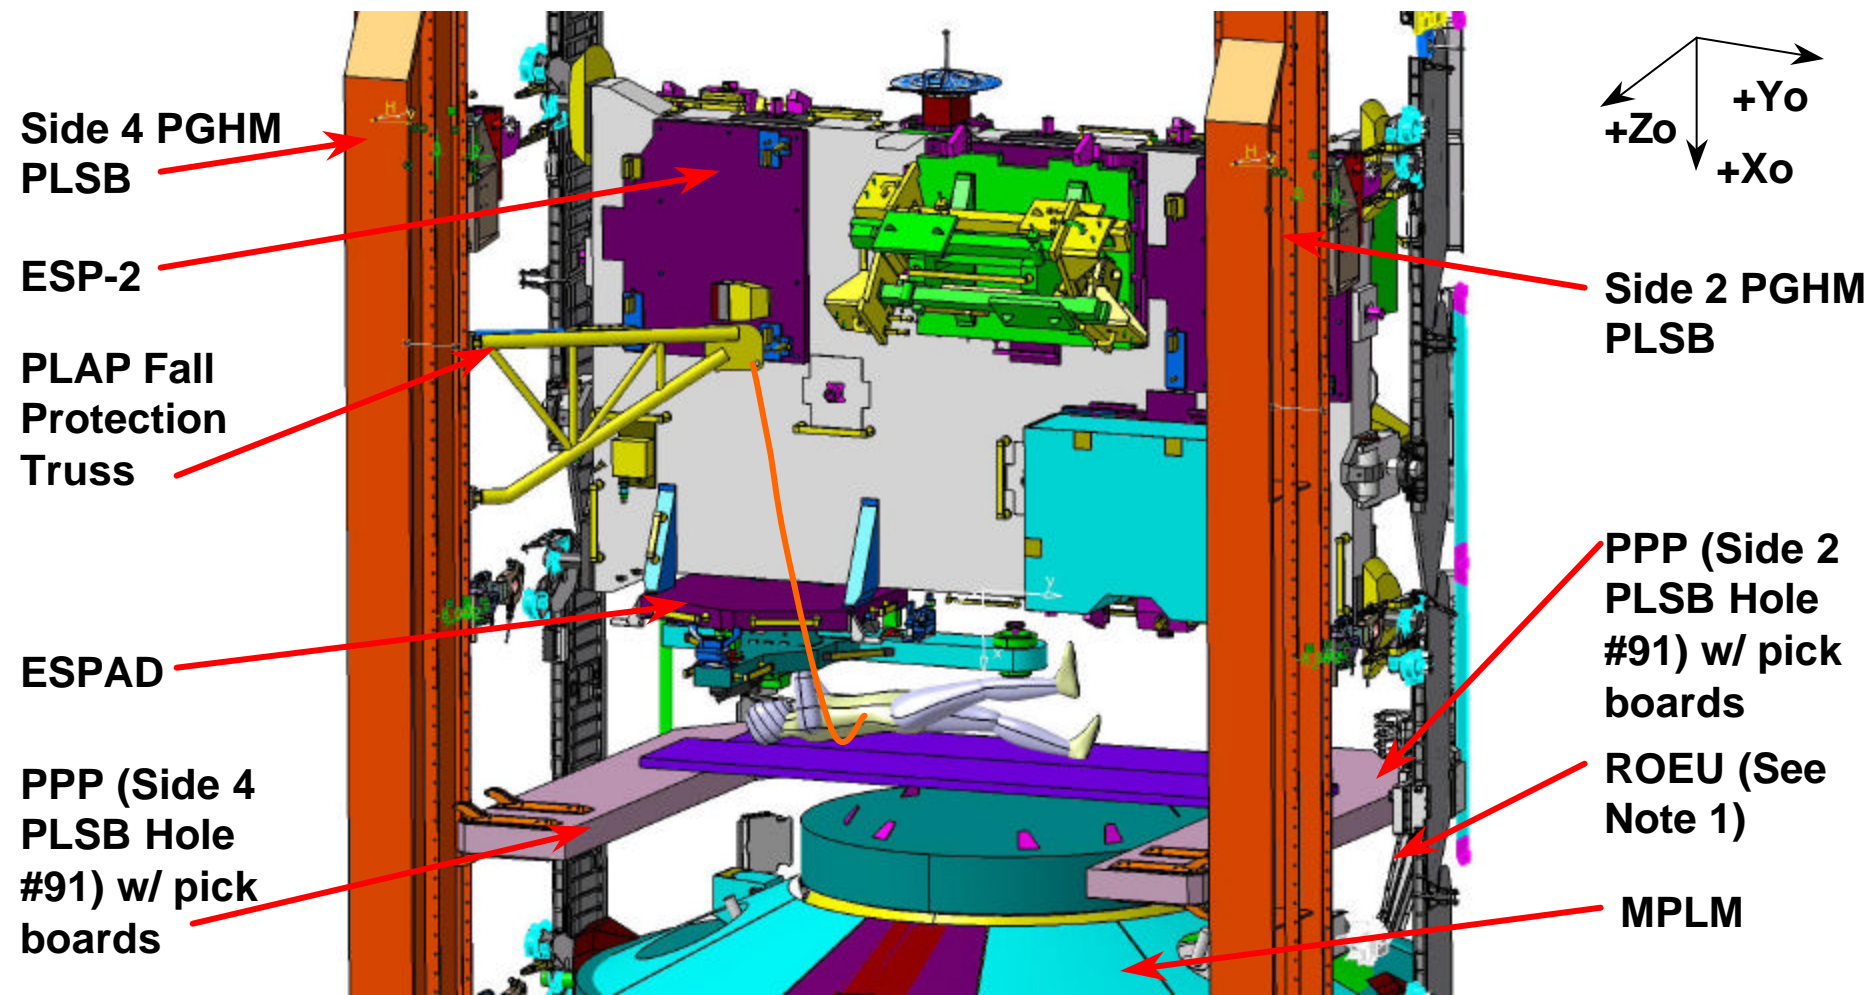
ESPAD ACCESS (KEEL SIDE)

1. ROEU must not be mated for this access to maximize clearance with PPP.
2. Vertical clearance between PPP and MPLM is ~4 inches, vertical clearance between PPP and ROEU is ~4 inches.
