FLYING *Safety*

December 2000

Are You FM Immune?

Expanded FM radio bandwidth in Europe, Africa and the Middle East will have implications for aviation safety

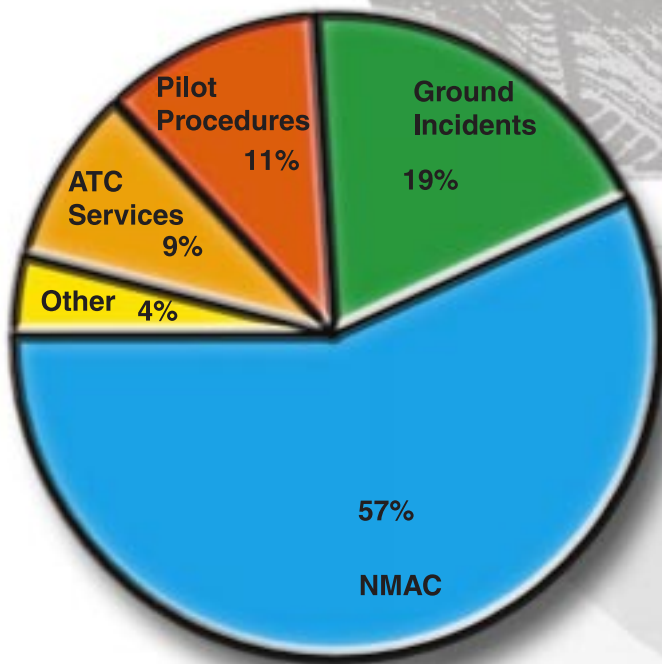
FY00 Reportable Incidents

**In FY00,
Near
Midair
Collisions
rose to
represent
57 percent
of the Re-
portable
Incidents.**

Once again, Near Midair Collisions (NMAC) accounted for the majority of Reportable Incidents. NMACs accounted for 53 percent of the Reportable Incidents in FY98, but only 48 percent for FY99. In FY00, NMACs rose to represent 57 percent of the Reportable Incidents. The majority of them were between USAF aircraft and civilian general aviation aircraft not using correct "See and Avoid" procedures. Base safety offices and air traffic controllers must keep the civilian flying organization knowledgeable of their local hazards and flying missions through their Midair Collision Avoidance (MACA) Program. Air traffic system user education is one of the keys to decreasing

The second largest category was "Ground Incidents," which increased from 15 percent in FY99 to 19 percent in FY00. The majority of these runway incursions were between USAF vehicles and USAF aircraft. There is an assortment of causes, mostly vehicle operators not adhering to, or understanding, ATC instructions around the runway environment. Units must continue to be aggressive and thorough in their flightline driving training programs, especially with contractors, who typically have very little experience operating around taxiways and runways.
